APPENDIX A

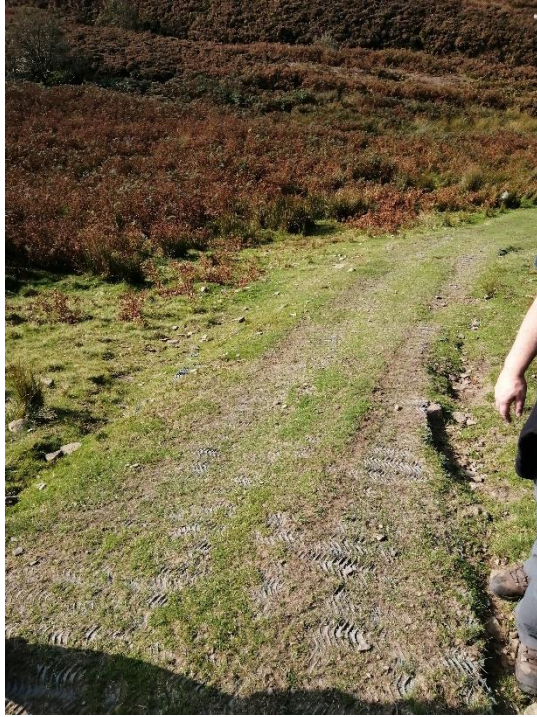
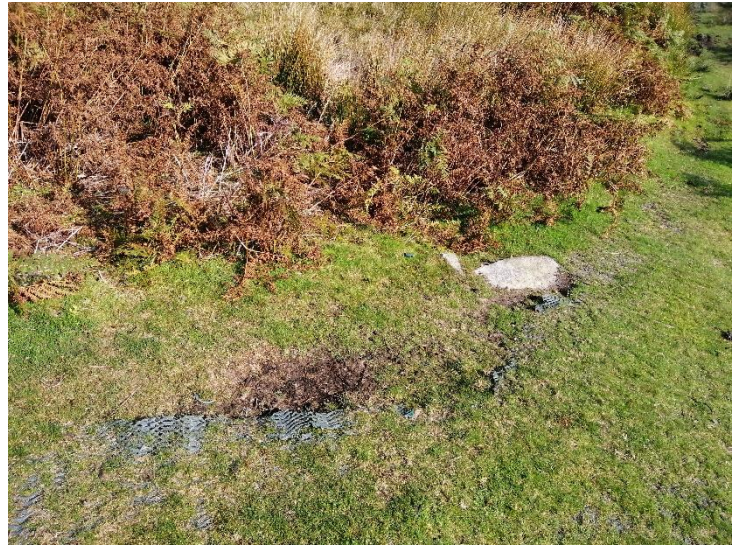
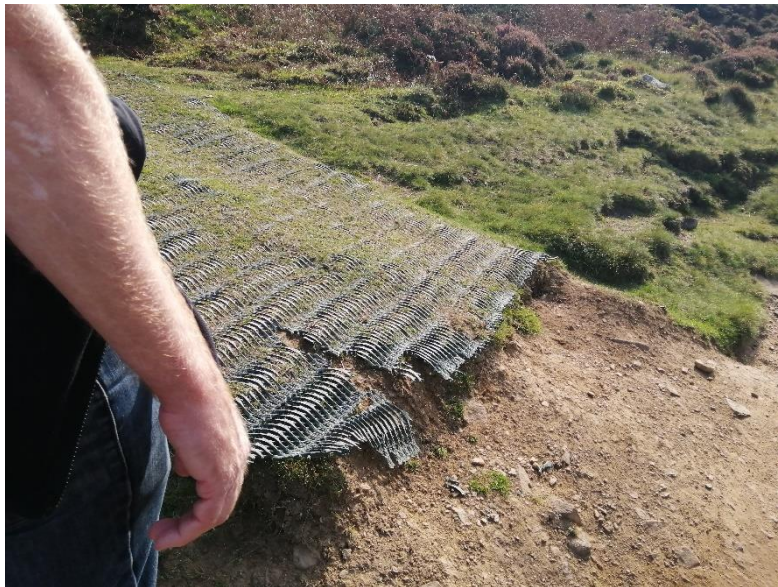
Figure 1 Midhope Moor track 2020 – the track is starting to break up in a number of locations along the clough. Limited vegetation growth on the mesh (probably as it is laid on a crushed stone).

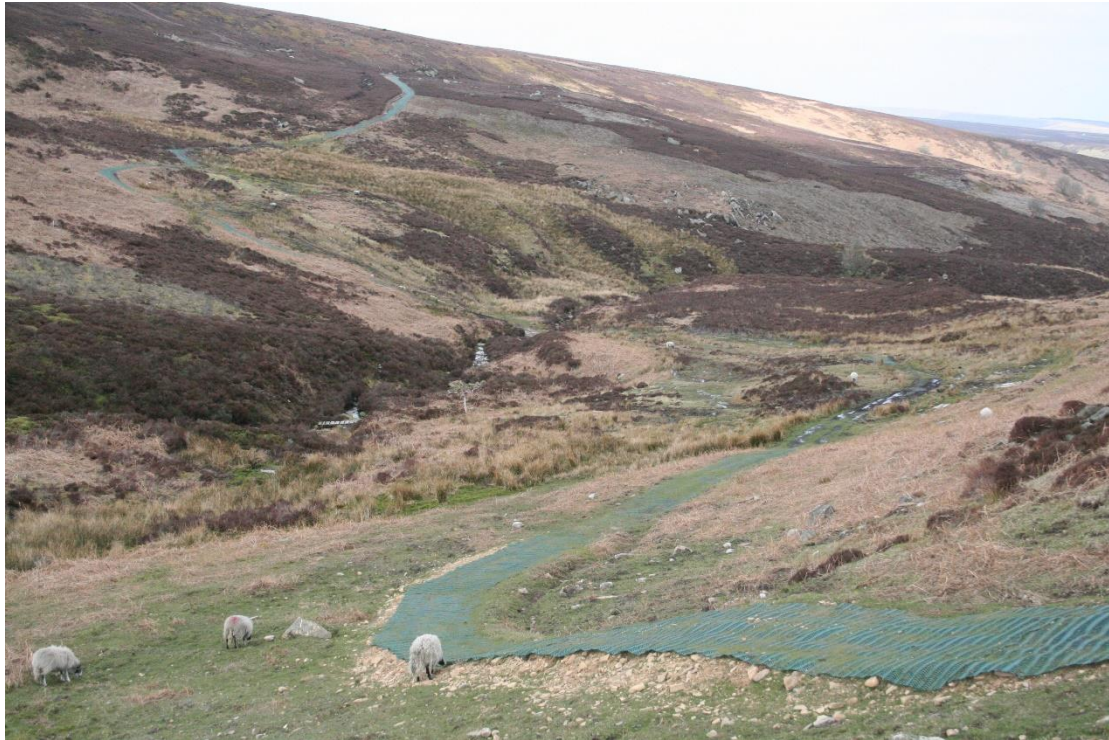
Figure 2 Midhope Moor track in 2018, showing that the track has been built up in this location.

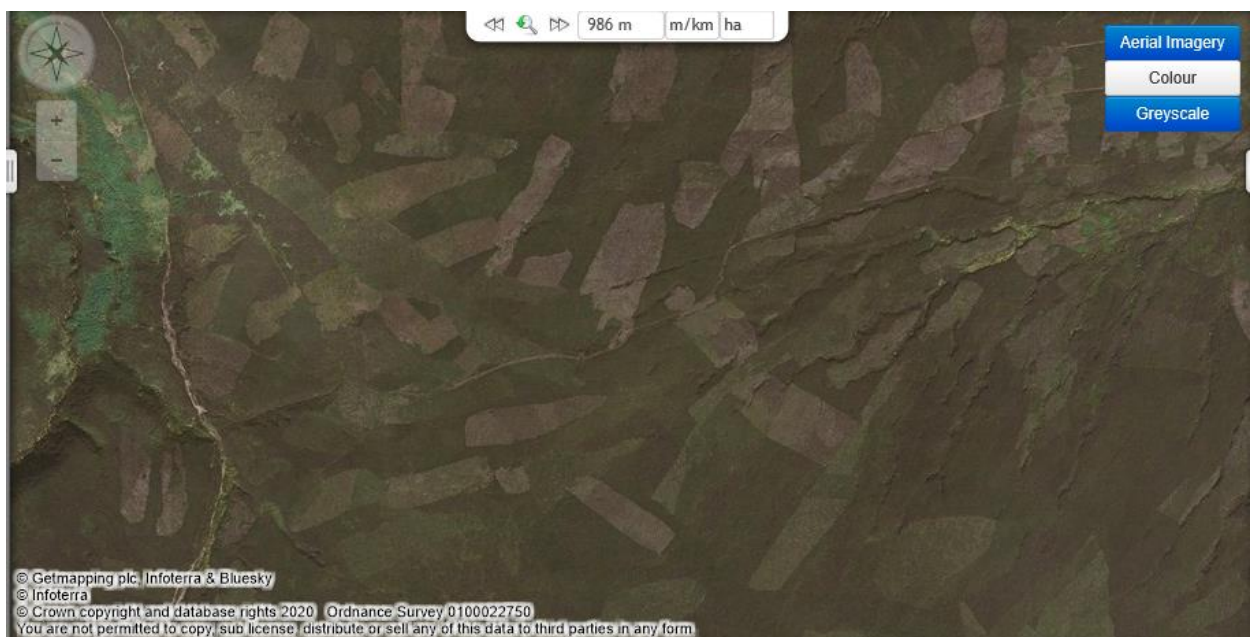
Figure 3 Aerial photo of midhope track in 2005

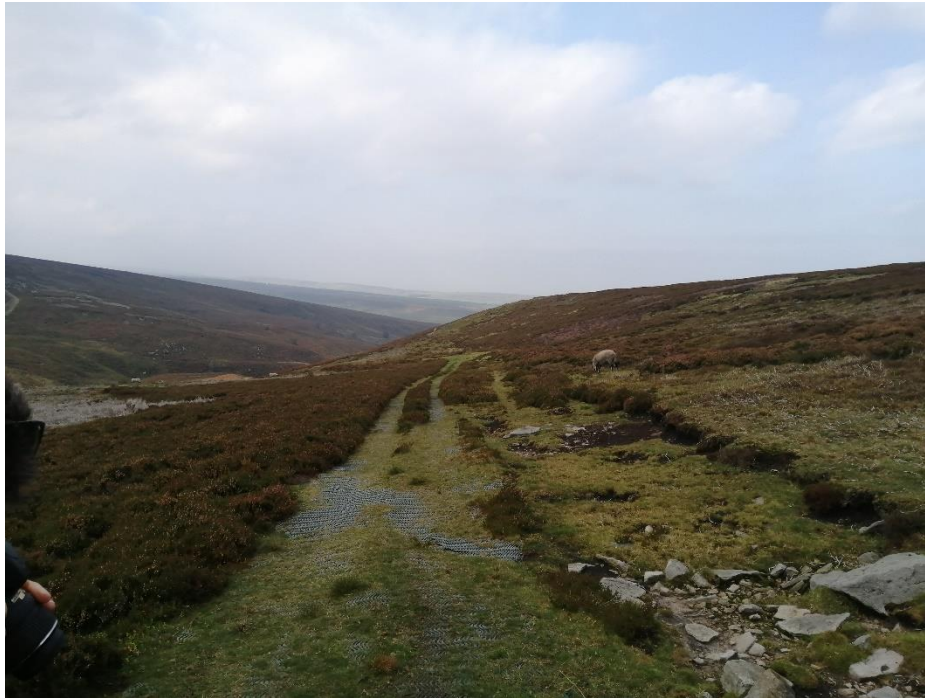
Figure 4 The new track has been sited parallel with the original route in places, which would have resulted in additional habitat damage.

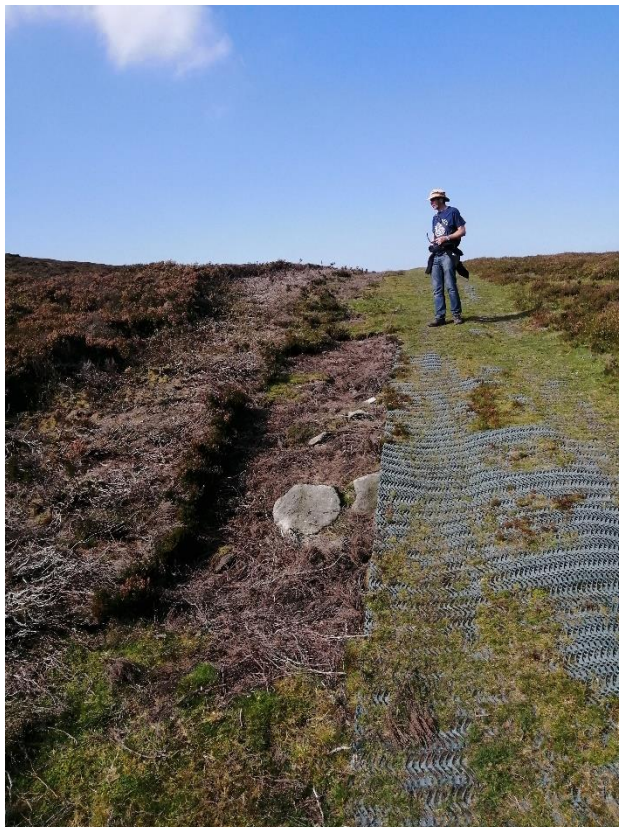
Figure 5 Heather brash cut alongside the track and used to repair eroding surfaces
