Enforcement Notice Appeal relating to Land at Mickleden Edge, Midhope Moor, Bradfield, South Yorkshire, S36 4GX

Proof of Evidence - **Appendix 1**  
on behalf of the Appellant Dunlin Ltd  
for Ecology and Habitats Regulations Assessment

# Midhope Moor Access Track Condition Assessment

October 2020

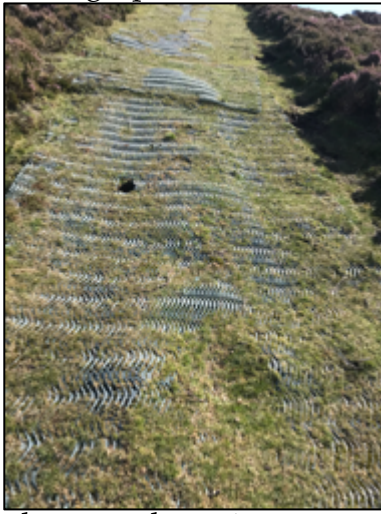
Photograph 1. Plot 2

3.2.3 The two plots that were entirely grassland (without any heather) were located on steep slopes of 30° and 45°. Unsurprisingly the steeper of the two slopes also had scattered patches of bare ground, which appeared as small gaps in the sward rather than larger discrete patches. On the less steep slope, bare ground was 5% and confined to small gaps in the sward.

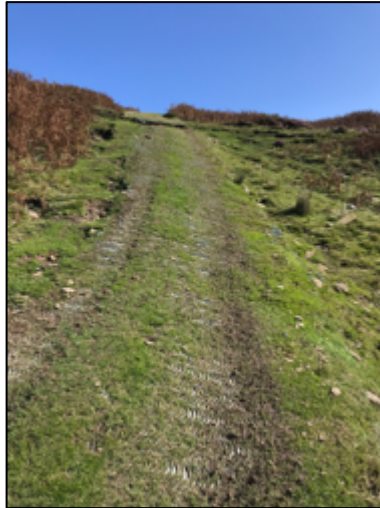
Photograph 5. Plot 11

- 4.1.2 With the exception of the slopes immediately adjacent to Bull Clough, where the artificial matting was not present and on the 45° slope of plot 11, bare ground was no more than 10% cover. The visibility of the matting on sampled plots was 5 to 15% cover rising to 25% on the steep slope of plot 11.

- 5.1.1 The track vegetation is in a favourable condition and is only actively eroding in the immediate vicinity of Bull Clough where there is a lack of matting. Much of the matting is barely visible, because of the overgrowth of vegetation, particularly grassland but also rushes on wetter ground and heather on drier ground. Only where the track is at its steepest on Plot 11 is the underlying matting clearly visible from a short distance.

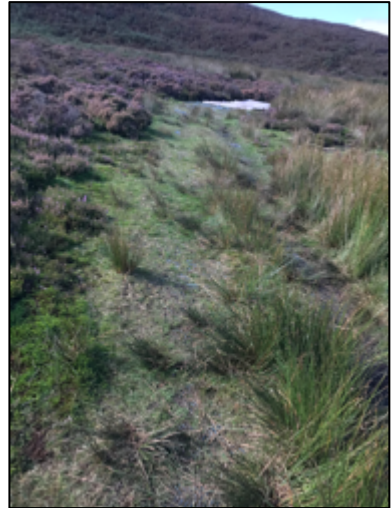
Photograph 6. Plot 14

3.2.6 In a few scattered locations the tracks crossed flushes. The wettest flushes were spanned by wooden poles wired together and pegged in place to form a flexible 'mattress' over the flush. Plot 14 (to the west of Bull Clough) was located on a patch of ground that was fairly wet on the day of the survey visit, but no standing water was visible. The plot was,

however, distinctive from other grassland plots because of the abundance of soft rush either side of the track and along the central strip of the track.

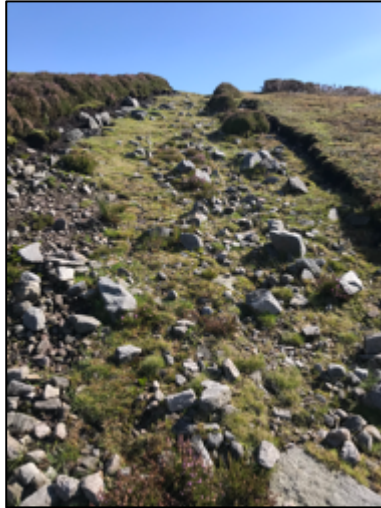
Photograph 9. Plot 3

- 3.3.5 Two plots were selected because they were obviously tracks that were no longer in use. Plot 3 was separated from the extant track by a strip of heather. The plot was part of a former track on a 30° slope. Plot 6 was located next to the extant track on flatter ground. Plot 3 was characterised by extensive bare ground and exposed rock (40% cover) most likely to have been caused by trampling and erosion. The vegetation was a mix of small patches of grasses, heather and bilberry in amongst the rocks and bare peat.

- 4.2.1 Plots 3 and 6 are both considered to be in unfavourable condition, because of the extent of bare ground and fragmented vegetation. There is, however, evidence of a recovery on plot 6, because a healthy stand of heather has established and seedlings are appearing in the neighbouring grassland. It is anticipated that both plots have the potential to re-develop into heather dominated vegetation if trampling is avoided.

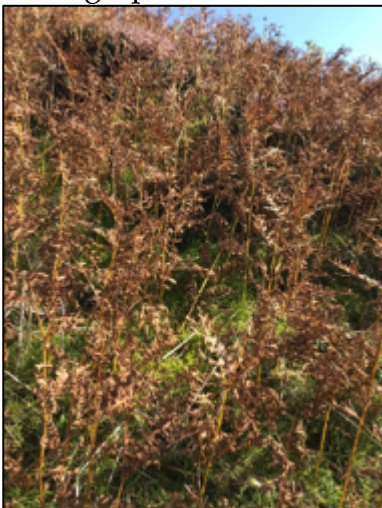
Photograph 14. Plot 12

- 3.3.2 For the purposes of this study it is assumed that there has been no loss of heathland habitat in recent years. With the exception of plot 12, which was located on a steep slope and was dominated by a mix of grasses and bracken *Pteridium aquilinum*, the remaining heathland plots had a cover of ericoid shrubs that ranged between 75% and 100%. The sub-shrubs were all in healthy condition with minimal evidence of grazing. No non-native species were encountered; grass cover was less than 10%, and bare ground was less than 10% cover. Plot 16 was in the pioneer stage of development having been burned a few years previous to the visit. All other stands were in the building stage of development.

- 4.2.2 The only heathland plot that was not in favourable condition was located on a steep rocky slope and past management and abiotic factors including slope and surface water run-off may have favoured the abundance of bracken and grassland. The patch of bracken and grassland habitat was, however, localised and unrepresentative of the surrounding heathland vegetation, which was otherwise considered to be in favourable condition.

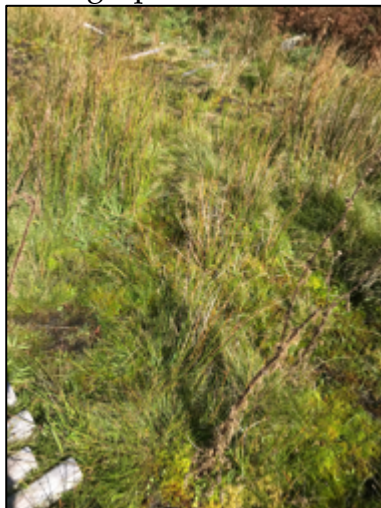
Photograph 15. Plot 13

- 3.3.4 The flush that was sampled had less than 25% bare ground, was not heavily grazed and had no non-native species. It did not, however, contain 90% cover of indicator species; the cover of soft rush and grasses was more than 10% in each case, and running water was visible.

- 4.2.3 The plot 13 flush was in unfavourable condition because of active drainage (visibility of running water), extent of indicator species and presence of unfavourable grasses and soft rush. There was, however, no signs of trampling by livestock or people and the vegetation on the other side of the track was intact without signs of active drainage. Without any further trampling it is anticipated that the cover of bryophytes, forbs and small sedges will expand to occupy the areas of open water and therefore, the flush is considered to be in unfavourable, but recovering condition.
