Figure 3: Photographs and assessment commentary
(photographs taken 5th December 2019)

Views from the wider landscape

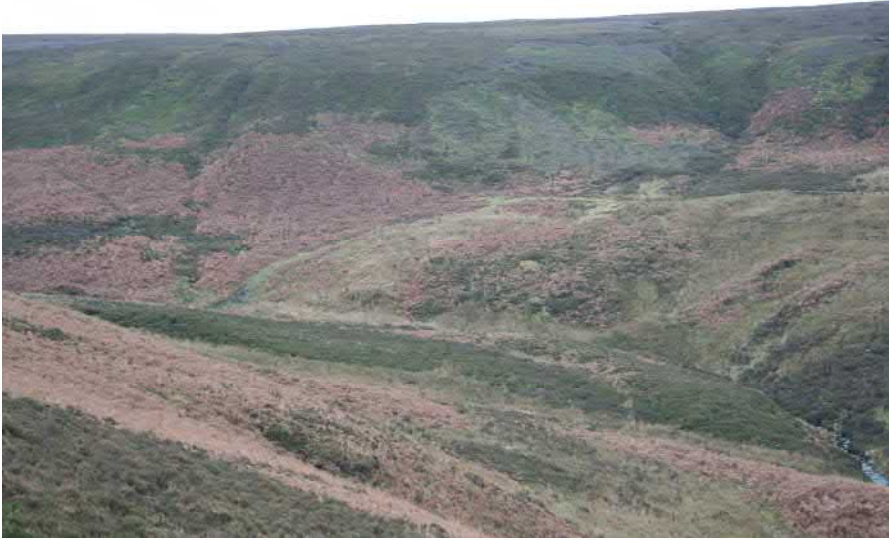
VP 1 – looking south west - approaching the track from the footpath to the North

A grassy strip through bracken / heather / rush mosaic – a noticeable view element, but not visually prominent.

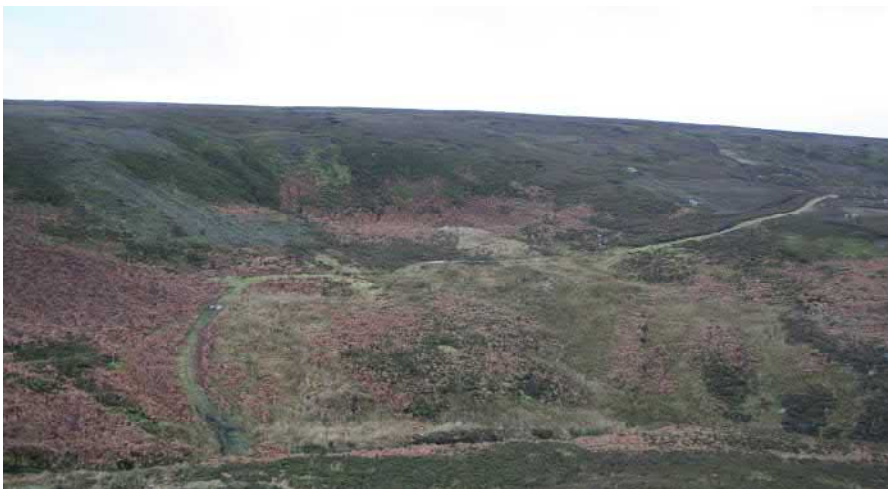
VP 2 looking west - approaching the track from the footpath to the North. The line of track is more prominent (and visually detracting) as you get closer. Sections of the mesh are visible.

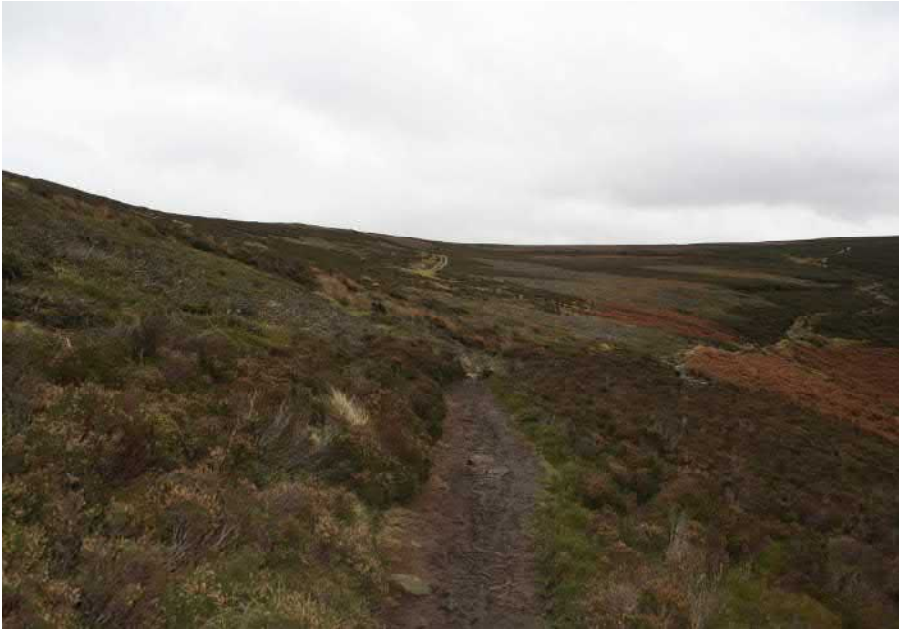
VP 3 looking south- approaching the track from Cut Gate PRow to the North. Due to field of view, the track is not prominent – but a short stretch of grass strip (with heather centre line) visible to the SW.

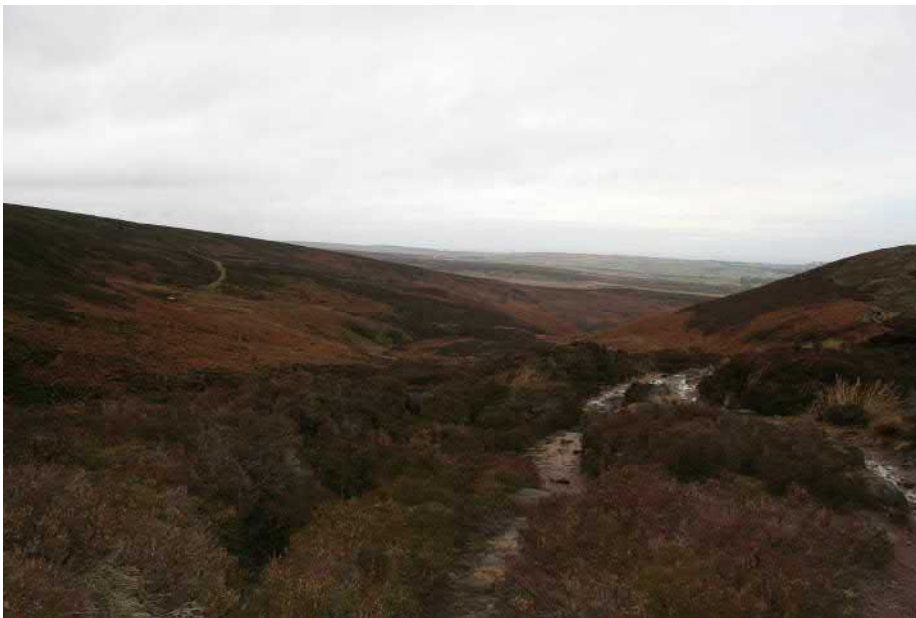
VP 4 looking north- approaching the track from Cut Gate PRow to the south
Again, due to the field of view the track is not prominent in a wide area – a short stretch of grass strip is visible to the north west.

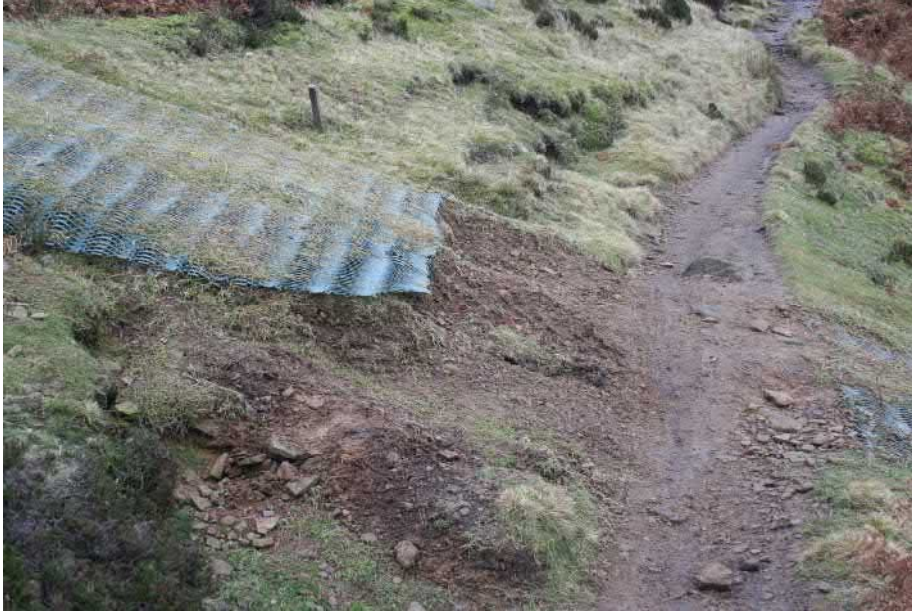
Photo 1 – looking south from Cut Gate PRoW.

Poor integration of mesh track with footpath. Track appears to be built up from the surrounding landform. Very limited vegetation growth on the mesh (probably as it is laid on a crushed stone). This section is a highly detracting element in the landscape and strongly conflicts with landscape character.

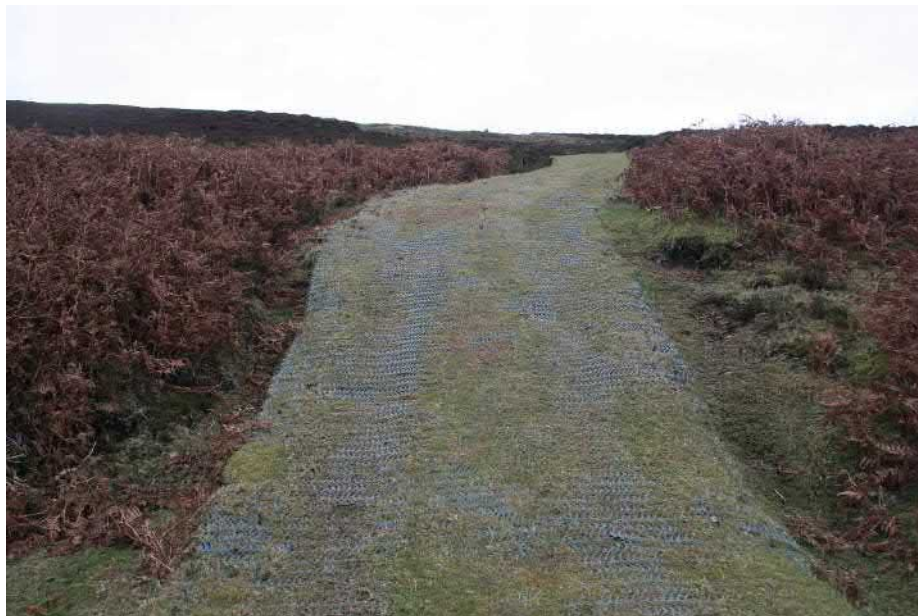
Photo 2 – looking east up mesh track from the Cut Gate PRoW

Very limited vegetation establishment – the mesh is very prominent and detracting. Levels are clearly built up from the surrounding landform.

This section is a highly detracting and incongruous element which strongly conflicts with landscape character.

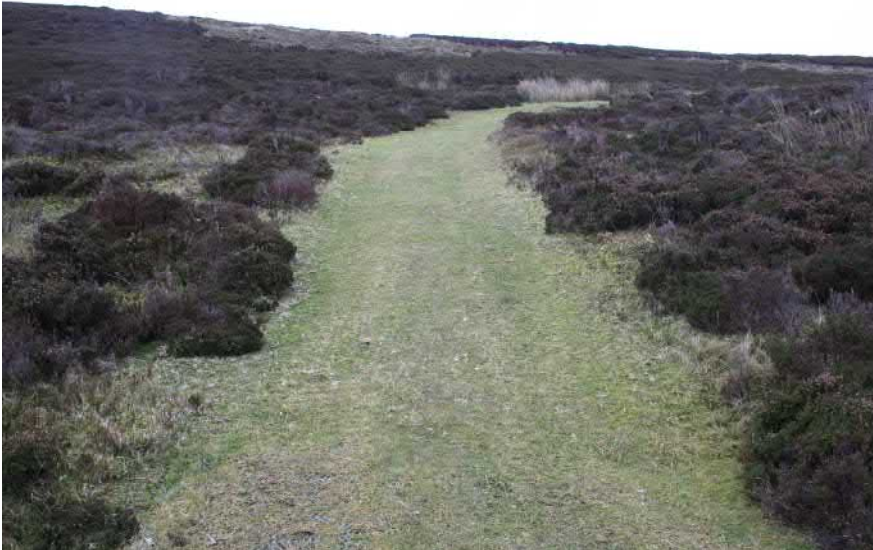
Photo 3– looking east up mesh track.

Better vegetation establishment (the mesh not generally visible) – but the track forms a grassy strip through surrounding heather.

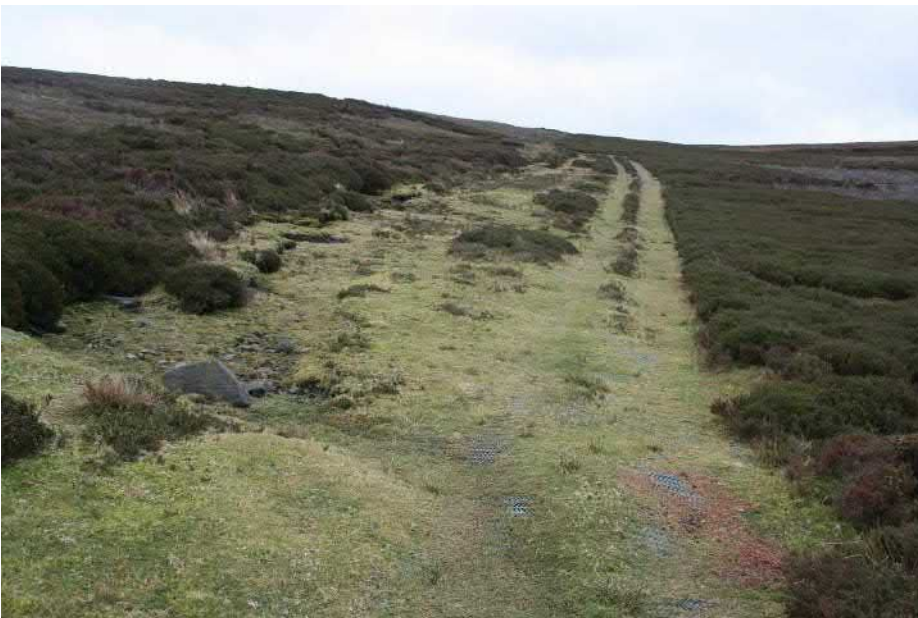
Photo 4 – looking south east along the mesh track

The mesh is generally not visible and there is some heather re-growth along the centre line of the track. Mesh line alongside previously damaged areas.

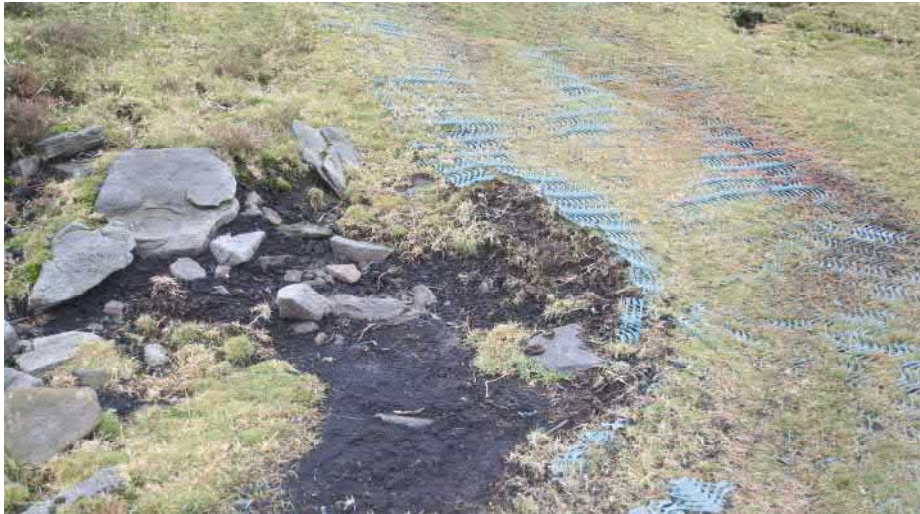
Photo 5 – looking east along mesh track – at base of incline.
Erosion by vehicle turning – mesh damaged and breaking up. Limited vegetation establishment.

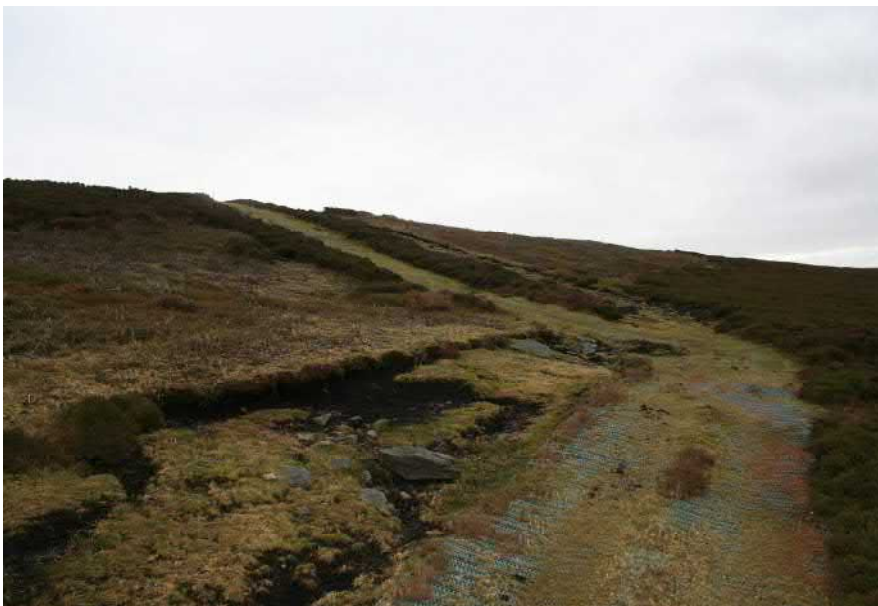
Photo 6 - looking south east along mesh track – towards the base of the incline
Poor integration with surrounding land, with limited restoration of previous route. Limited vegetation establishment. The track is a prominent detracting feature which conflicts with landscape character.

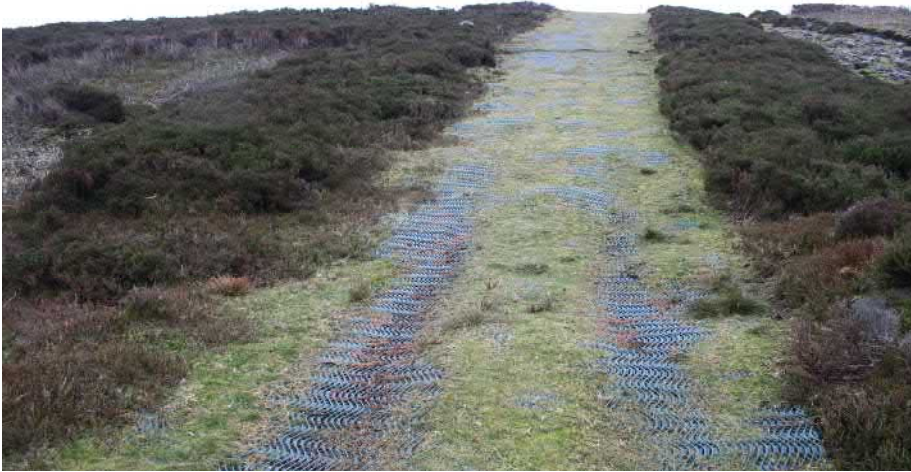
Photo 7 - looking east along mesh track – at base of incline
Very limited vegetation establishment – the mesh is prominent and incongruous.

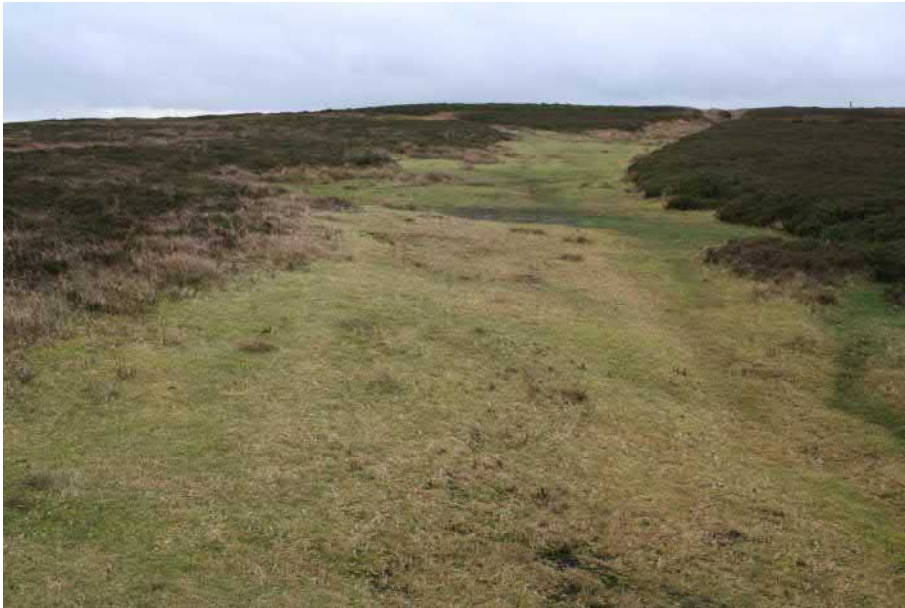
Photo 8 - looking south east along mesh track – at top of incline
Better vegetation establishment (the mesh is not generally visible) with grass. This section is not visually inappropriate due to integration with surrounding grassed areas.

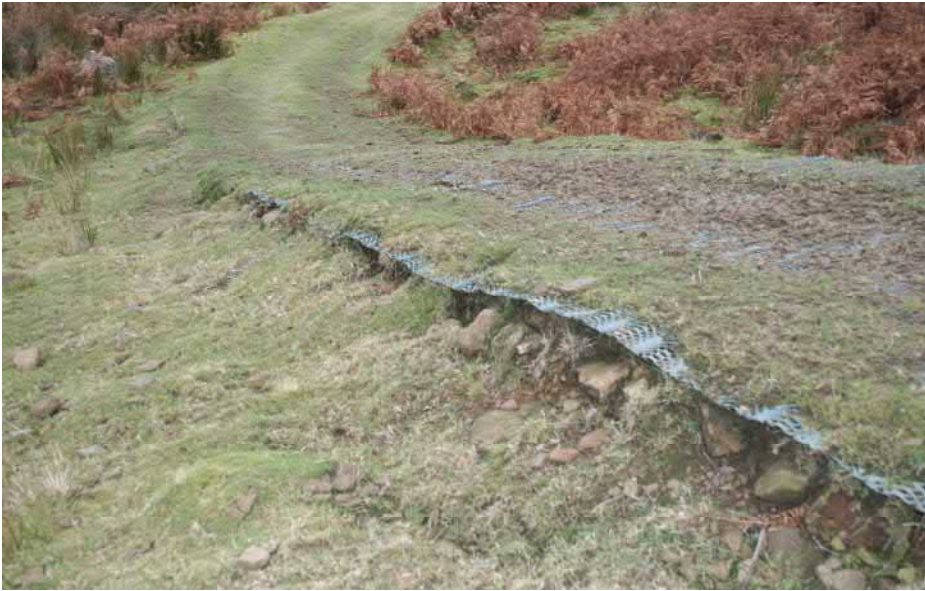
Photo 9 - looking west down mesh track – from Cut Gate PRoW.

Track level built up (presumably to reduce crossfall) and poorly integrated with surrounding landform. Very limited vegetation establishment and edges of mesh breaking up. Highly detracting.

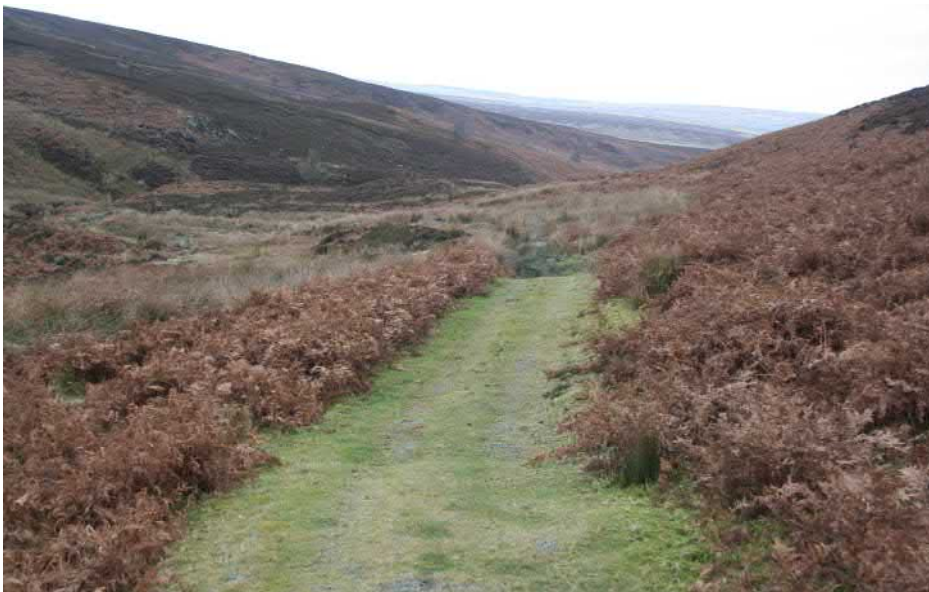
Photo 10 - looking north west along mesh track – at base of incline

Reasonable grass establishment, but track is prominent as it contrasts with the surrounding bracken.

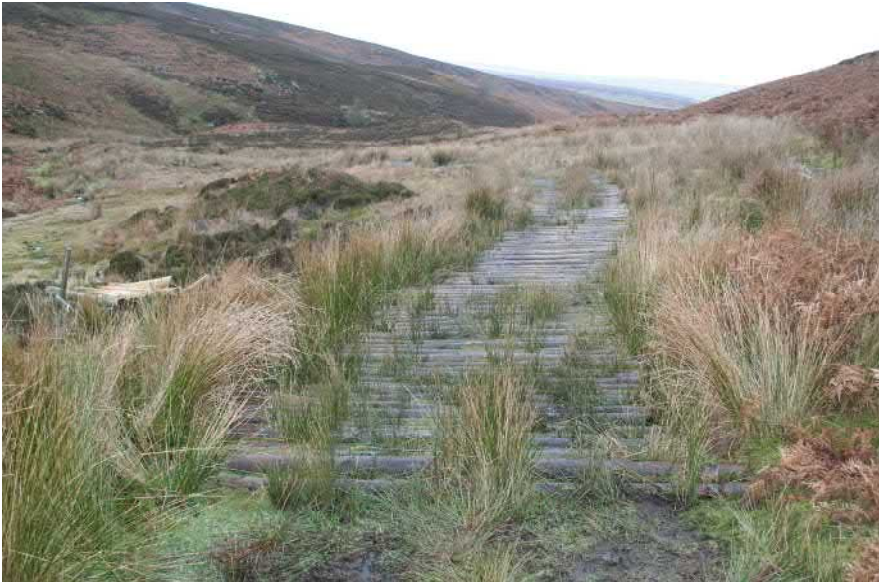
Photo 11 - looking north-west along mesh track – logs rafts placed over mesh.

A series of ongoing remedial works have taken place in the wetter rushy areas. Once weathered, the log rafts are not highly visually prominent – rushes to grow through to aid integration with landscape – but they are still contrasting elements.

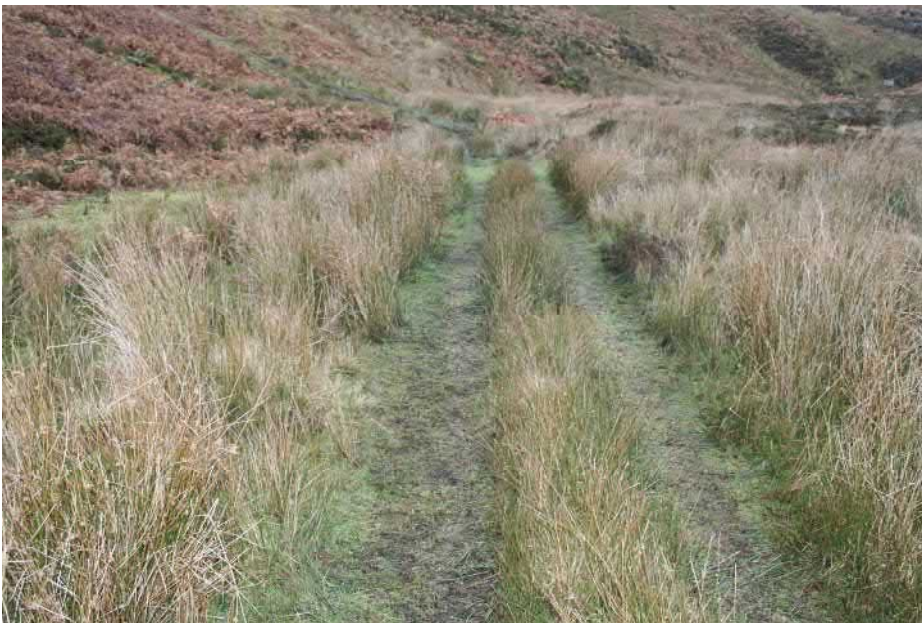
Photo 12 - looking north-west along mesh track

Greater rush vegetation establishment on the mesh in this section reduces visual intrusion.

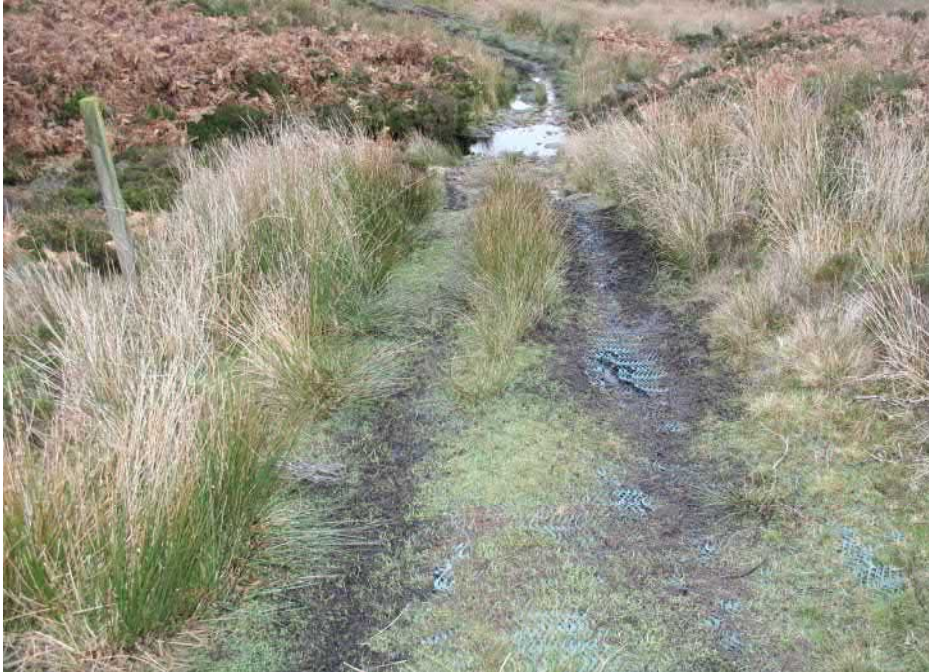
Photo 13 - looking west – incline down to the crossing point at Mickleden Beck
The mesh is breaking up and sinking into the wet ground on slope.

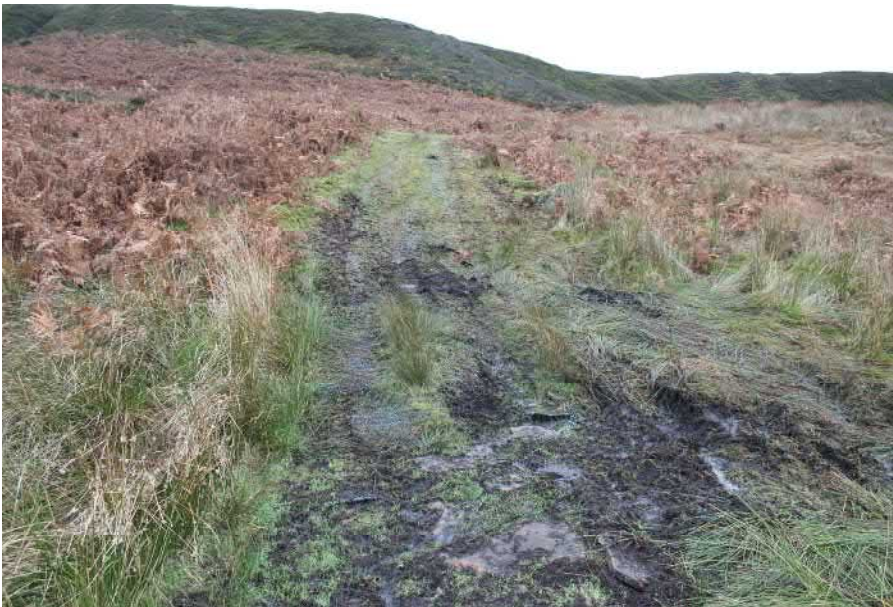
Photo 14 - looking west – climbing up from the crossing point at Mickleden Beck
The mesh is again breaking up and sinking into the wet ground on the slope.

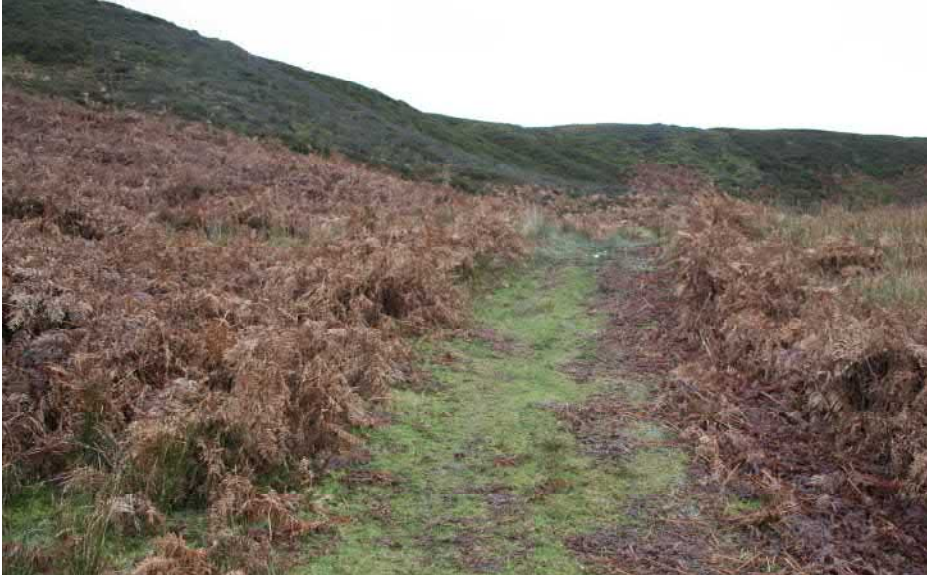
Photo 15 - looking west along the mesh track.

Reasonable grass establishment on the mesh, but the track is relatively prominent through the surrounding bracken.

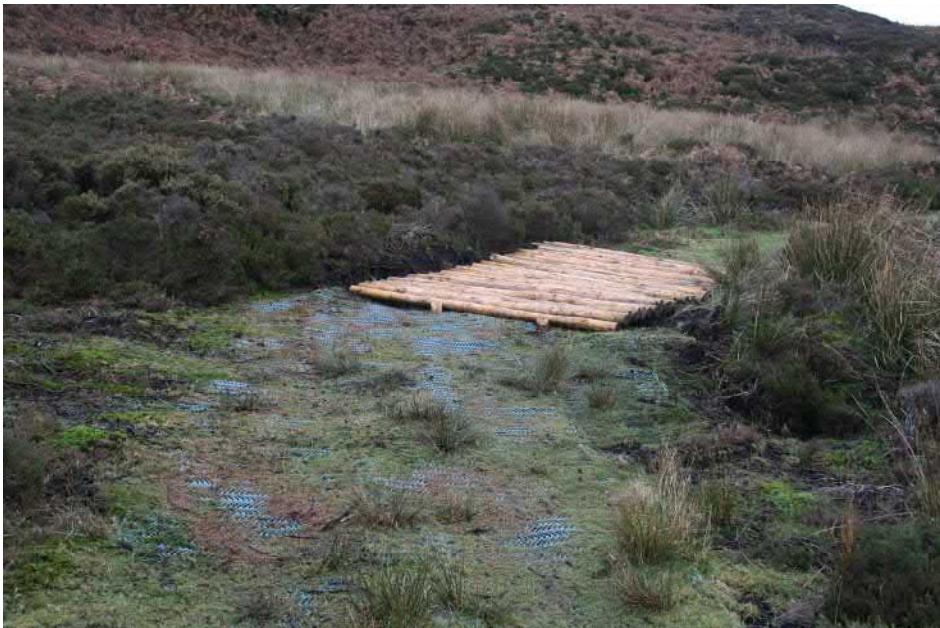
Photo 16 - looking north-west along mesh track

Poor vegetation establishment and the mesh is clearly not preventing damage to the wet flushes – remedial works (installing more log rafts) in progress.

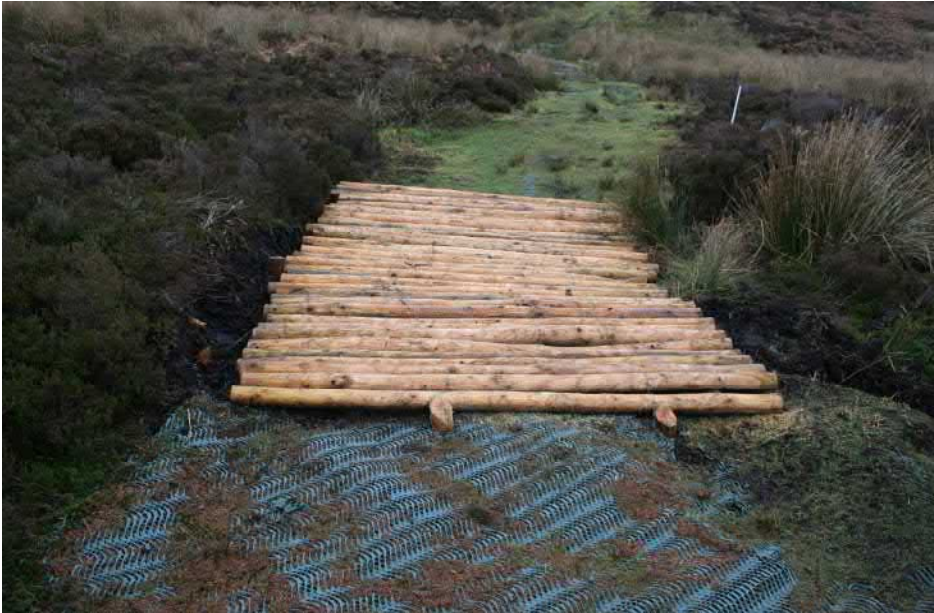
Photo 17 - looking north-west along mesh track
As above.

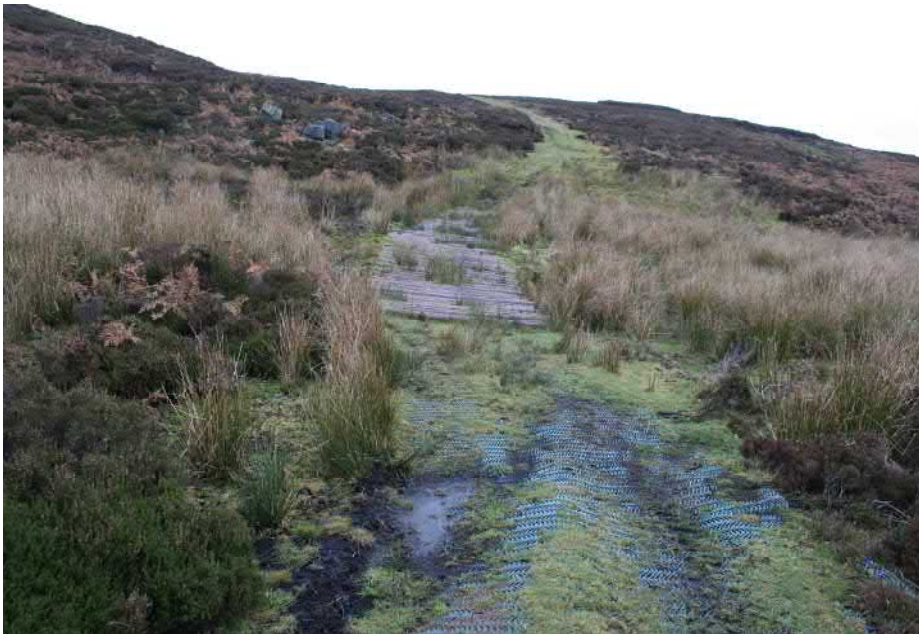
Photo 18 - looking north-west along mesh track
Limited vegetation establishment and mesh again not coping with wet ground conditions. The log rafts are slightly less intrusive than the mesh (due to colour and better rush re-growth).

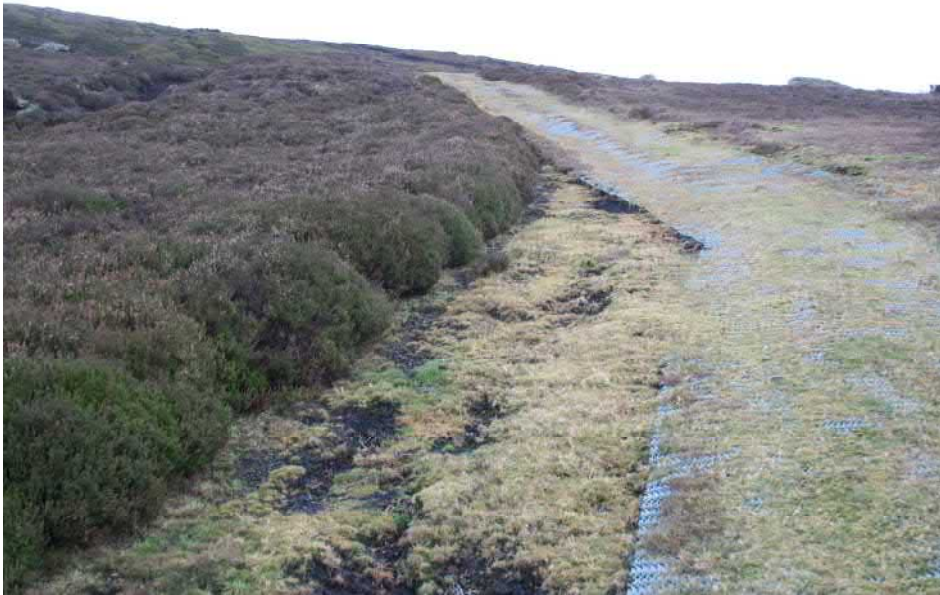
Photo 19 - looking north-west along mesh track – on incline
Poor vegetation establishment on mesh. Mesh poorly integrated with the landscape and very prominent through surrounding heather.

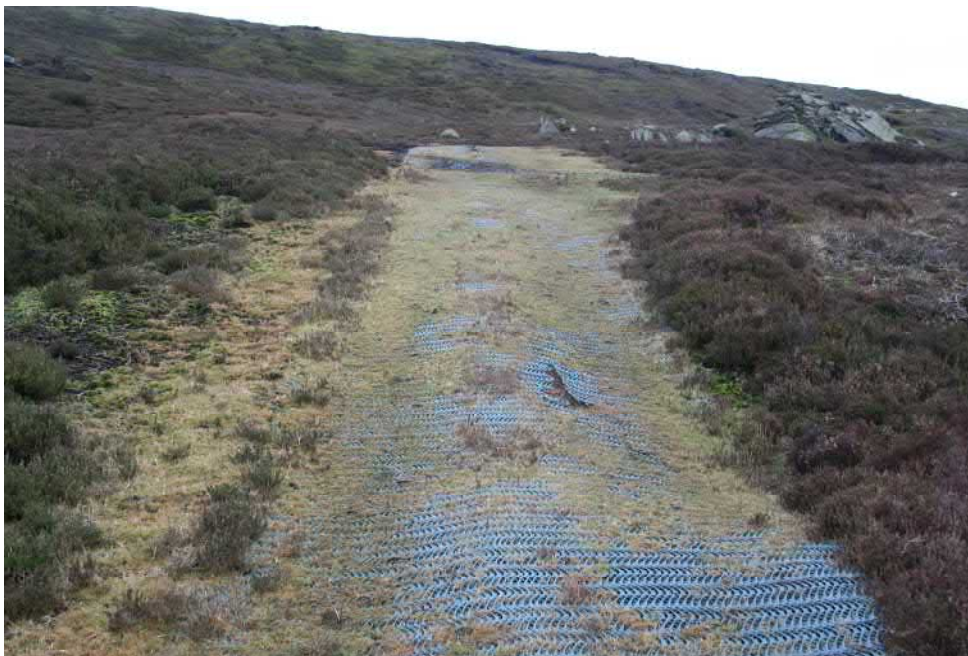
Photo 20 - looking north-west along mesh track – on incline
Very limited vegetation establishment. Mesh clearly damaged and breaking up. Mesh poorly integrated with landscape and prominent through surrounding heather.
