**Tree Report: An appraisal/census of some of the Parkland trees at
Thornbridge Hall.**

Ashford in the Water. DE45 1NZ

**Date of Survey: Various dates, May to July 2021.
(And previously in February 2017.)**

File reference: Thornbridge Hall 05

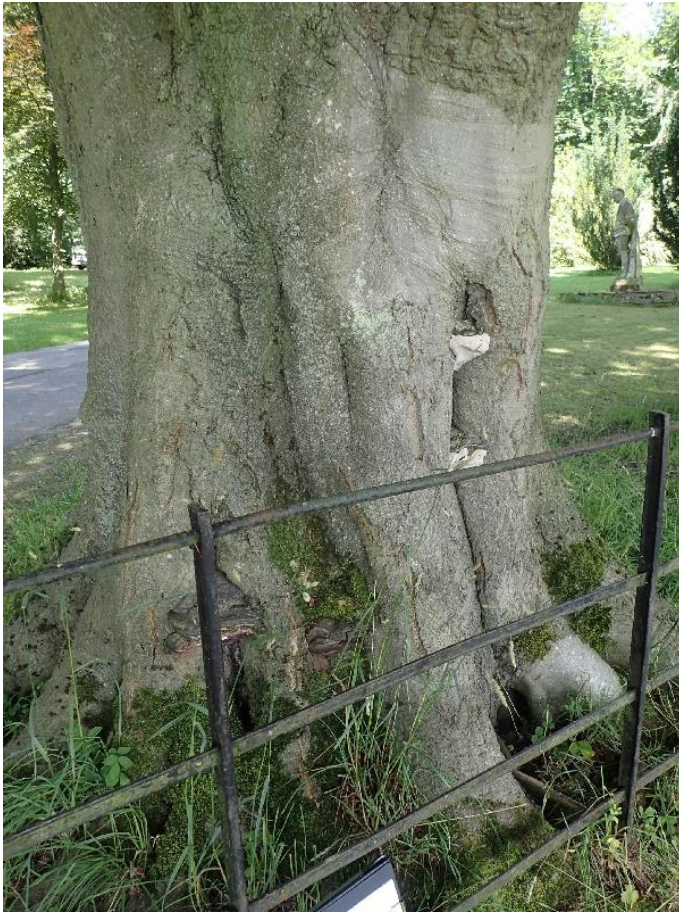
Photograph 1.

No.	Species	Ht	TD	Comment
1.	Beech	26	1330	This tree was not actually in the park proper but hard against the fence. I've included it because it is infected with at least two serious decay fungi, and has been for some time. The tree's crown is merged with another Beech tree's that isn't obviously infected with anything.

Photograph 1 shows the trunk of tree 1, just outside the park. The railings are the boundary. I've included this because it is sprouting so many fungal fruiting bodies that I could not ignore it.

The fungus is either *Ganaderma austral* or *G. applanatum*. The common names of these two are Southern Bracket or Artist's Fungus, but as it's difficult to distinguish between them, it's probably as well to simply call them *Ganaderma*.

I also found another fungus; *Kretzschmaria deusta*. These are both fungi that are likely to be causing decay and consideration needs to be given to removing the tree or managing its decline.

1. The only tree I consider to be a potential threat to anything is tree 1. This should be inspected more thoroughly, possibly with a drill or increment borer, to examine the extent of the fungi's influence.

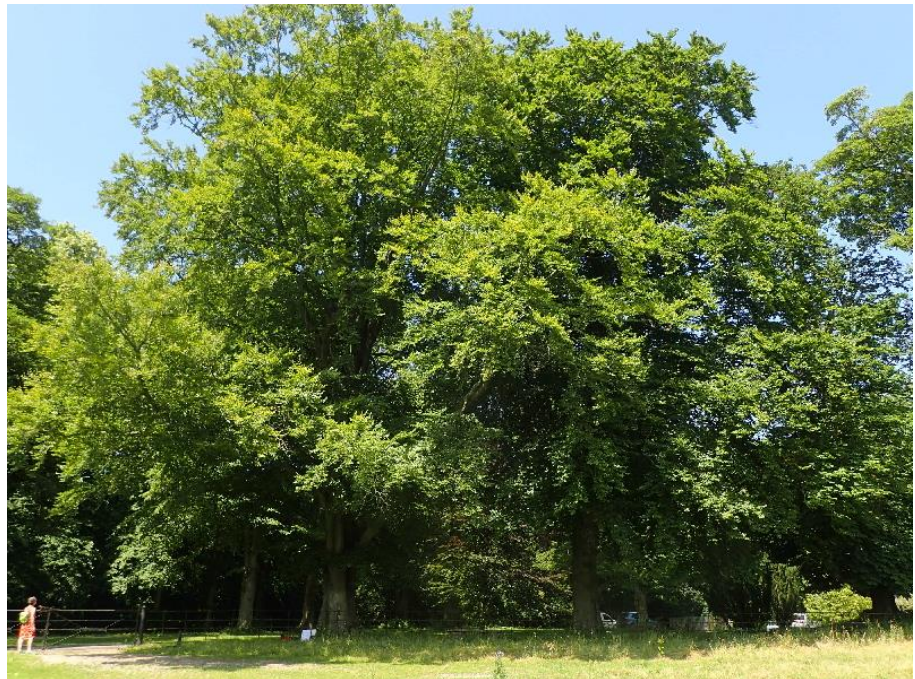
Photograph 2.

Photograph 2 is a view of the tree with its companion to the right. This situation needs to be monitored even though there is no obvious indication of dysfunction in the foliage.

Some areas of the trunk around the fungal fruiting bodies appeared to be less solid than others. This requires further investigation.

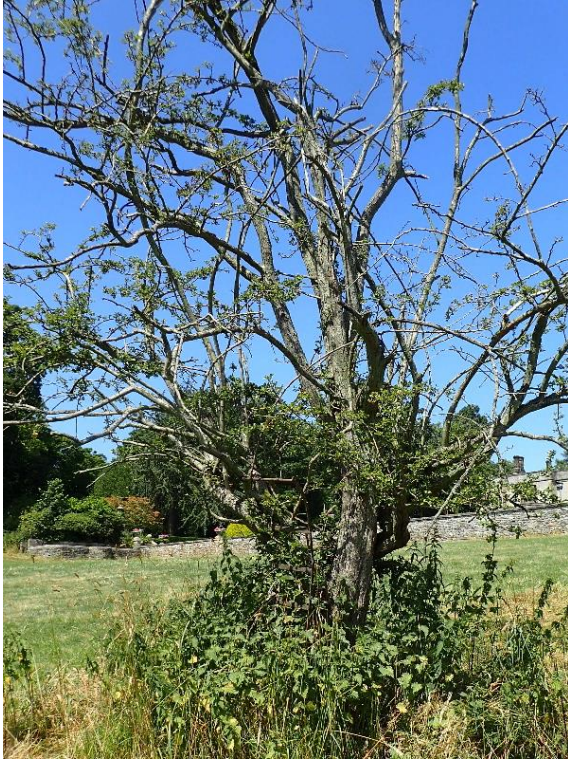
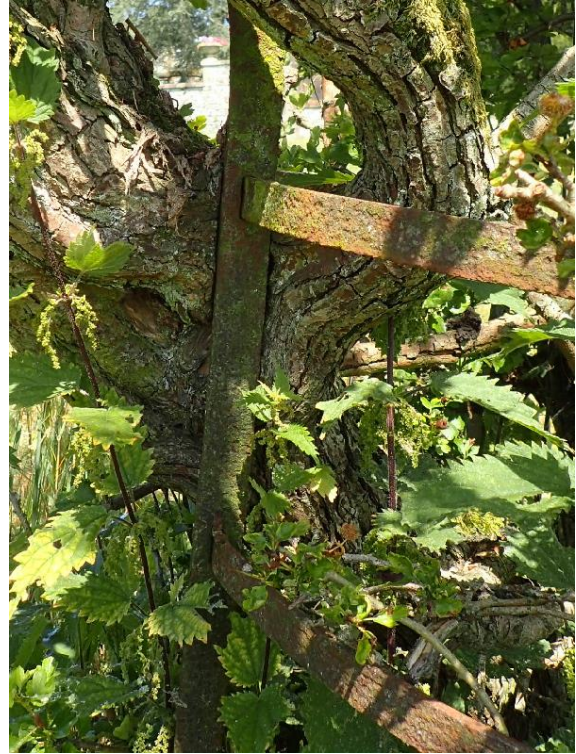
2.	Hawthorn	5		Almost completely dead. Within an old tree guard.
3.	Common Lime	25	1010	Crown relatively narrow, some ground damage from livestock.
4.	Common Lime	25	1300	Several secondary stems. Ground beneath the crown disturbed by livestock.

Photographs 2 & 3 show the dead Hawthorn tree 2. Hawthorns are not really parkland trees and thus I wonder whether the tree originally planted in the guard died and the Hawthorn set itself.

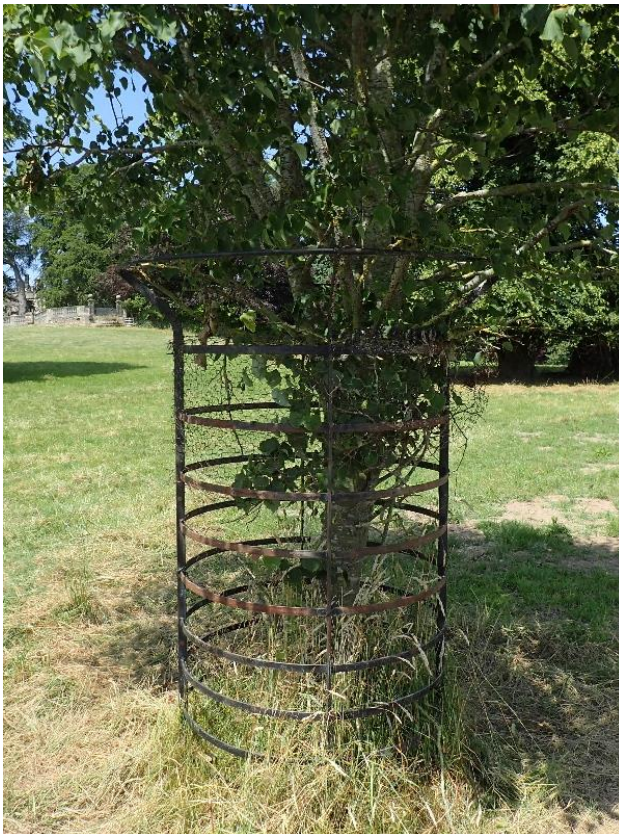
Photograph 5.

9.	Small Leafed Lime.	5	200	TD estimated. Within a tree guard, apparently recently planted. Some formative pruning would be prudent.
10.	Norway Maple.	15	910	Dark foliage, possibly the cultivar Schwedlerei (I recall this tree having red/purple foliage in May). 17 metre crown spread.

Photograph 5 shows the only other tree guard I noted in the park. This is clearly recently planted tree because one of the clients initials (and a birthday?) are profiled in the crossbars. Tree guards like this were used to protect trees planted in parkland, where animals were likely to browse the bark. This tree would benefit from some formative pruning.

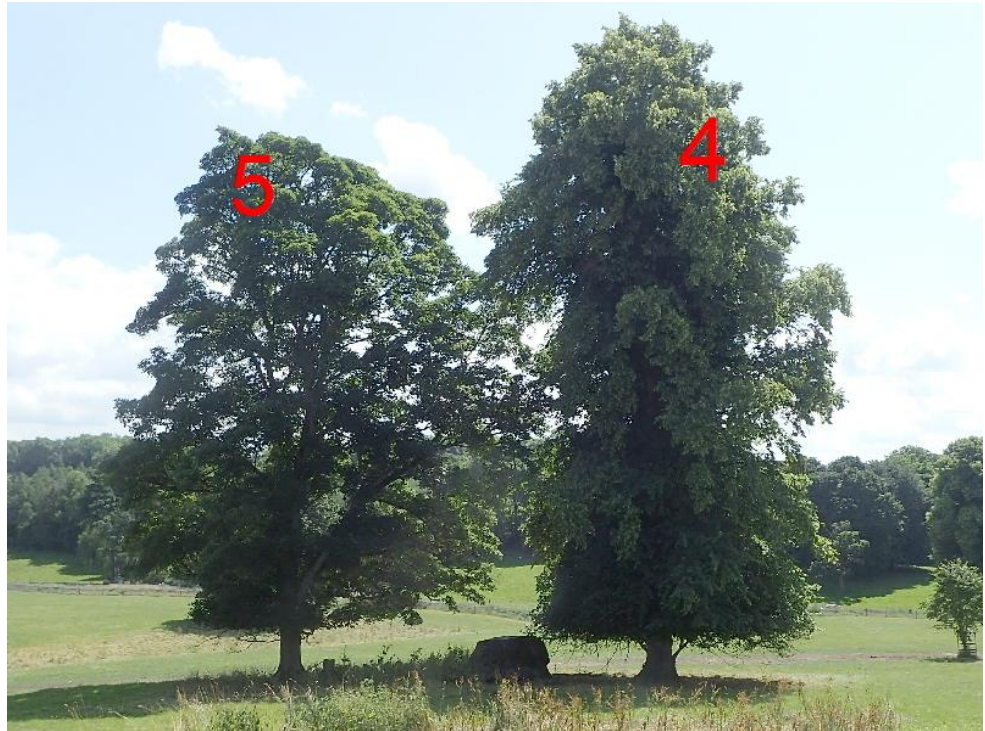
Photograph 6.

Photograph 6 is a view of trees 4 & 5, taken looking roughly south east.

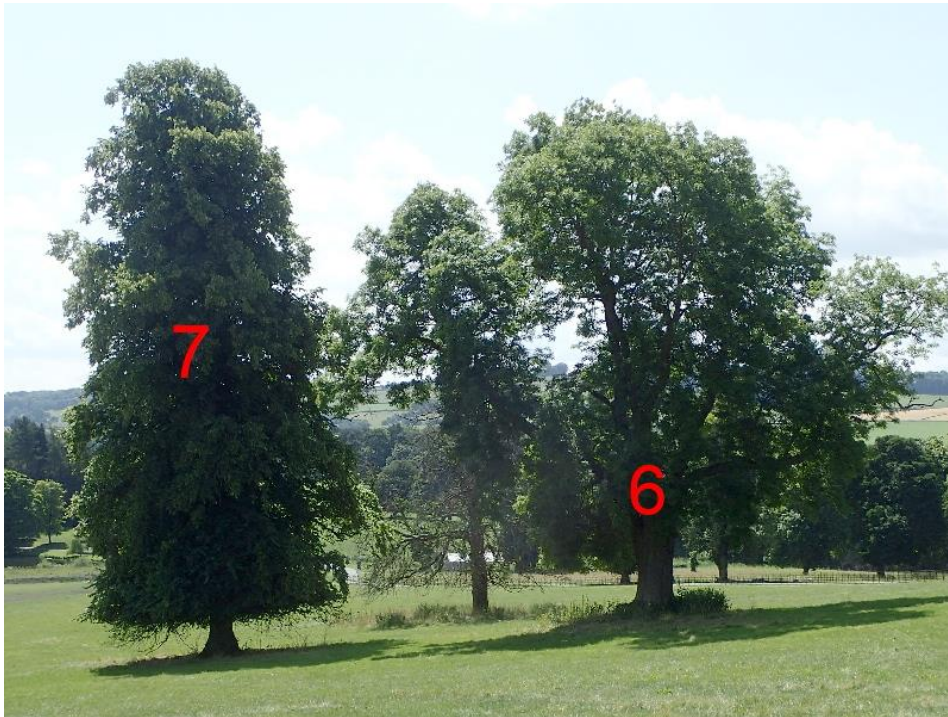
Photograph 7.

5.	Sycamore	22	810	A reasonable specimen, a companion to tree 4.
6.	Ash	21	1380	This tree has suffered significant crown damage and as a result is an excellent habitat tree. its condition could reasonably be regarded as parlous, some work to manage its decline and thus preserve the numerous niche habitats might be justified. Some ground damage at its base.

Photograph 7 is a view of trees 6 & 7, taken looking roughly south west. A branch from Ash tree 6 obscures the view of tree 8, whose trunk can be seen between the two trees.

I described Ash tree 6 as an excellent habitat tree, this is because it has suffered damage that has left it with nooks and crannies that might be exploited as roosts or nest holes, by bats or birds, or even small mammals such as dormice. Thus; despite this tree being really in fairly parlous condition, it's probably one of the most interesting in the park.

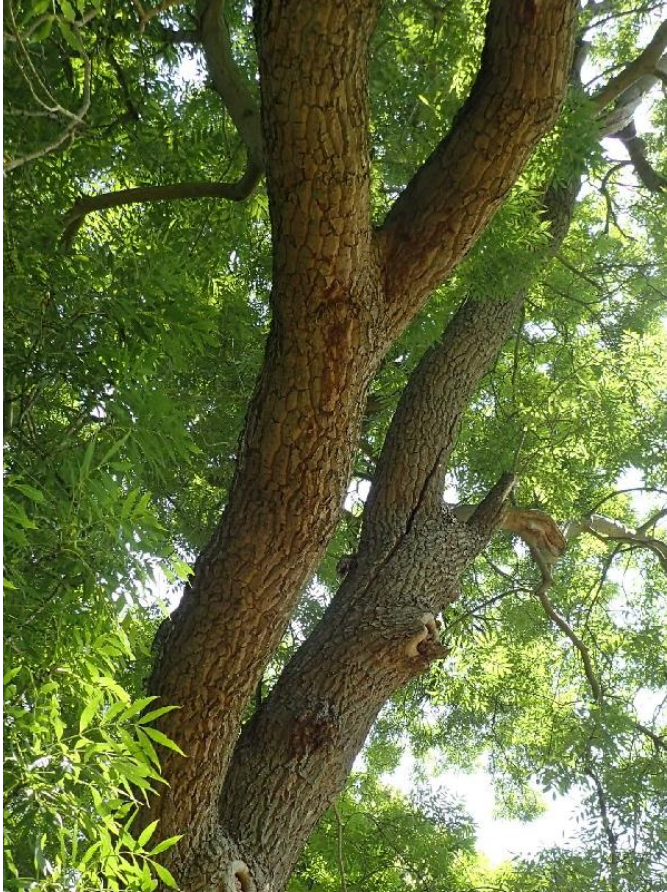
Photograph 8.

Photograph 8 shows a crack in one of the branches at the eastern side of tree 6. If this tree was at the side of a road then some action would need to be taken to remove the risk of that branch collapsing onto a passer-by, but as it's not close to any frequently used space it can be left alone.

Although some ecologically minded individuals would prefer to see trees like this left to their own devices, to collapse and eventually rot away into the soil, others would take action to preserve the various niche habitats. In this case as there is no shortage habitat in the area, unless there are extremely valuable animals grazing nearby, leaving it to its own devices is probably most sensible.

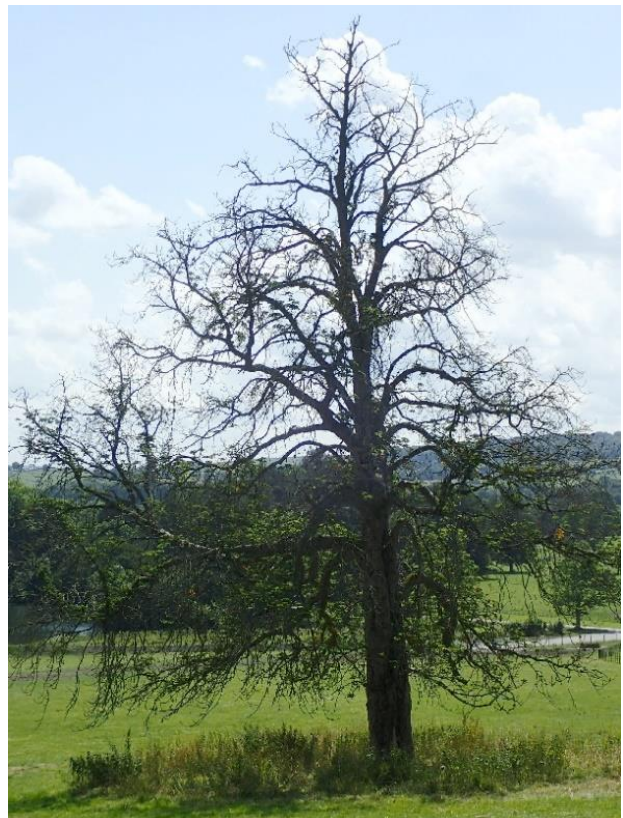
Photograph 9.

7.	Lime	24	1030	Again with a relatively narrow crown. A reasonable specimen tree.
8.	Horse Chestnut	18	1010	Almost dead due to Horse Chestnut Bleeding Canker, and possibly livestock damage.

Photograph 9 is a better view of tree 8, more obviously dead in this picture than photo 7. This is another tree that will soon start to collapse. As long as there is nothing of great value to damage, this is tolerable. Standing dead wood is a valuable resource from a habitat point-of-view.

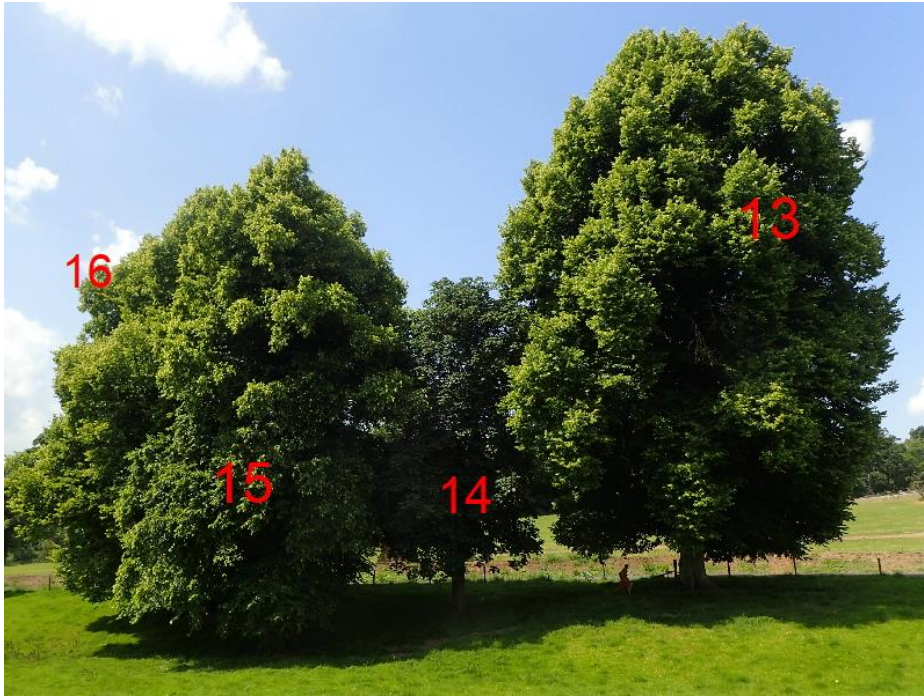
Photograph 10.

Photograph 10 is a view of trees 13-16 taken looking north west.

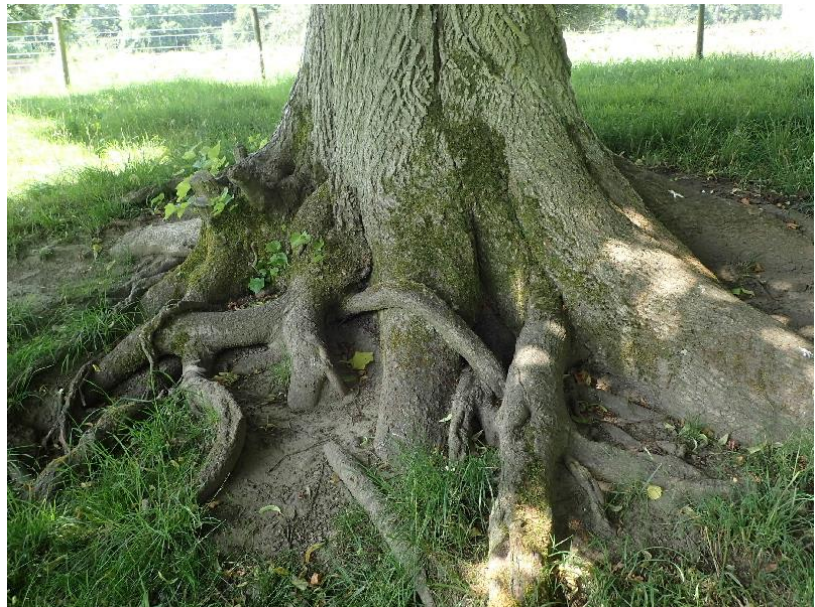
Photograph 11.

15.	Common Lime	23	900	Crown slightly one-sided, but a good specimen within the group.
16.	Common Lime	24	970	Another good specimen at the edge of the group. Roots exposed (by livestock?) but not really damaged.

Photograph 11 is a view of the base of tree 16. It seems that livestock sheltering under the tree has led to the soil being eroded from around the roots. I did not particularly notice any bark being browsed or any specific damage to the roots. The soil is compacted by livestock, but not too badly.

Livestock damage to trees is fairly common when trees grow in fields that are grazed. Some Ecologists claim that deficiencies in livestock's diets lead them to seek trace elements that are found in bark. In this park I did not particularly notice any bark damage although lower branches on some trees are quite obviously browsed. In some deer parks trees appear almost to have been trimmed (in the manner of a hedge) to maintain the foliage at a level parallel to the ground (for example Chatsworth Park) but the "browse-line" seems much less rigid around this park.

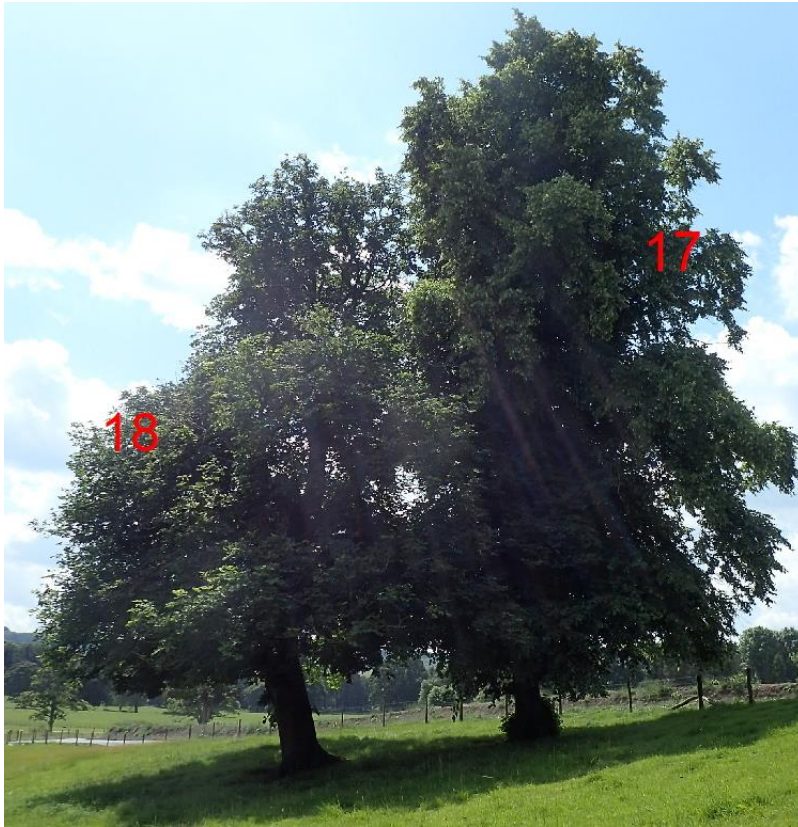
Photograph 12.

17.	Lime	22	800	Good.
18.	Horse Chestnut	19	800	Fairly severe crown damage, some necrotic bark but otherwise good.
19.	Sycamore	14	600	Dead.
20.	Pink Horse Chestnut	5	600	TD estimated. Just a broken stump.

Photograph 12 is a view of trees 17 & 18. Tree 18's rather strange crown shape is a result of a large branch having collapsed, although it is actually still growing but resting on a lower branch.

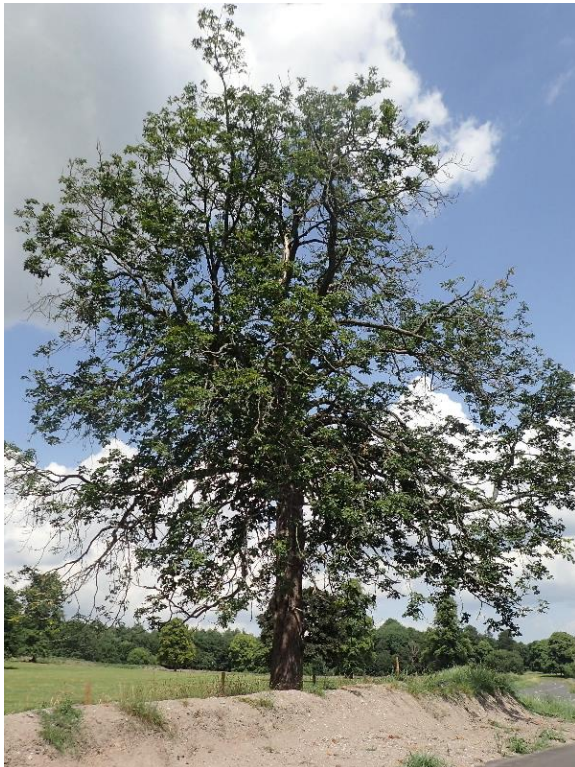
Photograph 13.

21.	Horse Chestnut	16	800	(Back at the north side of the drive.) Severely affected by Horse Chestnut Bleeding Canker, effectively dead.
22.	Horse Chestnut	17	1120	Some small signs of Horse Chestnut Bleeding Canker, but otherwise it appears remarkably healthy.

Photograph 13 shows tree 21, which is well on the way to dying, while tree 22 in photo 14 appears in much better health. What appears to be a second tree trunk in photo 14 is actually a stump that's been dug up from elsewhere and left there. I'm not sure where this was from but there are several other trees with root-balls dumped alongside. I don't think

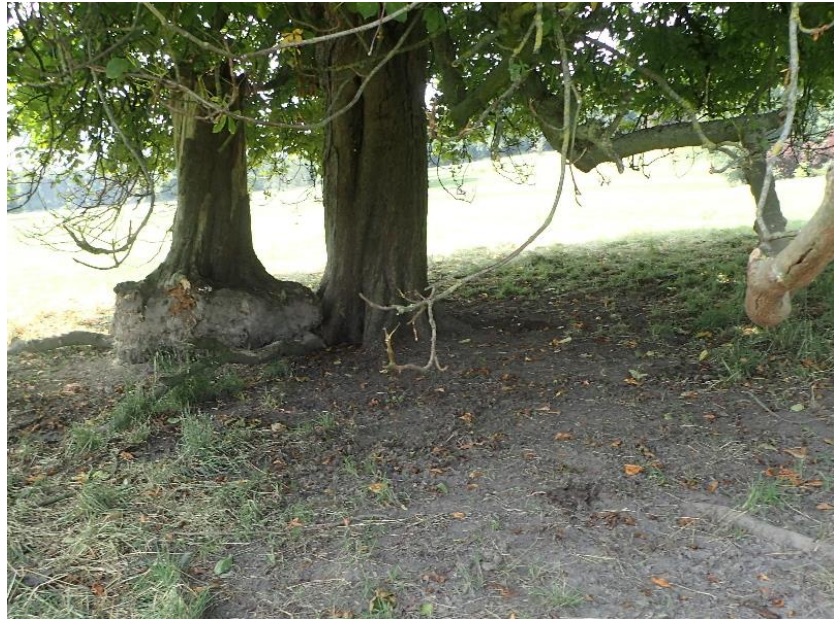
Photograph 15.

25.	Horse Chestnut	17	1110	Crown spreads 19 metres. Lower branches have been recently browsed. (Differently browsed to other trees.)
26.	Norway Maple	13	750	Dark foliage, again my recollection is that this was purple in May although it's now simply tinted brown. Possibly the cultivar Schwedlerei. Extremely hollow, with an open basal cavity.

Photograph 15 shows tree 25 with a dumped-root, ground compacted by livestock, and lower branches browsed.

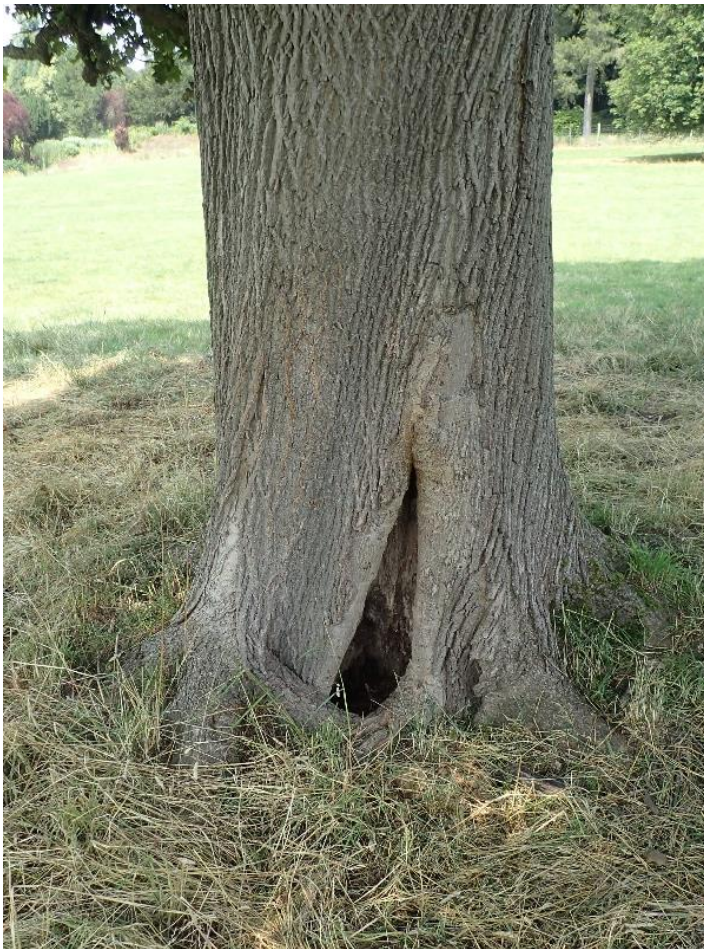
Photograph 16.

Photograph 16 is a view of the base of tree 26, with a very deep cavity. Again, this tree is not particularly near anything so there is no need to worry about it posing a hazard to passers –by.

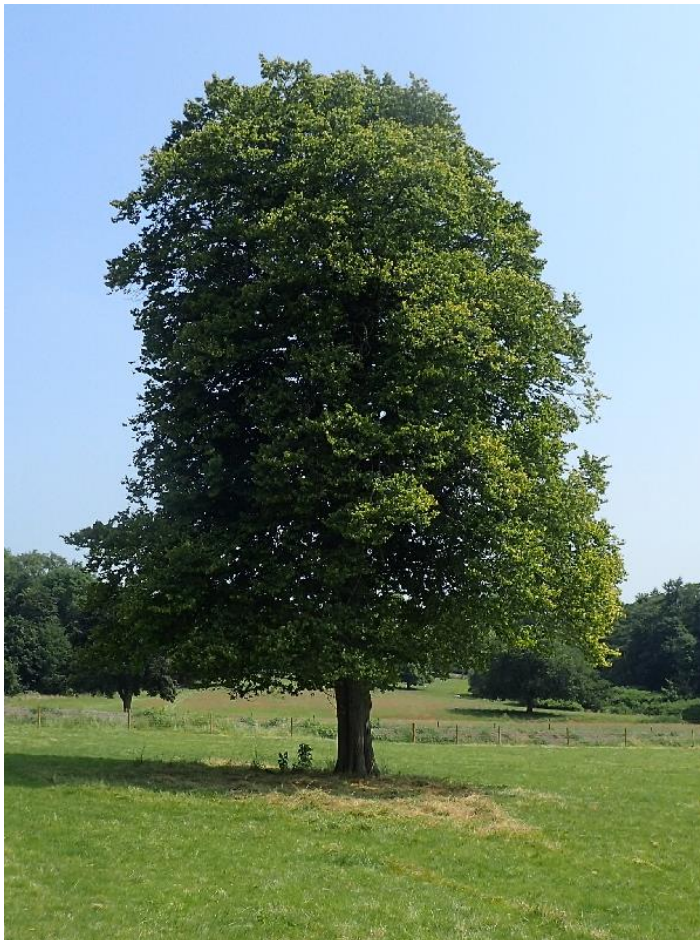
Photograph 18.

No.	Species	Ht	TD	Comment
27.	Common Lime.	25	890	16 metre crown spread seems quite narrow, but probably isn't. (See discussion below.) A decent tree.
28.	Small Leafed Lime	16	700	Good. A clear stem with no epicormic growths. A pleasing specimen. There is an unusual black lichen on the north side of the trunk.

Photograph 18 is a view of tree 28, the Small-leaved Lime.

I understand the park was designed and laid out in the late 1890s, so assume that a majority of the trees date from that time or soon after, but it's possible that this tree dates from later than that, perhaps planted while the estate was in Sheffield Council's ownership. The Forestry Commission's Information note on calculating the age of large and veteran trees suggests the tree is approximately 70 years old. (Tree 27 using the same FC note gives an age of 91 years, which seems reasonable.)

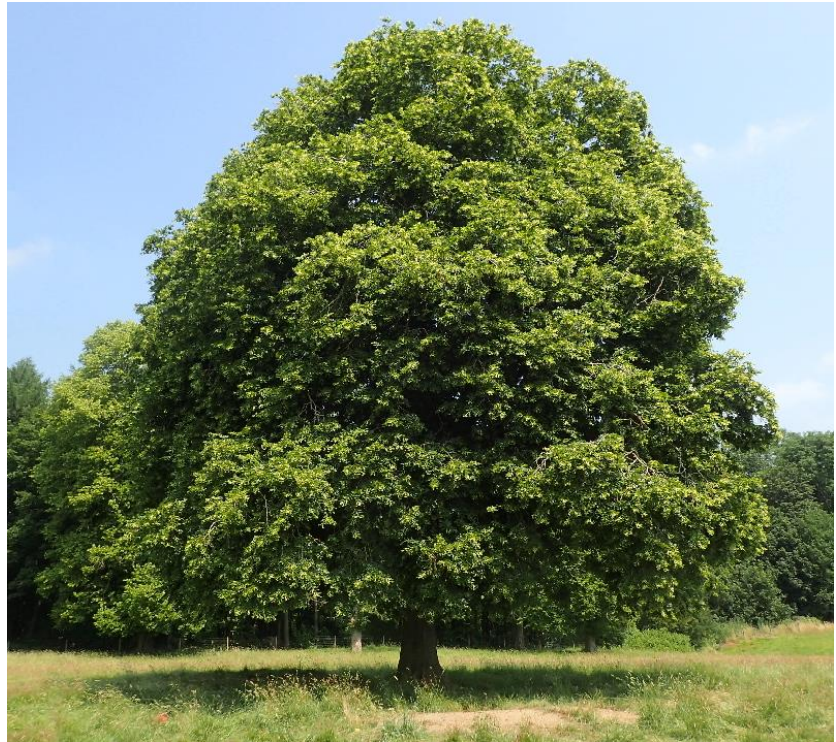
Photograph 19.

Photograph 19 is a view of tree 32, another pleasing specimen. There was quite a lot of soil disturbance at the base of this tree which revealed the tree to be hollow.

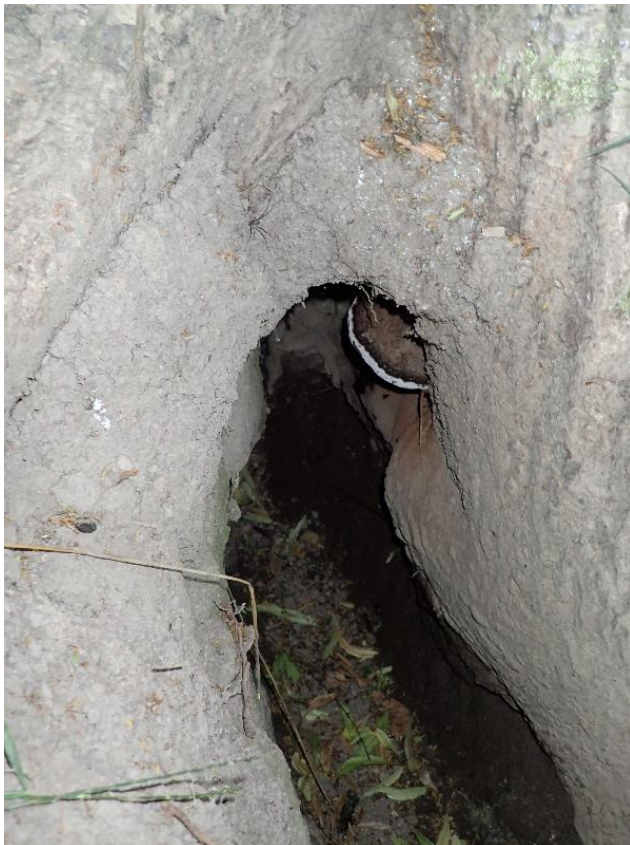
Photograph 20.

31.	Pussy Willow	10	300 max	A group of trees. 5 trees 14 stems. Possibly self-sown. These are not traditional parkland trees.
32.	Common Lime	25	850	Cavity at the base, with a fungal fruiting body. Extensive soil disturbance at the base, possibly Badgers as well as livestock. Healthy otherwise.

Photograph 20 shows the hole at the base of tree 32. It has a fungal fruiting body growing in there, which suggests some ongoing decay.

I don't know if whatever creature disturbed the soil around the tree excavated this hole. In the past, before the arboricultural fraternity became aware of the ecological value of the organisms that lived on trees, and indeed the whole circle of life that surrounds trees, steps might have been taken to prevent wildlife inhabiting the ground in which trees grow. Fortunately we now have a better view of ecology and would not accuse wildlife of causing damage.

Again, as tree 32 is not close to any road or area with public access, I am not concerned by it potentially falling. Also as the tree appears very healthy there is no real reason to assume that the fungi is affecting the tree greatly.

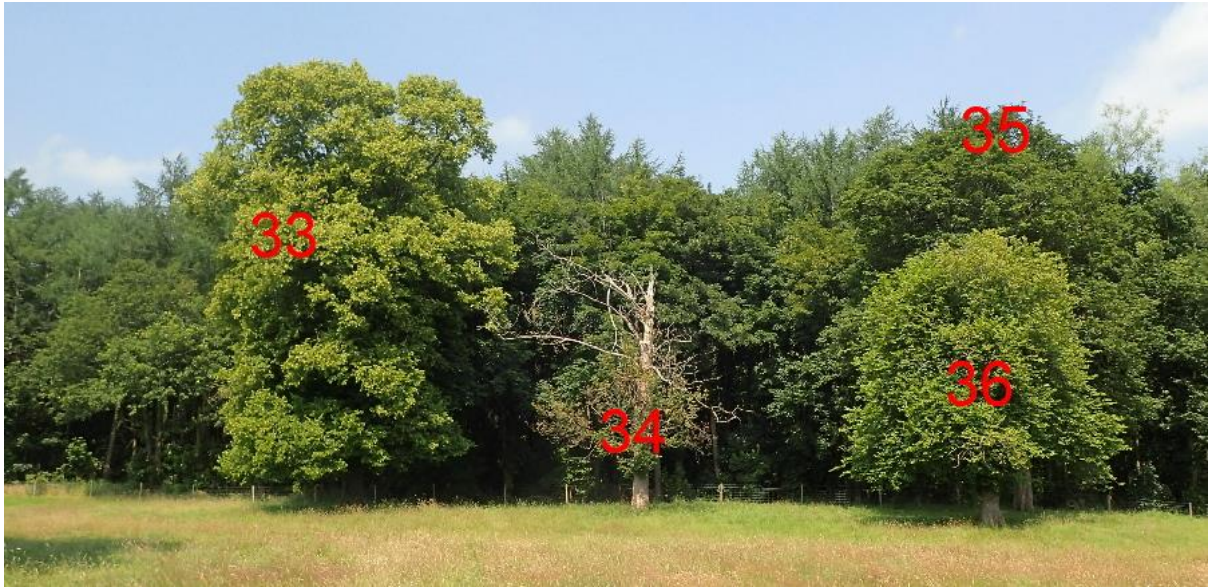
Photograph 21.

Photograph 21 looking north shows trees 33-36. The woodland in the background is on the embankment that adjoins the Monsal Trail (a repurposed railway line).

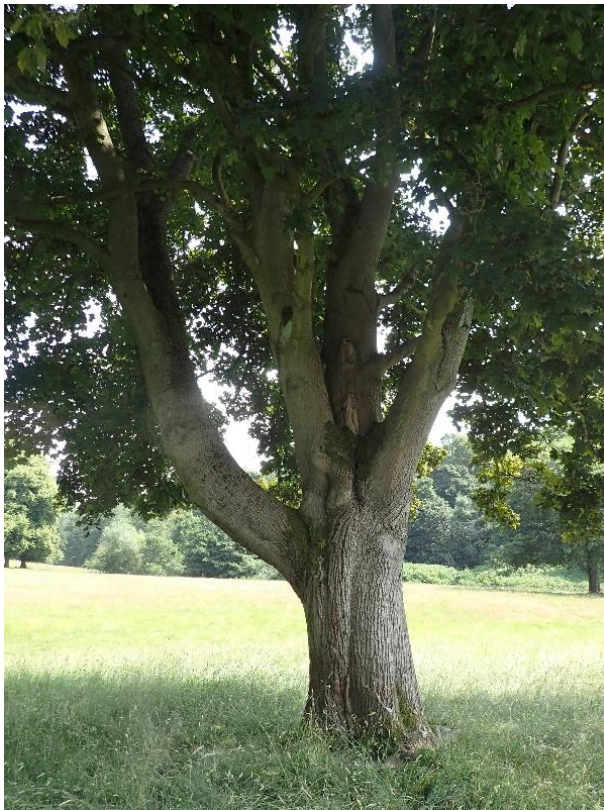
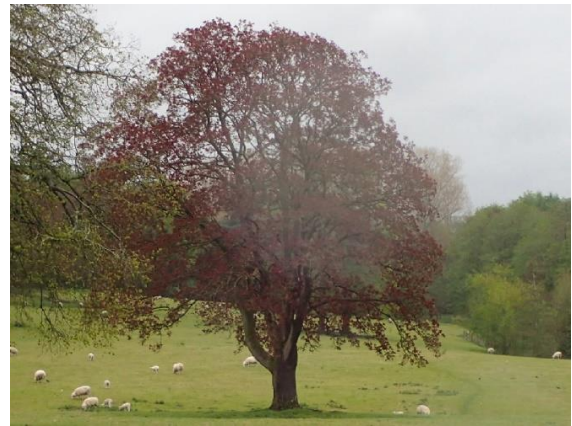
Photograph 22 shows Norway Maple 37 and photo 23 shows it on a rainy day in May this year. This cultivar's (Schwedlerei) leaves emerge a purple colour but then turn green (with a brown tint) later. There are numerous varieties of Norway Maple with purple leaves that stay purple through the summer until giving a colourful autumn display.

The purple leaved cultivars of Norway Maple (or other trees) are not always admired; some people regard them as a black-hole in the landscape. At least they usually show very good autumn colour. This is a reasonable specimen, even if the leaf colour could be looked upon as dull for most of the year. (In going through my photographs to include here, I noted that tree 37 and tree 26 have a very similar appearance; both have a single, very large lowest branch.)

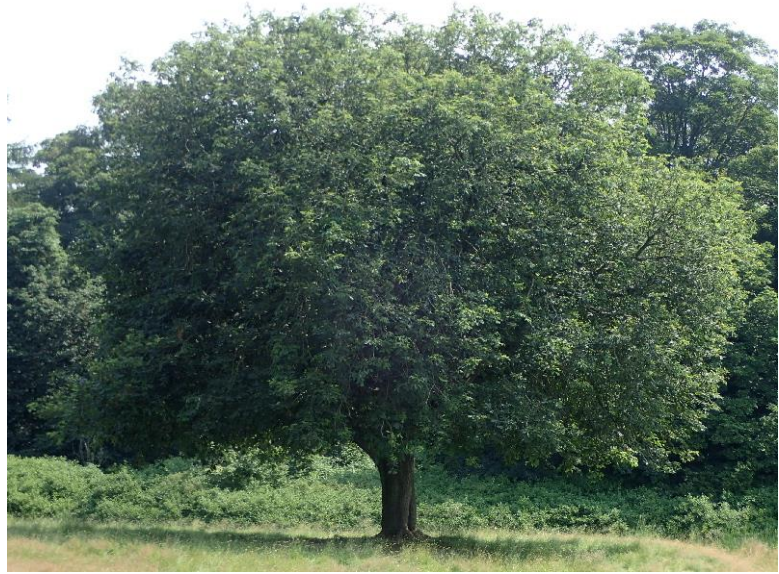
Photograph 24.

38.	Horse Chestnut	14	830	Soil at its base compacted by livestock. 15 metre crown spread means it has a slightly squat profile.
39.	Common Lime	27	820	Good, crown spreads 12 metres. Some minor dead wood.

Photograph 24 shows Horse Chestnut 38 with its rather broad crown profile in relation to its height.

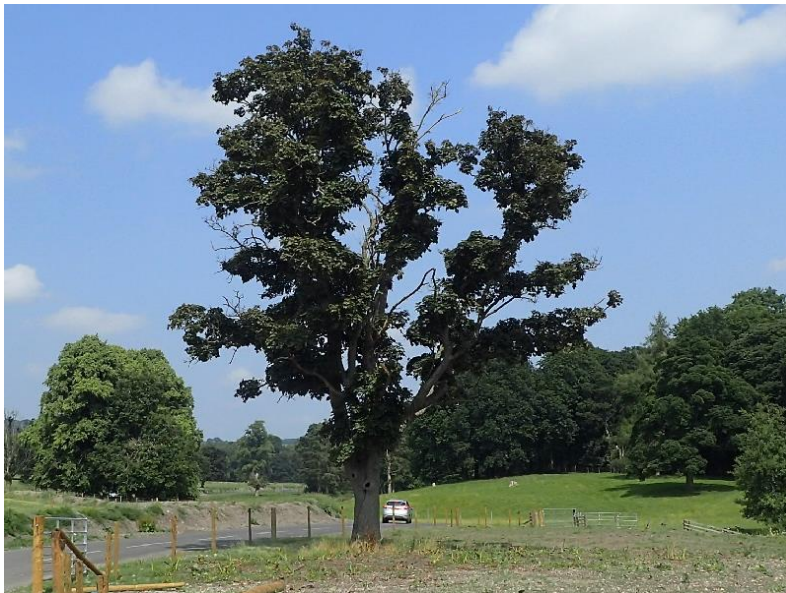
Photograph 25.

40.	Norway Maple	13	690	50% dead and unlikely to recover. Another Schwedlerei.
41.	Sycamore	14	640	Between the drive and the pond. Some minor die-back.
42.	Sycamore	16	660	Between the drive and the pond. Some minor die-back.

Photograph 25 shows tree 40. Although there has obviously been some excavations around this tree, it was declining long before these took place. I was told there has been a drainage problem here that left the tree waterlogged.

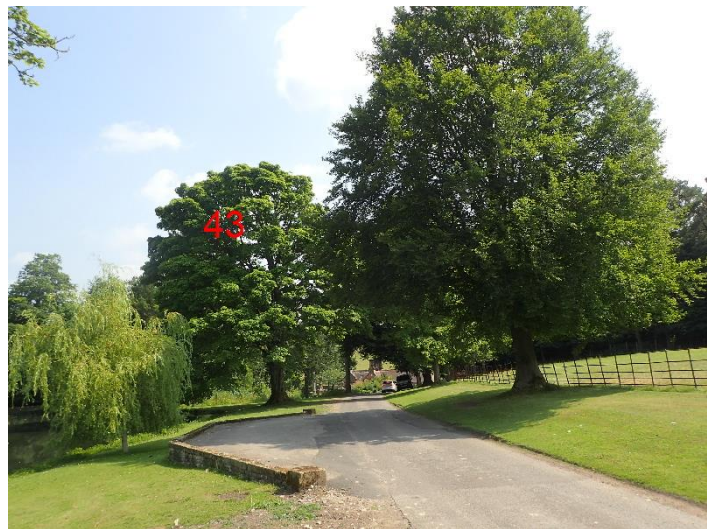
Photograph 26.

Photograph 26 is a view looking south east towards the entrance of the park from the A6020. The tree to the right of the drive is a Beech that I was not asked to include. It's in reasonable condition. behind the Beech and opposite tree 43 is a Yellow Buckeye, (*Aesculus flava*) a near relative of Horse Chestnut. It would be good to see some more of this species planted in the park.
