Tree Report: Thornbridge Hall, Ashford in the Water. DE45 1NZ

Client: Mr J & Mrs E Harrison.

Date of Survey: Various dates, May 2021.
(And previously in February 2017.)

File reference: Thornbridge Hall 02

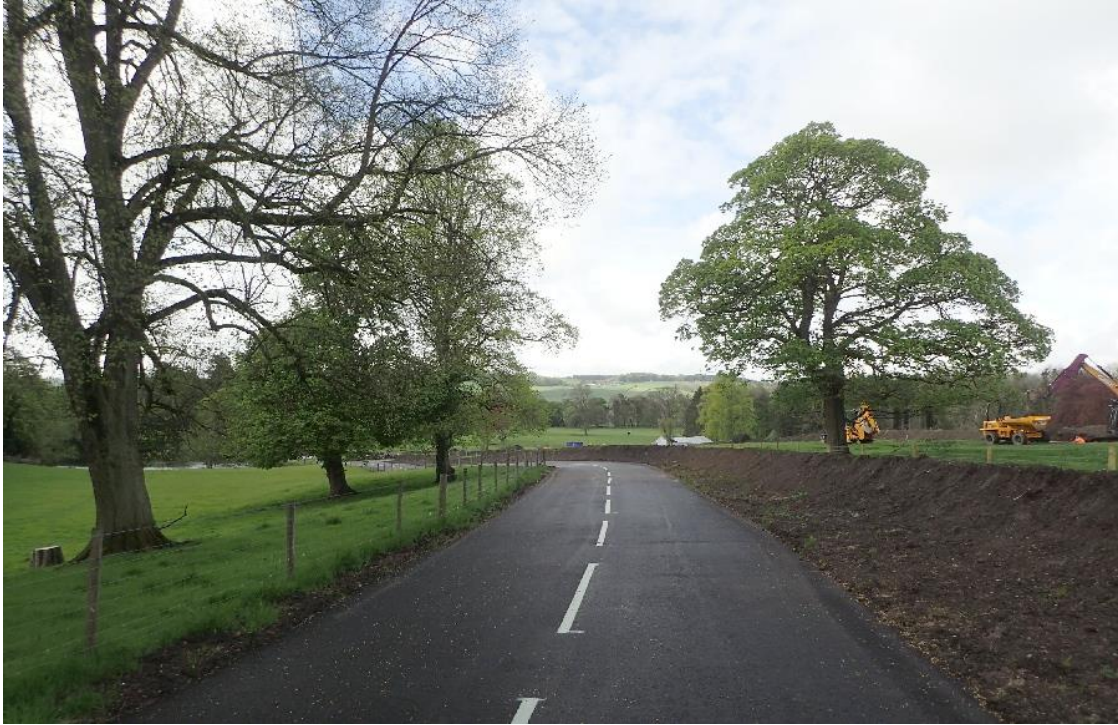
Photograph 1.

Photograph 1 is a view looking roughly southwest from roughly half-way along the drive. The driveway encroaches the RPAs of at least 3 trees, although I do not think that this intrusion is sufficient to cause any lasting damage. The bund of soil to the north of the drive is a concern but it is not likely to have caused any damage in the RPA of the tree to the right. The soil currently heaped up within the RPA could be removed and leave the roots beneath undisturbed.

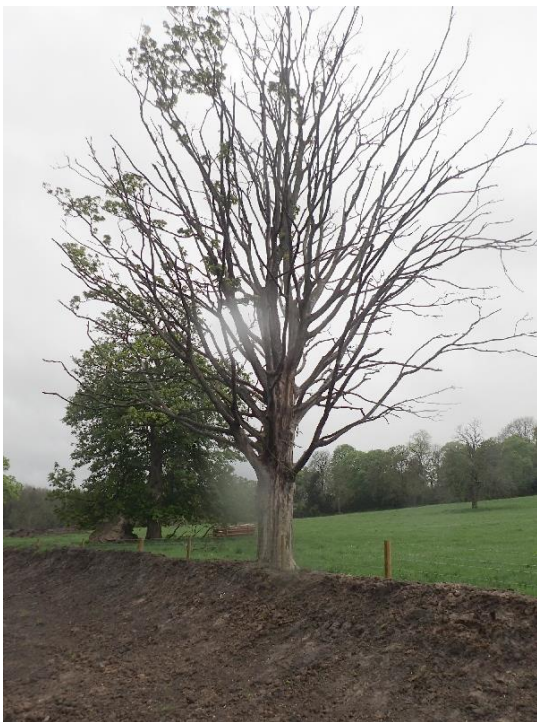
Photograph 2.

Photograph 2 shows another tree at the side of the new drive, which has clearly been effectively dead for several years. This is nothing to do with the recent driveway installation. The tree is a Sycamore.

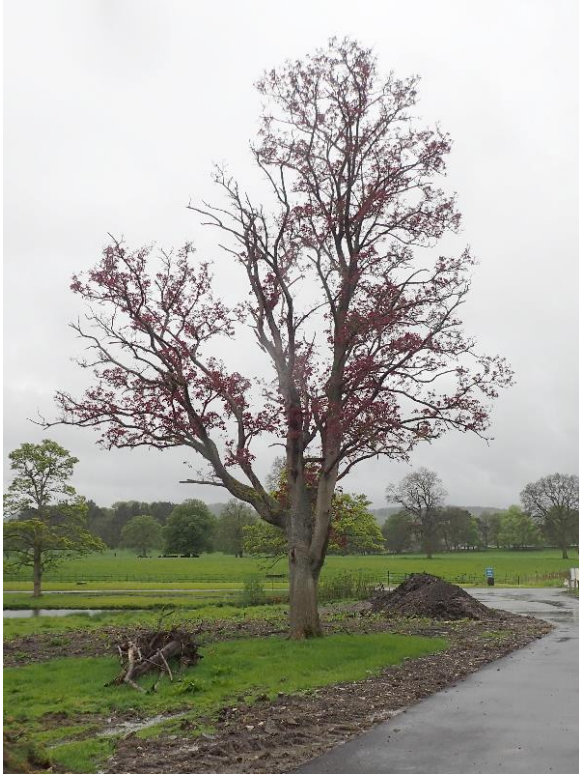
Photograph 3.

Photographs 3 & 4 show two more trees in extremely poor condition. Photo 3 is a Purple leafed Norway Maple: I understand there is an ongoing drainage problem near this tree. it's poor condition may very well relate to water-logged soils. Photo 4 is a Horse Chestnut, almost certainly one of the pink-flowered cultivars. I say this because it has a graft union at the top of the trunk. Pink Horse Chestnuts are almost always sickly trees; they suffer from a sort of canker (usually called bud proliferation) that almost certainly is due to poor plant breeding. It's condition is also not related to recent activity.

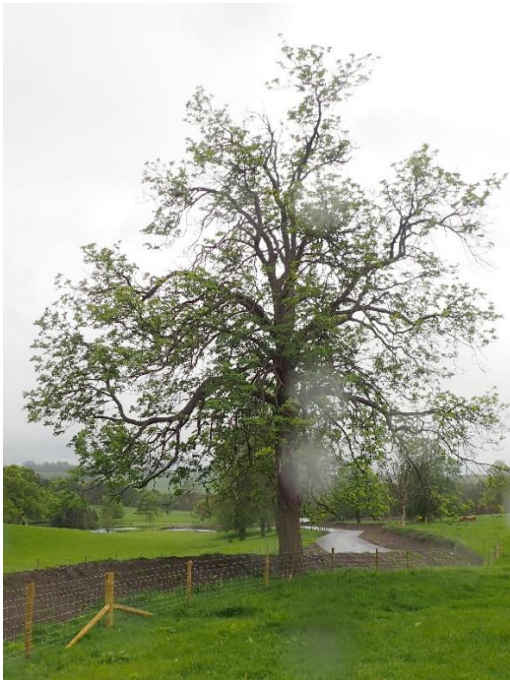
Photograph 5.

Photograph 5 is another Horse Chestnut showing the early signs of decline. This is almost certainly due to Horse Chestnut Bleeding Canker.

Unfortunately Horse Chestnut as a species is having a pretty hard time of things at the moment, with two sorts of Bleeding Canker (one bacterial, one fungus-like) affecting it, and a leaf mining moth as well. I also couldn't help but notice that livestock damage to some trees around the parkland is quite significant. (There's a Lime tree just to the east of the car park bund that is being undermined by Badgers excavating a sett. We have recently seen a tree topple due to Badger excavations!)

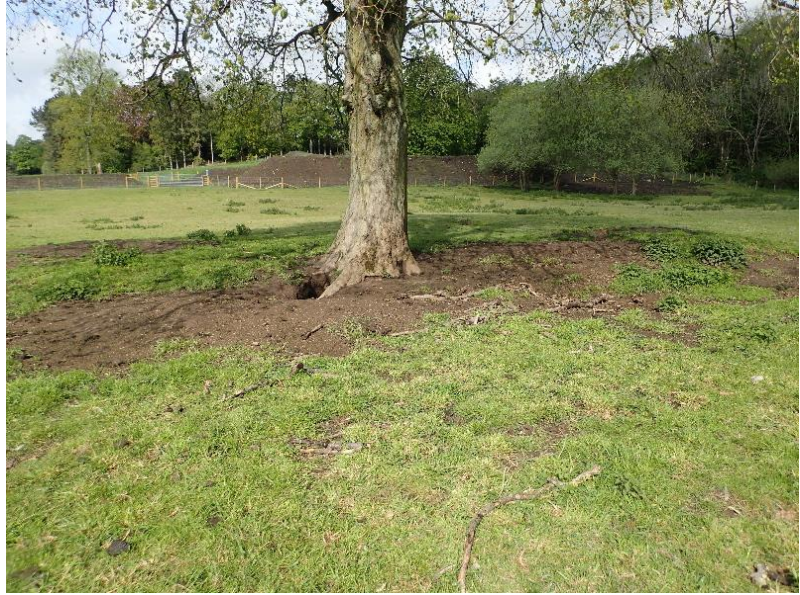
Photograph 6.

Photograph 6 shows the Lime tree with quite extensive excavations at its base. The car park bund is in the background. This tree is well away from any surfacing work; I've included the photo to illustrate the other issues that may be affecting trees.

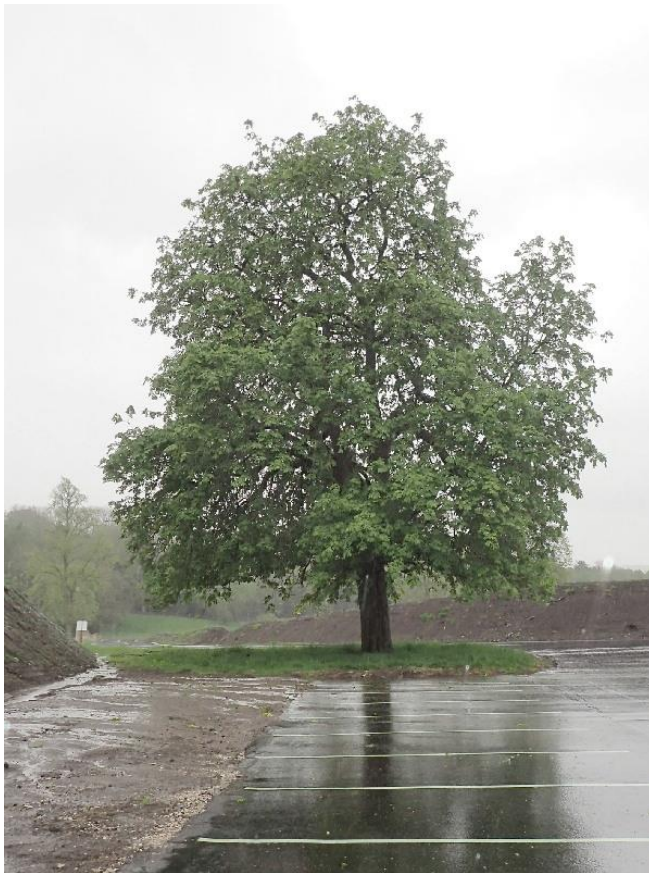
Photograph 7.

Photograph 7 shows the tree furthest down the car park. This is approximately 18 metres tall and I measured the trunk diameter to be almost a metre. This means its RPA should be a circle of radius 12 metres. the patch of grass that surrounds the tree is not that big it's approximately 16 metres across and the right hand boundary is 6 metres away from the tree.

There are some signs of minor dieback, albeit nothing as obvious as the tree in photo 5.

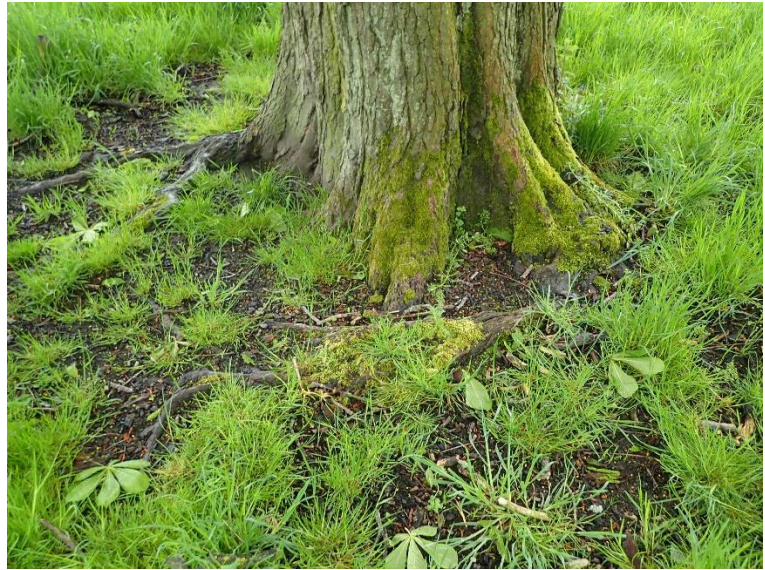
Photograph 8.

Photograph 8 shows the base of the tree, the rather patchy grass suggests that livestock previously gathered and grazed beneath the tree. It's not immediately obvious but the tree's roots have suffered some damage, compacted soils and damaged roots, from the livestock. This sort of damage is fairly typical for parkland trees.

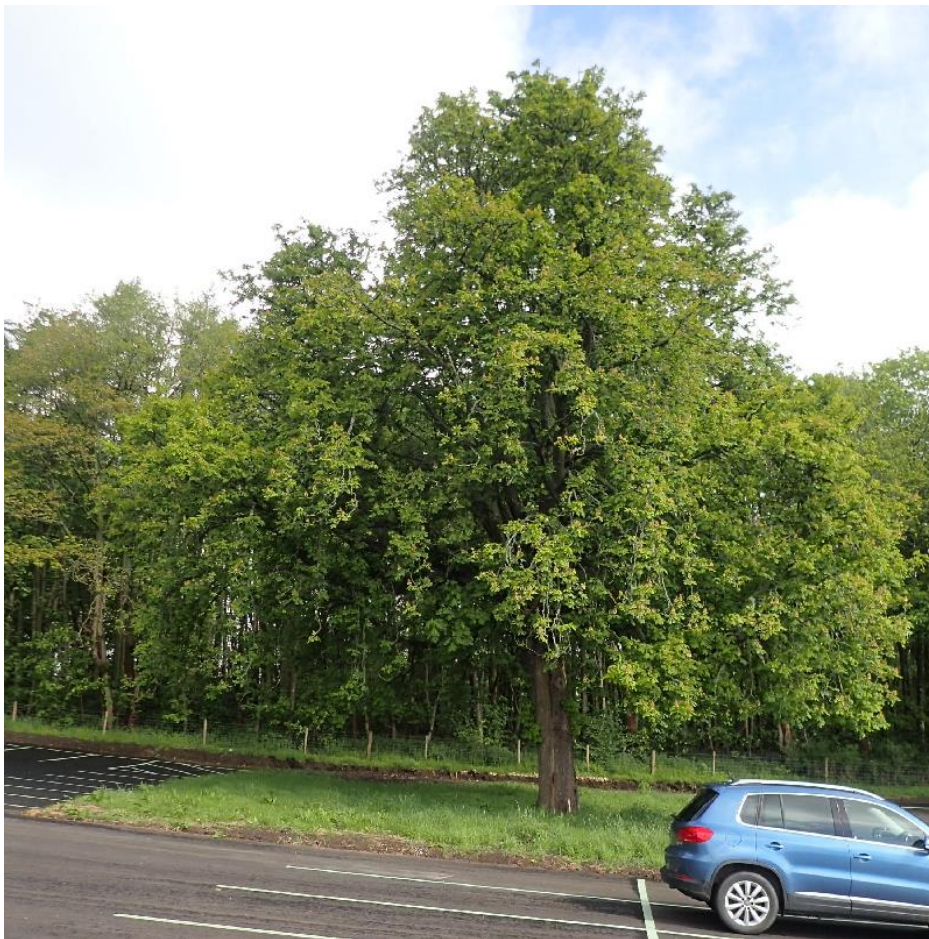
Photograph 9.

Photograph 9 shows the other Horse Chestnut, higher up the car park. Its trunk diameter is slightly less at 950 mm, and its height is 18 metres.

The patch of grass in which it stands is 20 metres by 15 metres, so about 25% smaller than BS5837 suggests; 300 m² rather than 408. (See BS5837 annex D.) Noticeably the tree's branch spread is roughly the same as the undisturbed ground.

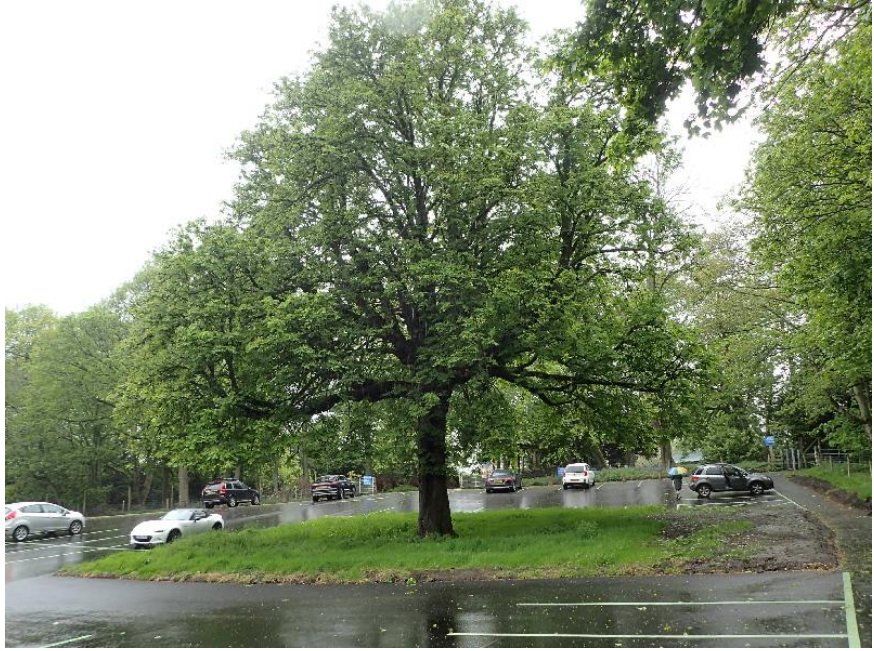
Photograph 10.

Photograph 10 is another view of the higher tree. This is taken looking roughly west.

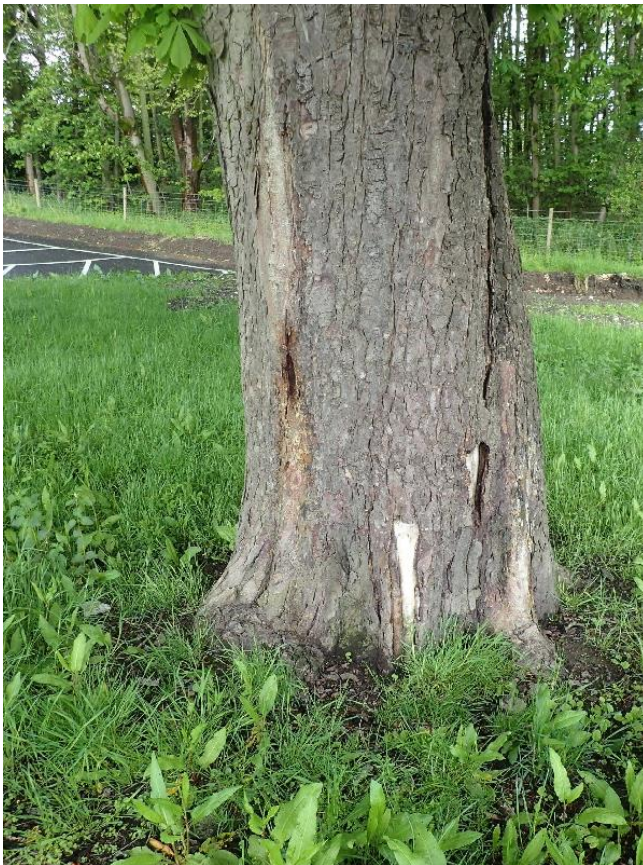
Photograph 11.

Photograph 11 is a view of the trunk of the western tree. I think this has suffered an attack of Horse Chestnut Bleeding Canker in the past that has led to the strips of exposed heartwood.

This tree is also showing signs of some dieback, much the same as the eastern tree.

Horse Chestnut Bleeding Canker seems to affect trees differently. I have seen some trees succumb fairly rapidly while others appear to recover only to decline later. The disease can lead to the timber becoming very brittle but I don't think that is a concern with either of the car park trees at the moment.

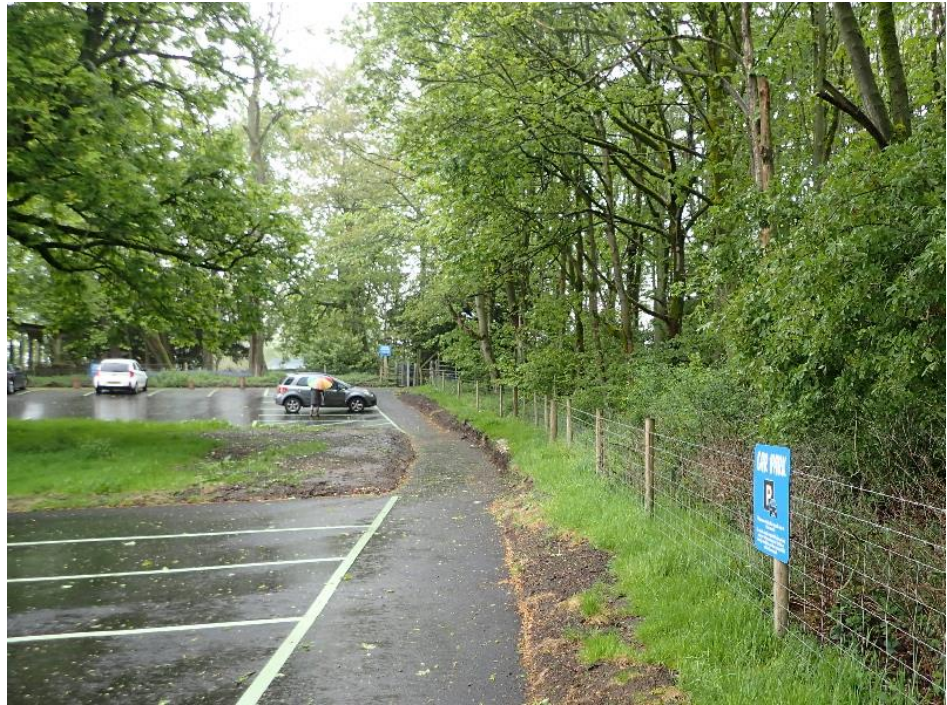
Photograph 12.

Photograph 12 is a view of the woodland edge looking west along the northern edge of the car park.

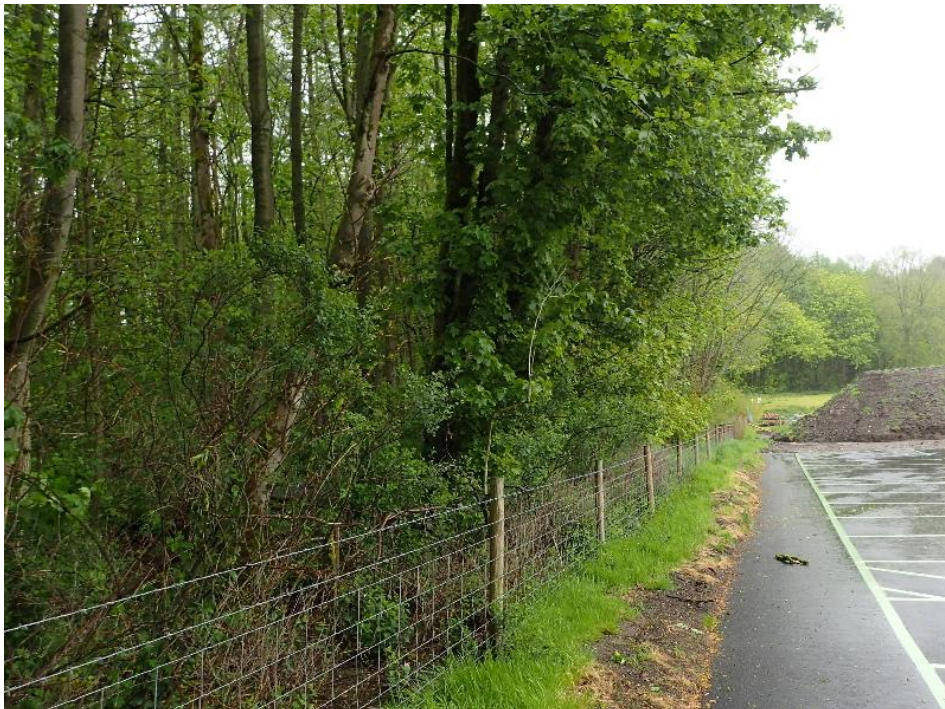
Photograph 13.

Photograph 13 is a view looking east along the northern edge of the car park.

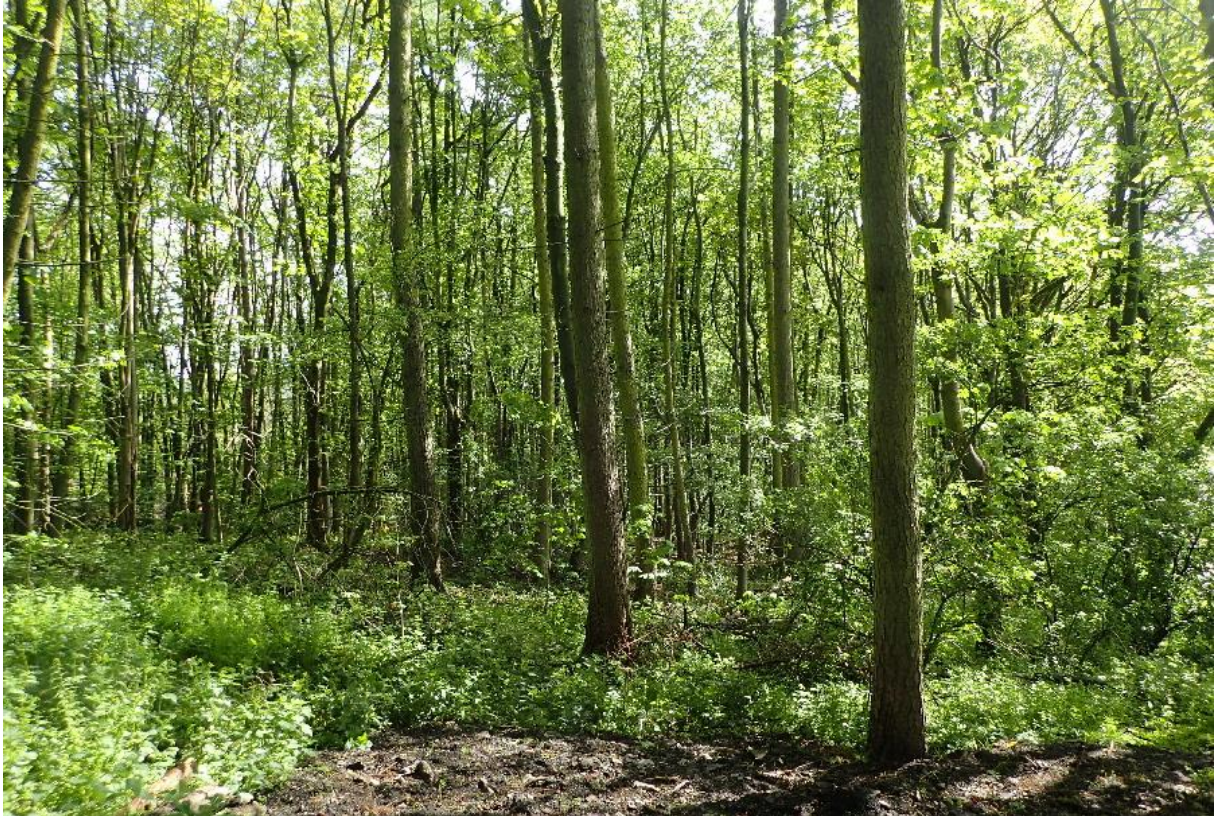
Photograph 14.

Photograph 14 taken looking roughly northeast, from the public footpath shows the western end of the woodland.

The woodland stretches alongside the Monsal Trail, along the parkland's northern boundary. I think it's fair to regard this as secondary woodland, and equally fair to note that it does not appear to have received any proactive management in recent years: While considering woodlands it should be noted that the Forestry Commission are quite concerned about unmanaged woodlands. The ecosystem services that are increasingly being recognised in planning guidance, are best provided by proactively managed woodlands. Planting trees and forgetting about them is not good practice in any situation. All trees that are likely to have a long life will require some nurturing.

None of the trees at this part of the woodland are particularly large and I do not think the individual trees have had their RPAs significantly intruded upon by the car park surfacing.

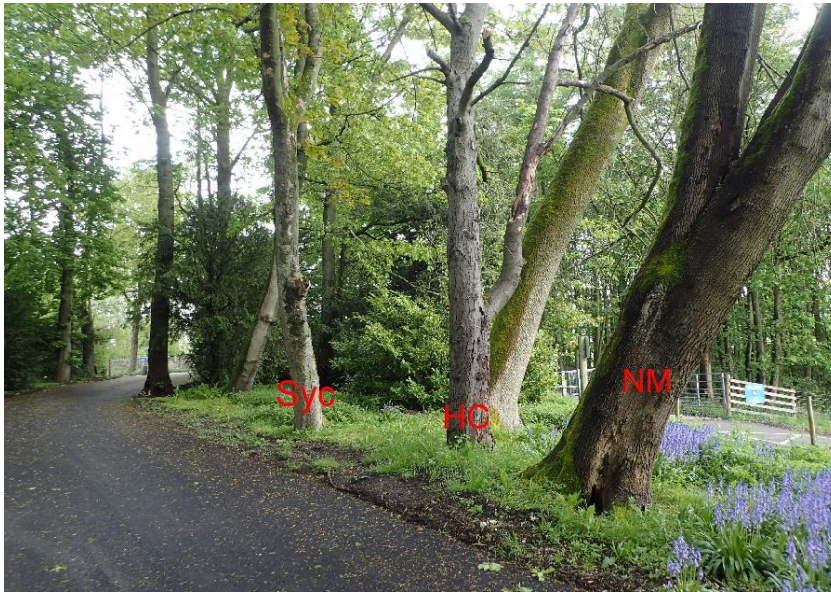
Photograph 15.

Photograph 15 is a view looking north along the drive. Obviously the tarmac is covering almost 50% of the RPAs of some of the trees. The trees here are labelled; Norway Maple, Horse Chestnut, and Sycamore.

I've highlighted these three trees because they are all in poor condition. The Norway Maple has an extensive pocket of decay at the base, the Horse Chestnut is completely dead, almost certainly due to Horse Chestnut Bleeding Canker, and the Sycamore seems to have two separate cavities higher in the crown. The Maple threatens the public footpath and should have been removed before now. (I will shortly be putting in notice to the local planning authority in order to get these trees removed.)

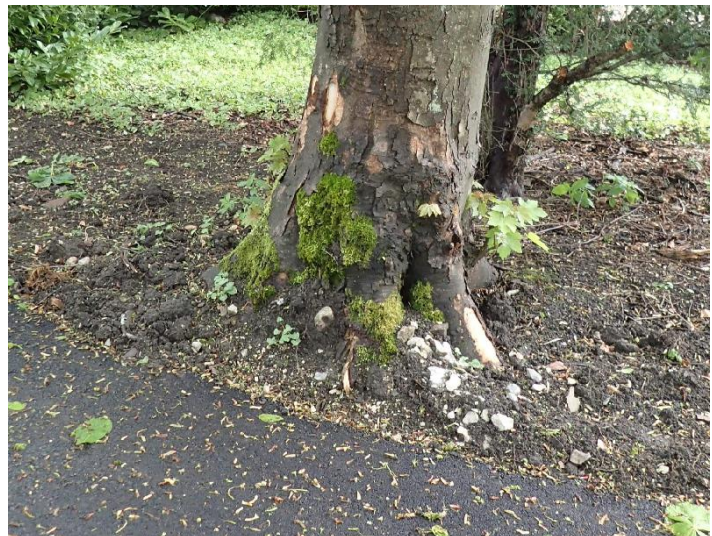
Photograph 16.

Photograph 16 shows the base of another tree at the side of the disabled access. This is not good, although it would be reasonable to note that probably less than 50% of its RPA has been affected.

It's difficult to know what the future may hold for trees like these. Quite clearly more consideration could have been given to the situation but had the problem been examined before the tarmac was installed, I think it likely that a similar route would have been chosen, although the three trees in photo 15 would have been removed before the surface was laid. The tree in photo 16 would probably also have been removed. It is my experience that damage of this sort, might take many years to develop and become stability threatening.

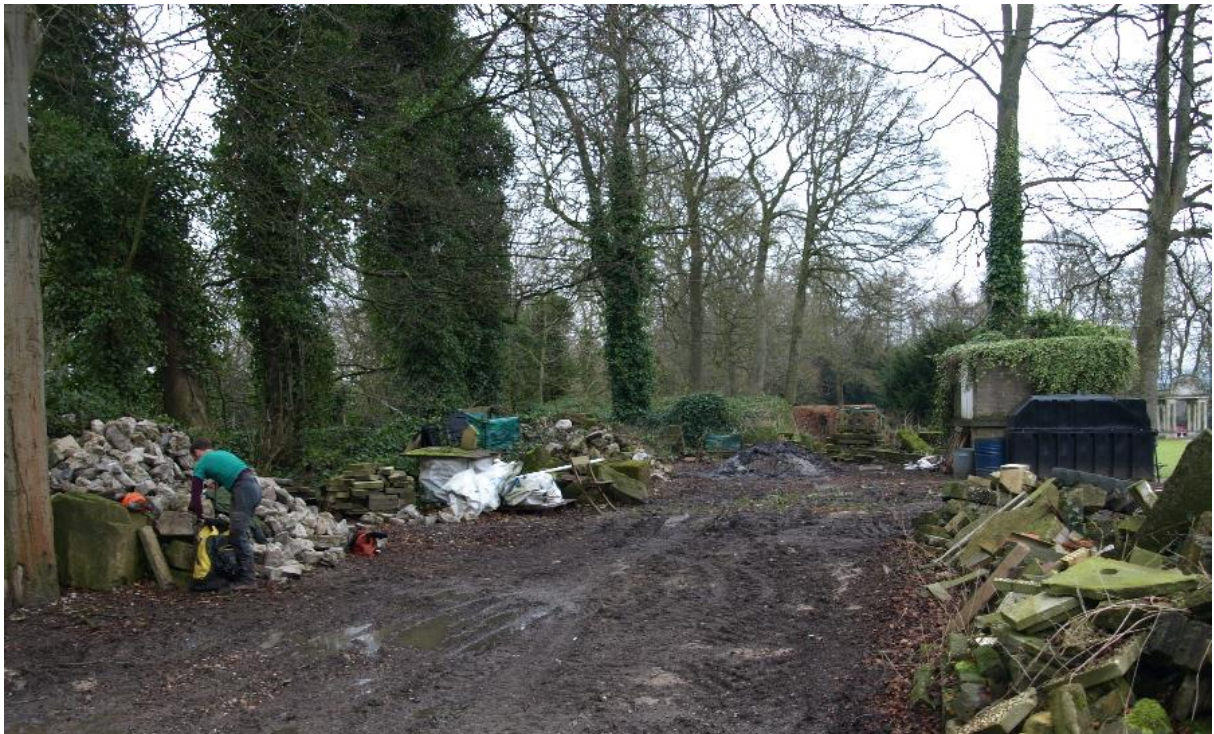
Photograph 17. (Taken February 2017).

Photograph 17 shows what can reasonably be called a stockyard. This is looking east along the boundary. Various bits and pieces of stone and building materials have been stored here without much concern for trees. I understand that some of the stone stored here probably dates from the time when the site was owned by Sheffield Council and used as an educational establishment. The Council undertook modifications in order to make it usable for teaching, without much consideration for the history of the place. (This is fortunate as in the 1980s, Sheffield Council notoriously demolished some of its buildings before they could be listed by Historic England.)

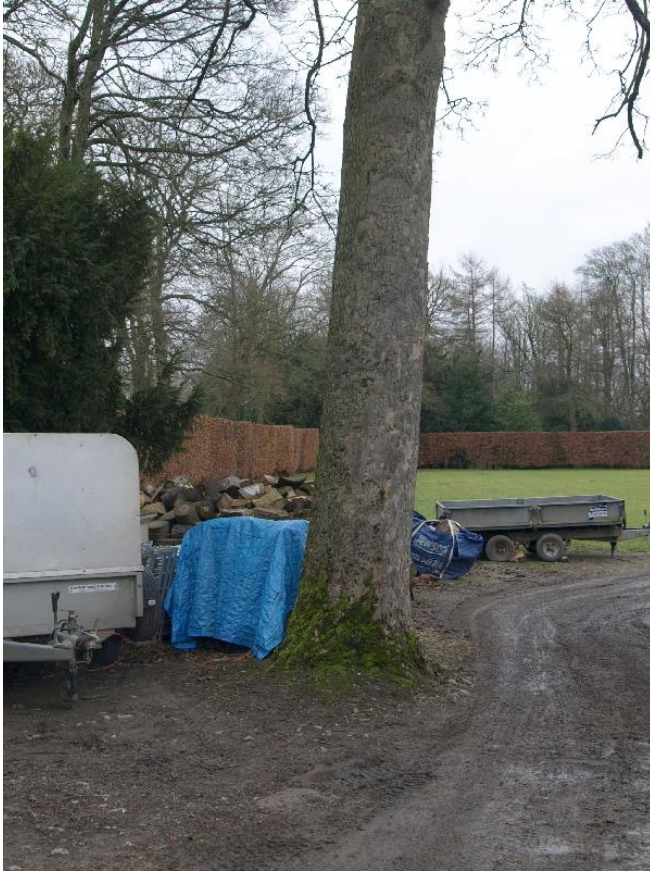
Photograph 18. (Taken 2017.)

Photograph 18 shows a Sycamore tree that is now surrounded by tarmac. It's not obvious in this photo but the tree is surrounded by hard-packed, compacted gravel. This tree is at the limit of my 2017 inspection.

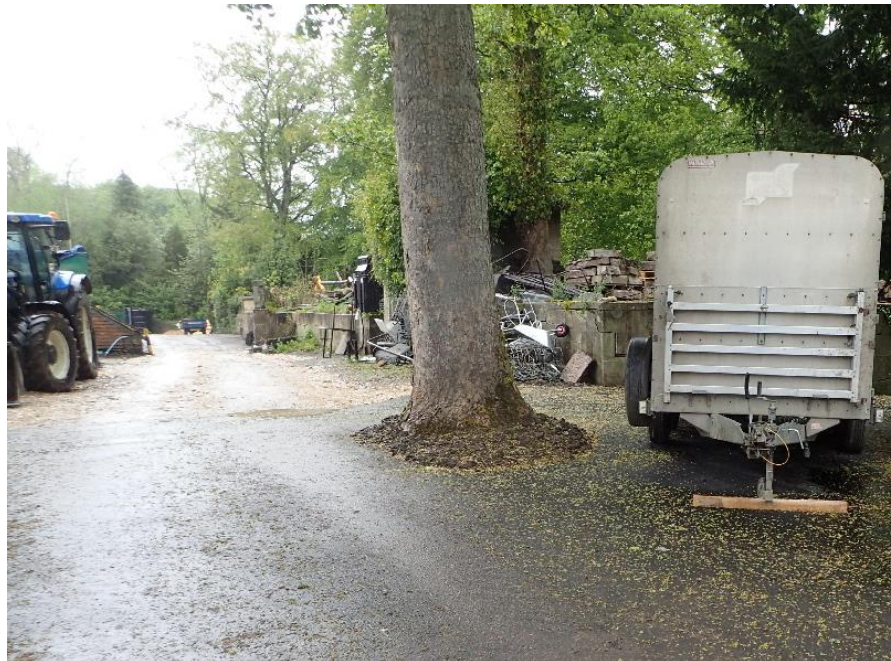
Photograph 19.

Photograph 19 is the same tree now. I presume the tarmac has simply been laid on the existing surface

It is possible that this new tarmac is preventing rainfall from percolating through to the soil beneath, and thus becoming available to the tree, but it is also possible that the compacted gravel is similarly impermeable.

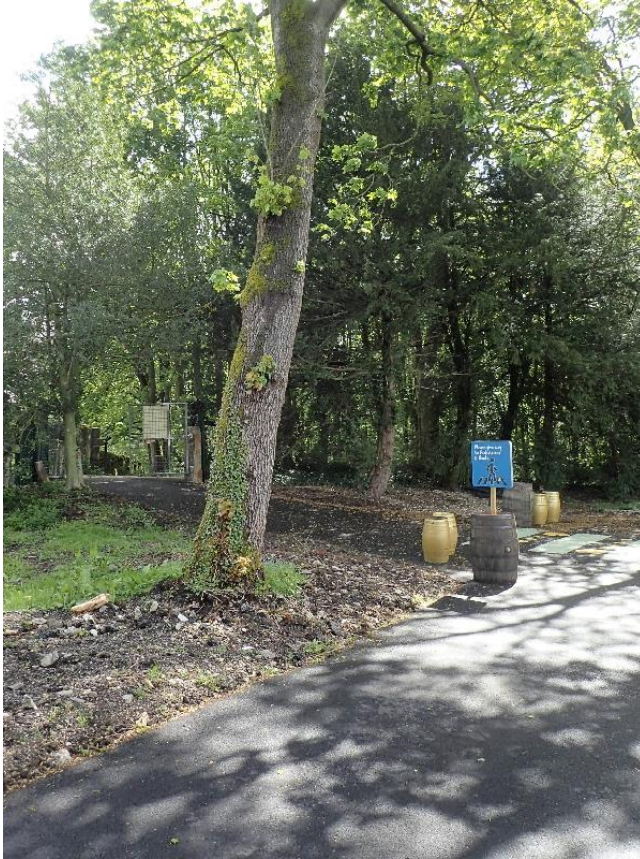
Photograph 20.

Photograph 20 shows a Norway Maple in front of the gate to the Monsal Trail. The tarmac here is less close to the tree but still covers a large portion of the RPA.

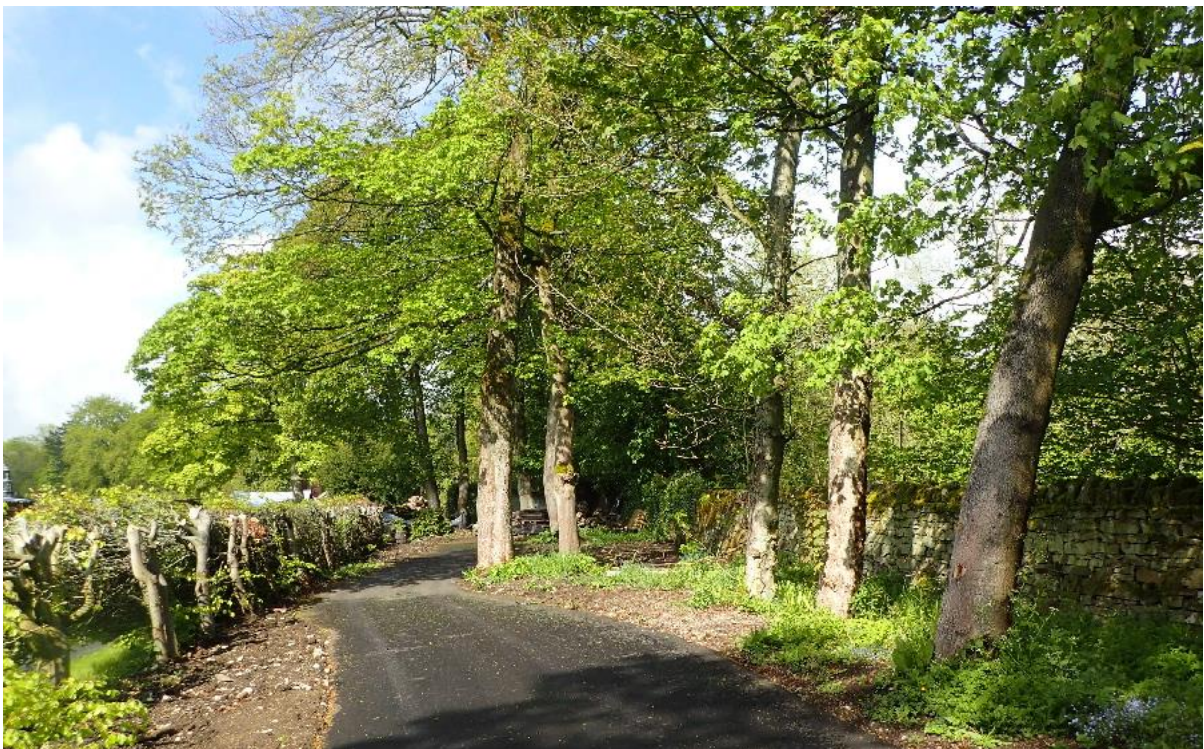
Photograph 21.

Photograph 21 is a view looking west along the Monsal Trail boundary; the trail is over the wall. I don't know what was here before the area was tarmacked. The tree in photos 18 & 19 is at the far end of the hedge at the left.

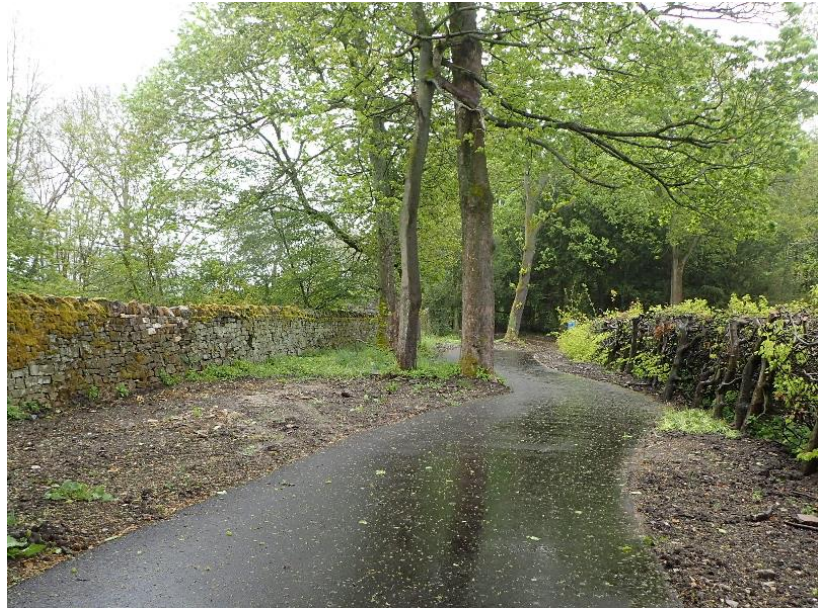
Photograph 22.

Photograph 22 is a view of the same trees in photo 21 but taken looking eastwards.

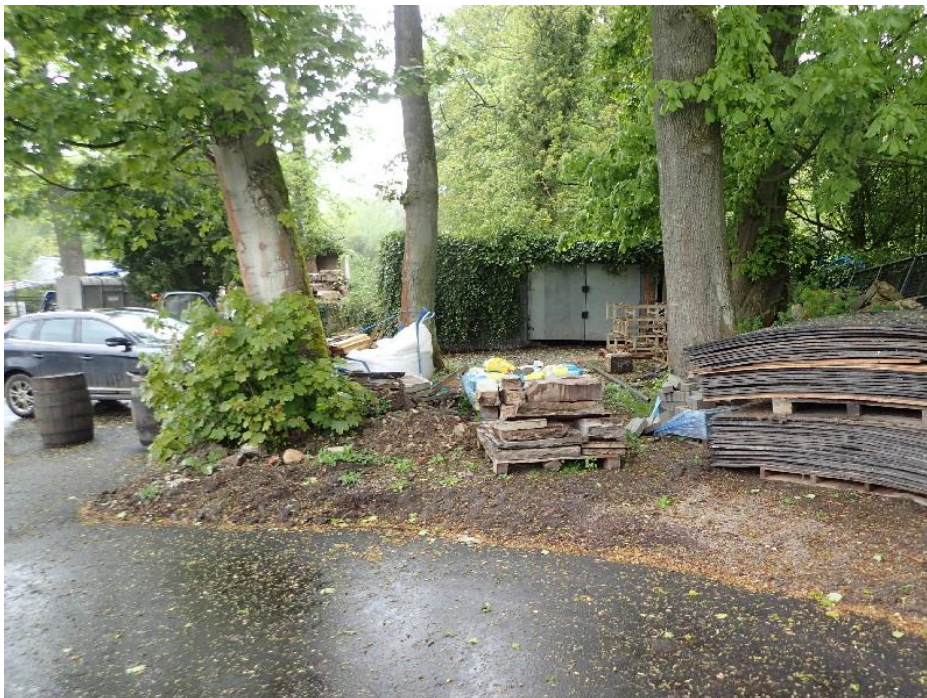
Photograph 23.

Photograph 23 shows the area at the end of the tarmacked area. The Sycamore in photo 18 is at the left hand side in the background.

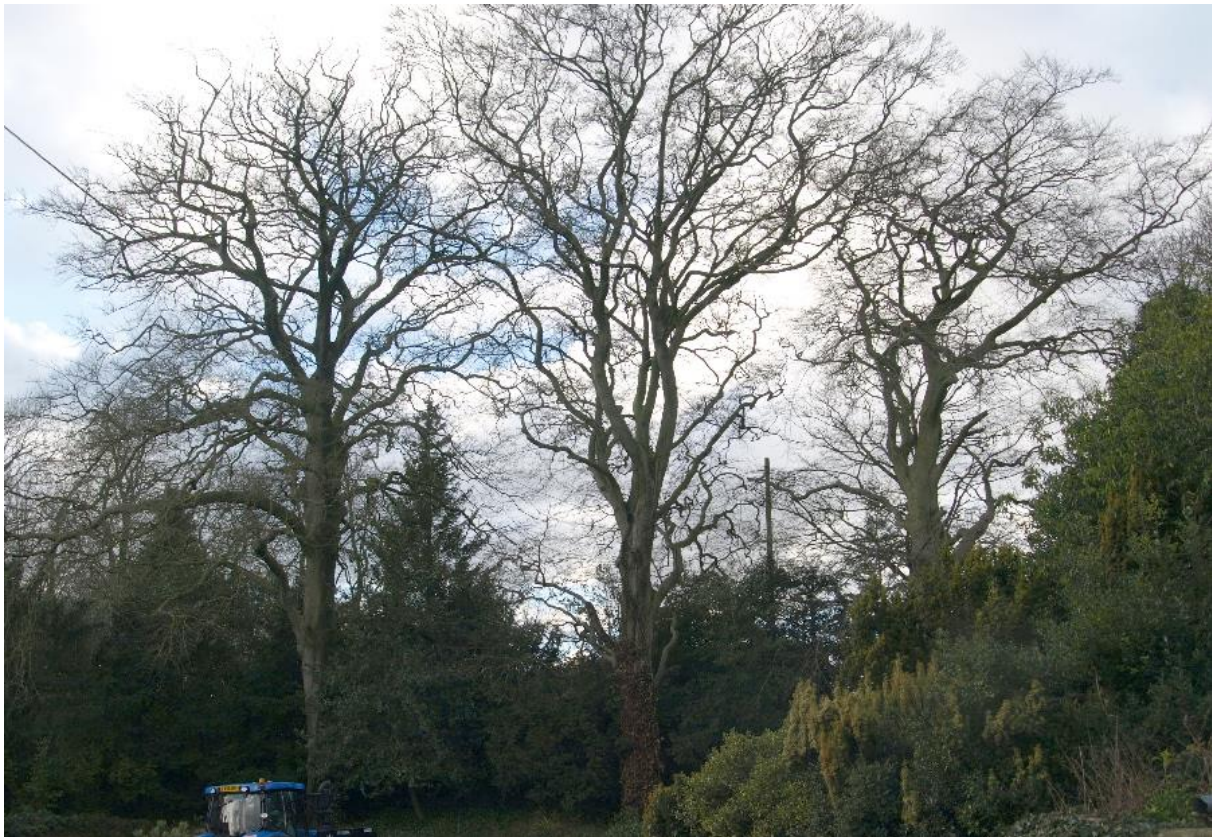
Photograph 1.

2.	Beech	23	1000	M	C1	Middle tree of group of three with 1 & 3. Will be a rather peculiar shape when tree 1 is removed.	452
3.	Beech	22	900	M	C1	Some decay and damage – one-sided crown due to tree 2.	366

Photograph 1 shows trees 1, 2 and 3. At this time of year it is fairly easy to see how the crowns of the individual tree fit together. I think it is obvious that when tree 1 (at

the left) is removed the remaining trees will be rather strangely shaped. While it might seem presumptuous of me to state that this tree is coming down, there is really little choice in the matter. The Giant polypore fungus (*Meripilus giganteus*) is a notorious cause of decay in Beech trees and while it is difficult to appraise the extent of decay, in this case, the crown is sufficiently degraded (died back) to reason that it must be removed. This appraisal is based upon the fact that at the time of my visit there was what appeared to be an expensive tractor parked beneath it and a quantity of dressed stone, which is likely to be valuable. It goes without saying that if this tree collapsed or toppled towards the Monsal Trail the consequences could be tragic.

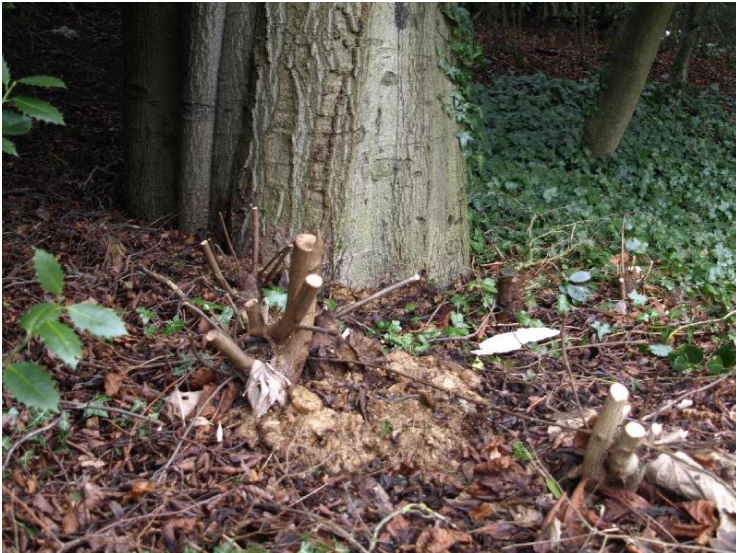
Photograph 2.

Photograph 2 is a view of the base of tree 1. The gunky-fawn mass between the cut saplings is the degraded fungal fruiting body. There is a similarly degraded mass at the base of tree 10.

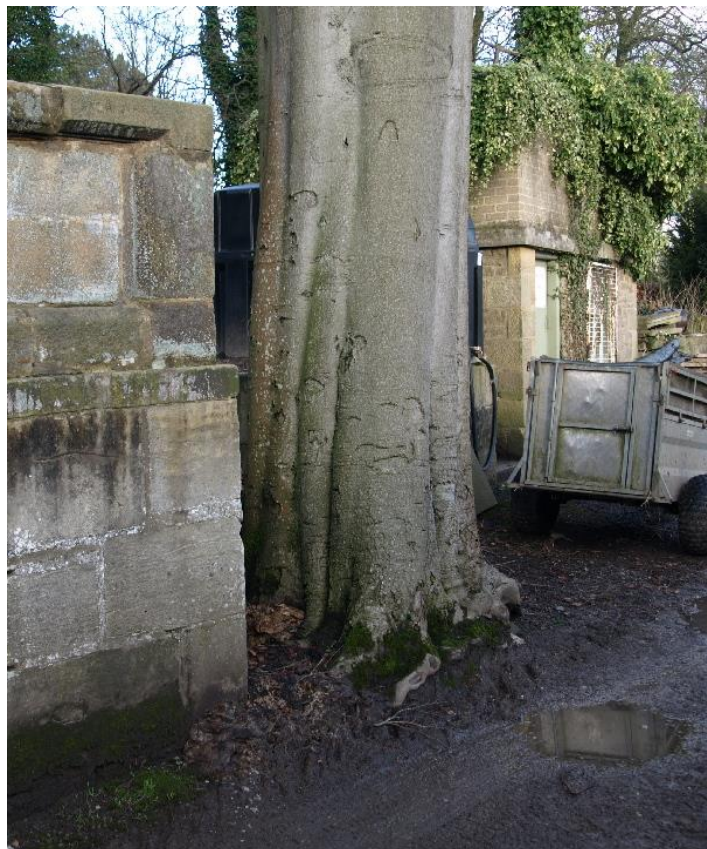
Photograph 3.

Photograph 3 is a view of the base of tree 10. It is clear that this tree has been suffering root damage from passing vehicles for a considerable period. The *Meripilus* fungus probably developed as a result of roots being repeatedly wounded although the tree growing in such a confined position will probably not have helped its resistance to infection. We should not blame the infection entirely on these factors; this is not a tree in the first flush-of-youth and generally resistance to disease decreases with age.

This tree cannot be retained as it is very close to a workshop and the former chapel building where it appears people work.

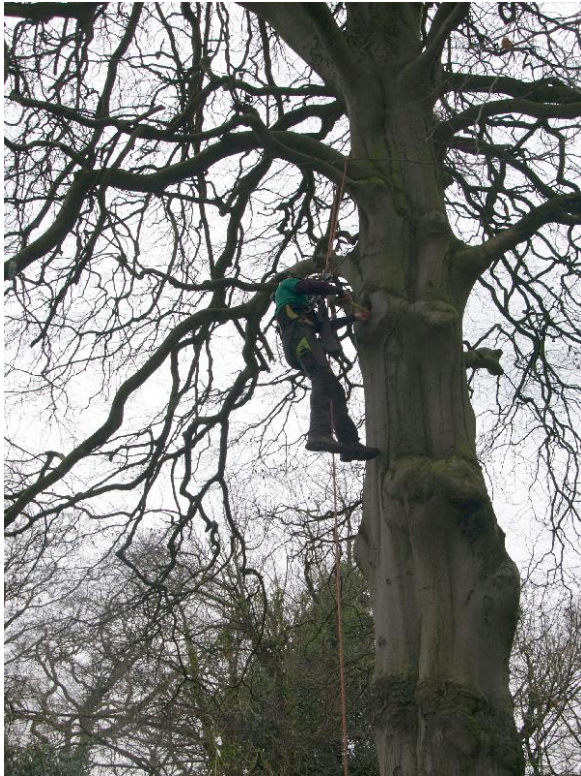
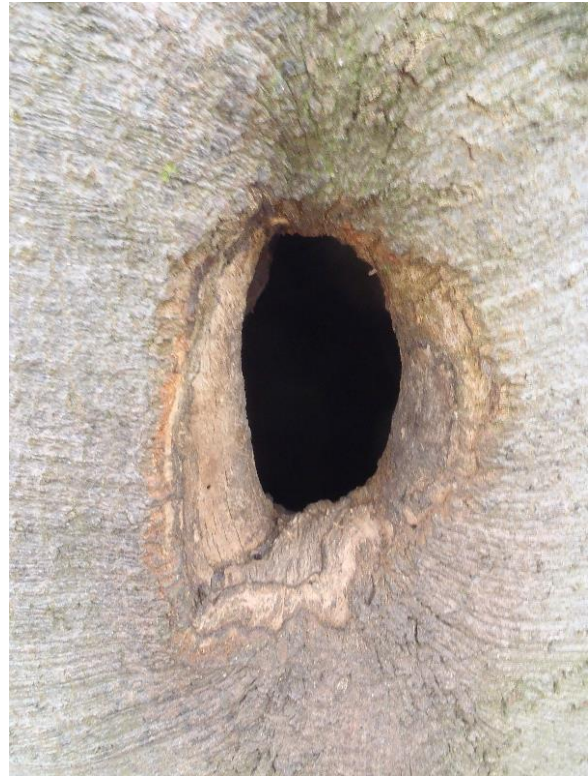
8.	Norway Maple	14	590	M	C1	Poor form and significant bark damage, probably due to Squirrels.	163
9.	Beech	20	910	M	U	Basal impact damage, significant cavity at 8m. The cavity is over 600mm deep and the diameter of the trunk at this point is less than 900mm. There is little option other than to remove this tree.	0

Photograph 4 is a view of my colleague sticking a steel tape measure into the hole in tree 9. Photo 5 is a view of the hole which is approximately 100mm from top to bottom. The cavity is at least 600mm deep and the stem's diameter is 900mm. While we were on site we watched a Jackdaw climb into the hole, which appeared to be to the distress of a Grey Squirrel. I presume the gnawing around the hole's perimeter is Squirrel damage. This tree should also be removed.

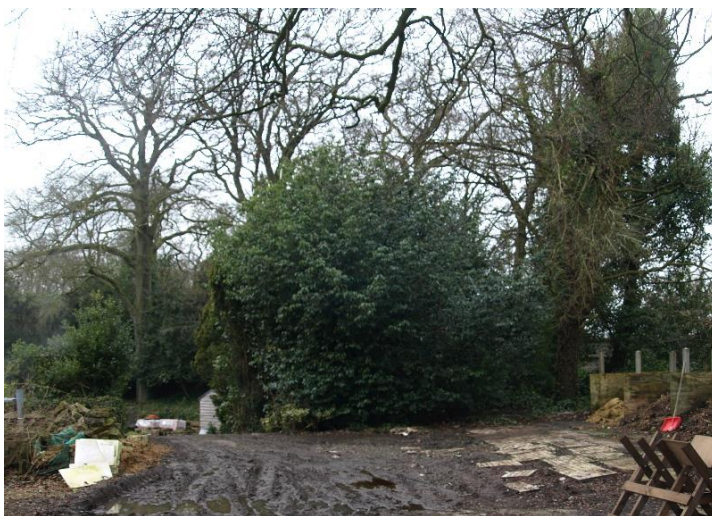
Photograph 6.

Photograph 6 is view from the base of tree 9 looking roughly west. Trees 1, 2 & 3 are in the background and the Norway Maple 8 is at the right. The evergreen shrub mass in the centre is largely Portuguese Laurel which is now recognised as an invasive pest. The proposed site layout requires the Laurel and the Maple to be removed.

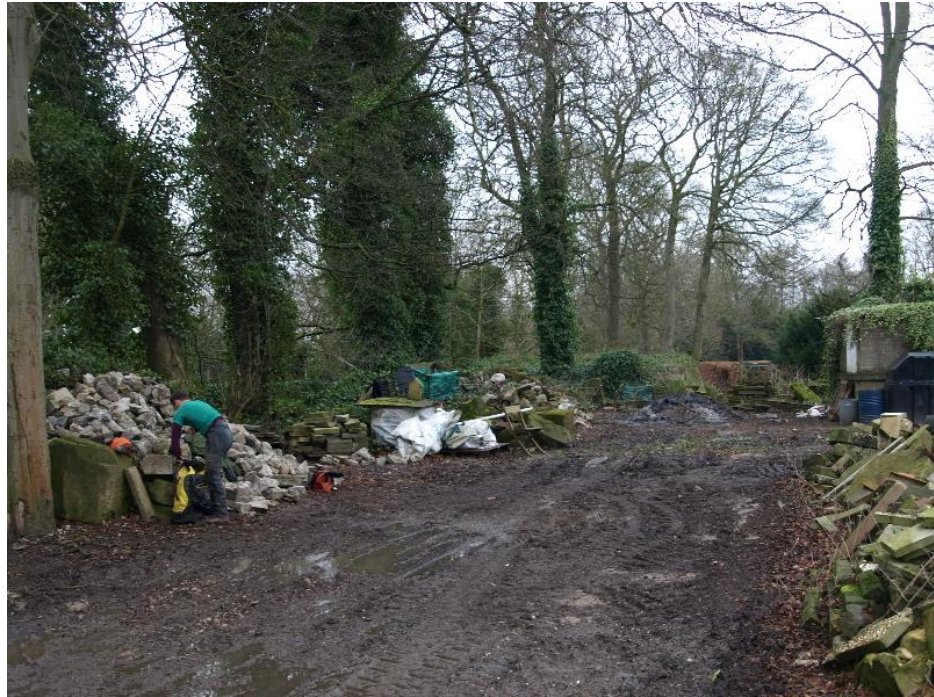
Photograph 7.

Photograph 7 is a view of the site from the base of tree 9 looking east. Trees 11 to 16 are all Ivy clad. While the plans call for trees 14 & 15 to be retained I think it would probably be more sensible to remove them and plant something new.

From photos 6 & 7 it is apparent that the area has been treated somewhat disdainfully for a long time. I don't mean that people deliberately set out to compact soils and create poor tree-growing conditions deliberately, simply that little thought was given to the trees. This is not unusual; people often seem to regard trees as fixtures and fittings, completely forgetting that they need to be able to extract moisture and nutrient from the soils around them.
