**PROOF OF EVIDENCE LONGSTONE EDGE PROHIBITION
ORDER APPEAL BY DR ALAN COBB**
For
PEAK DISTRICT NATIONAL PARK AUTHORITY

December 2015

Report Title: Proof of evidence Longstone Edge prohibition order appeal by Dr Alan Cobb

Client: Peak District National Park Authority

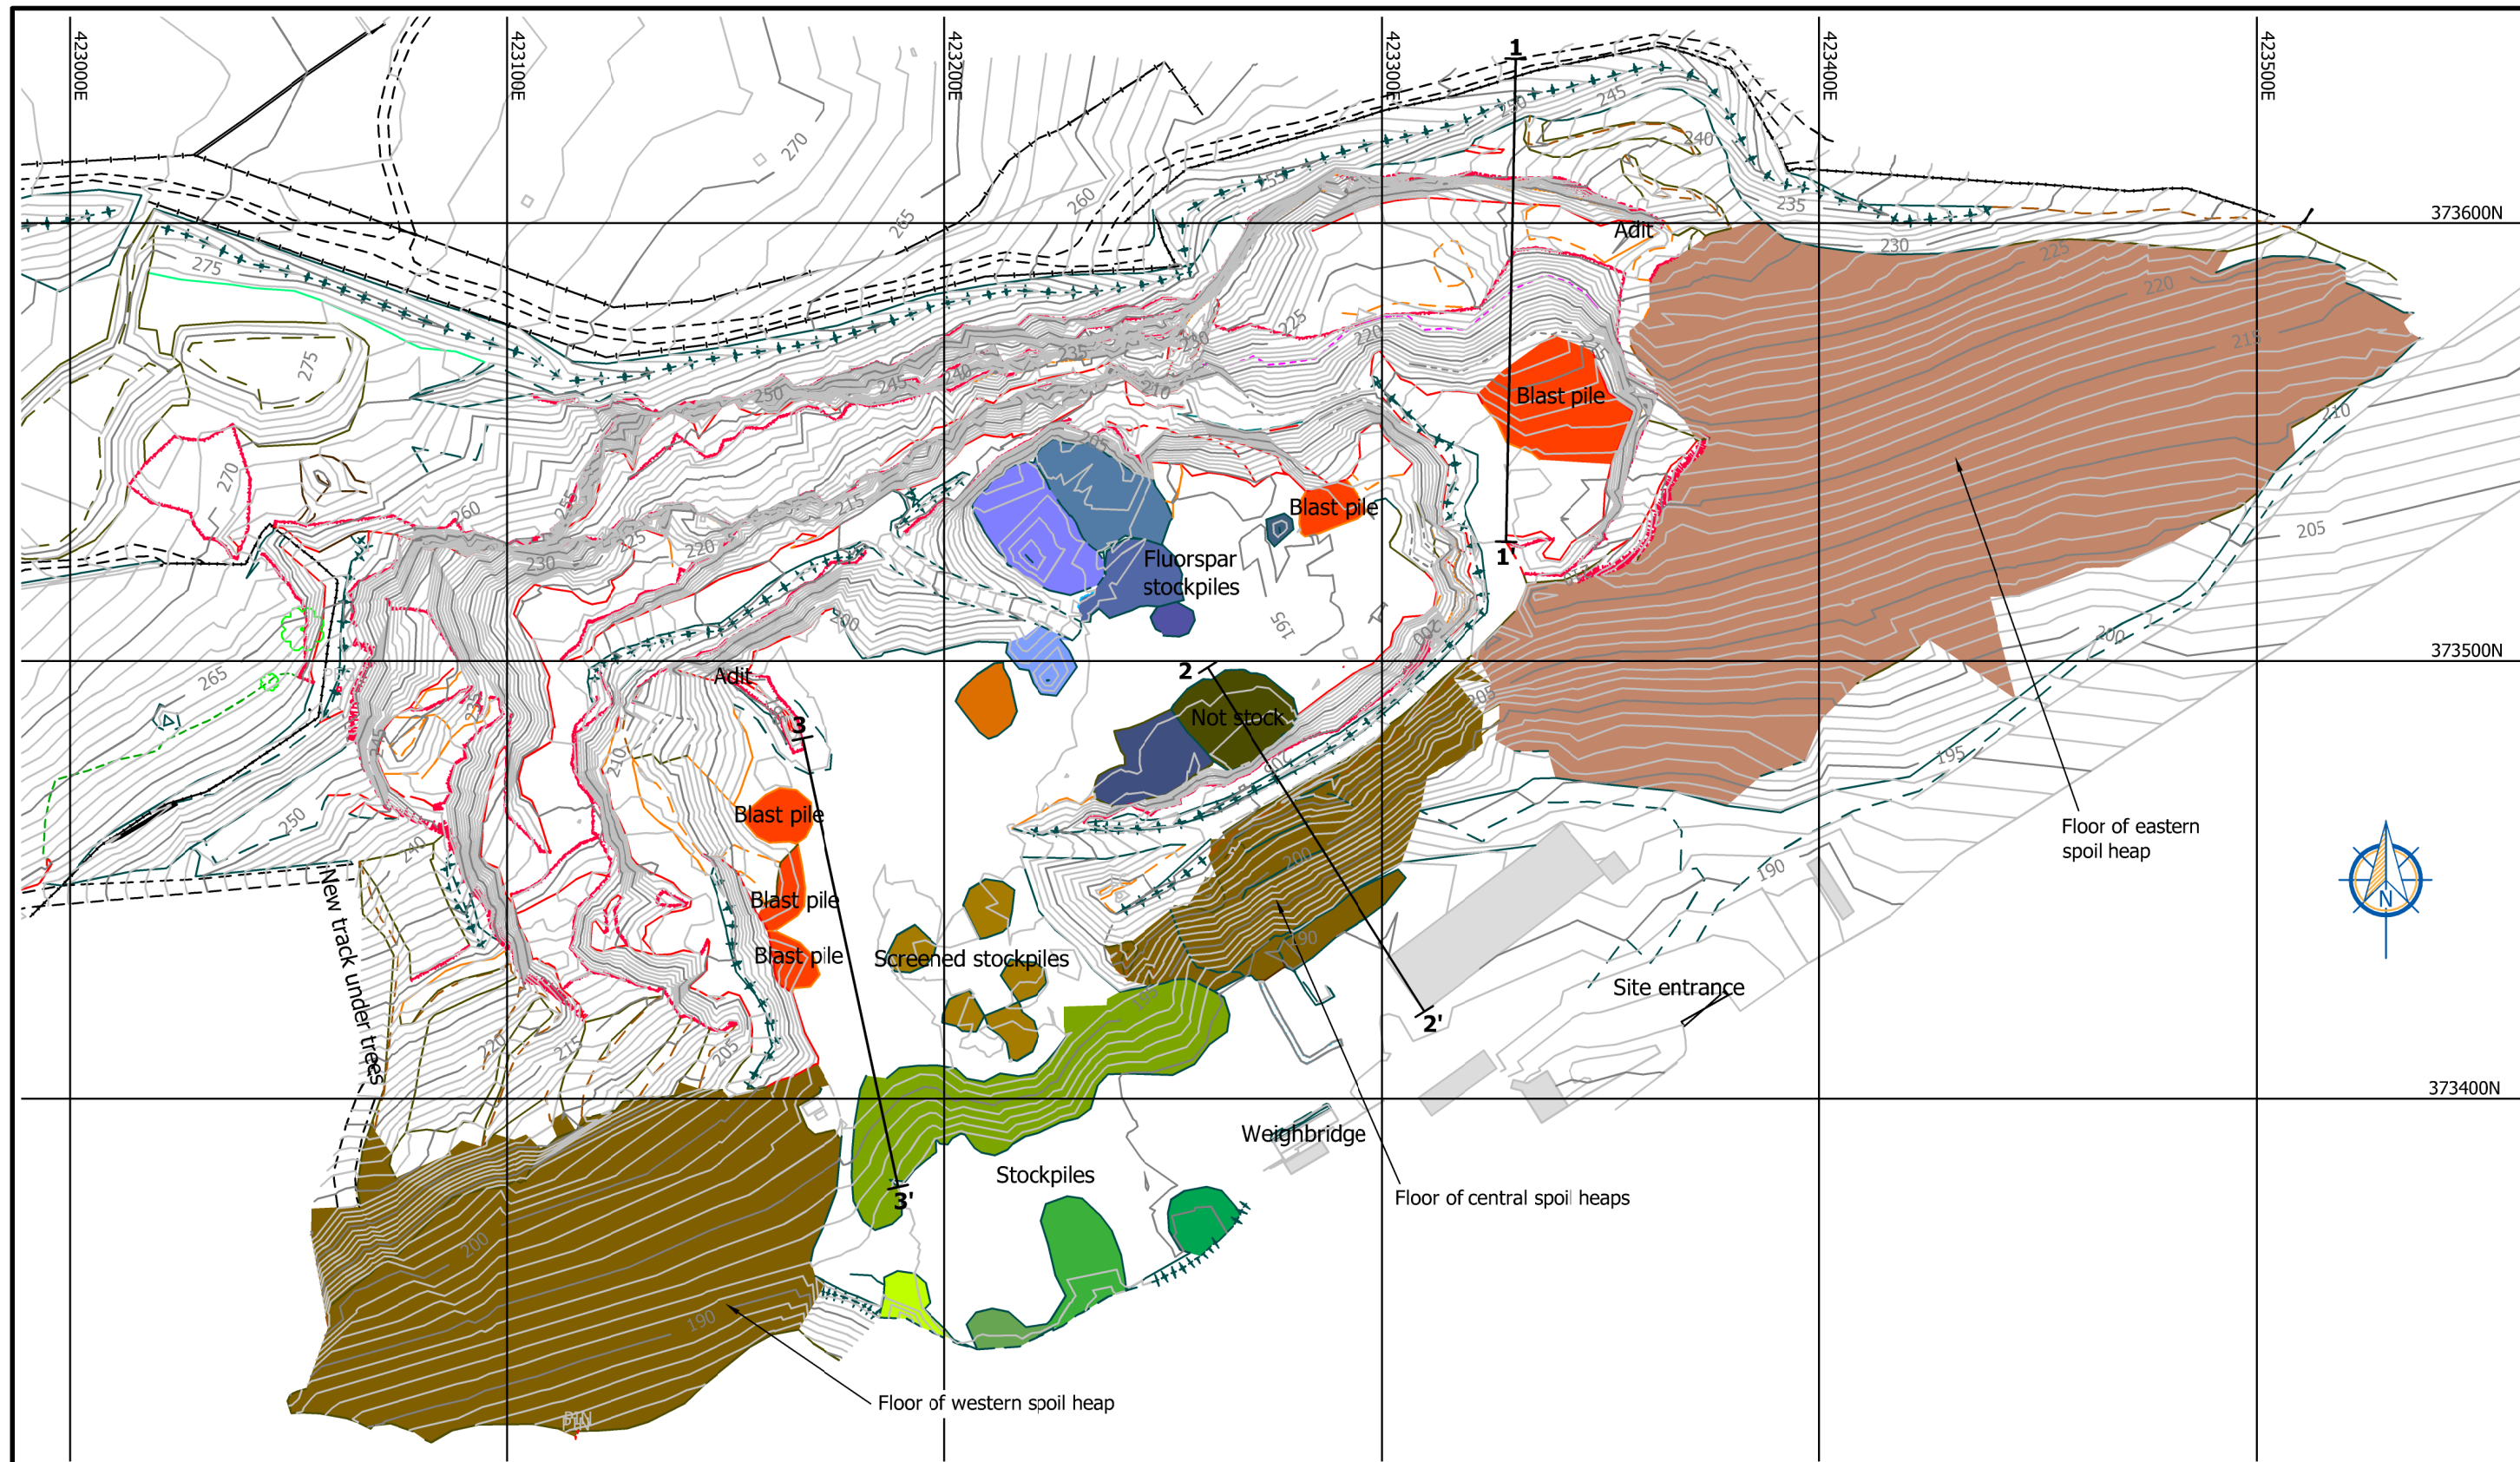
Backdale assumed base of spoil geometry

- Eastern area - based on OS DTM data, which appears to predate the majority of the tipping.
25. The resulting ground levels are shown on Drawing No. PPLEINC1405-3.

26. The levels shown in Drawing No. PPLEINC1405-3 give the following quantities of spoil:
- Western tip – 32,800m³.
 - Central tips – 500m³.
 - Eastern tip – 31,250m³.
27. This gives a total of 64,550m³ of material above old ground level outside the quarry excavation area that is available for restoration. As actual original ground levels are uncertain, volumes of available material cannot be accurately determined.

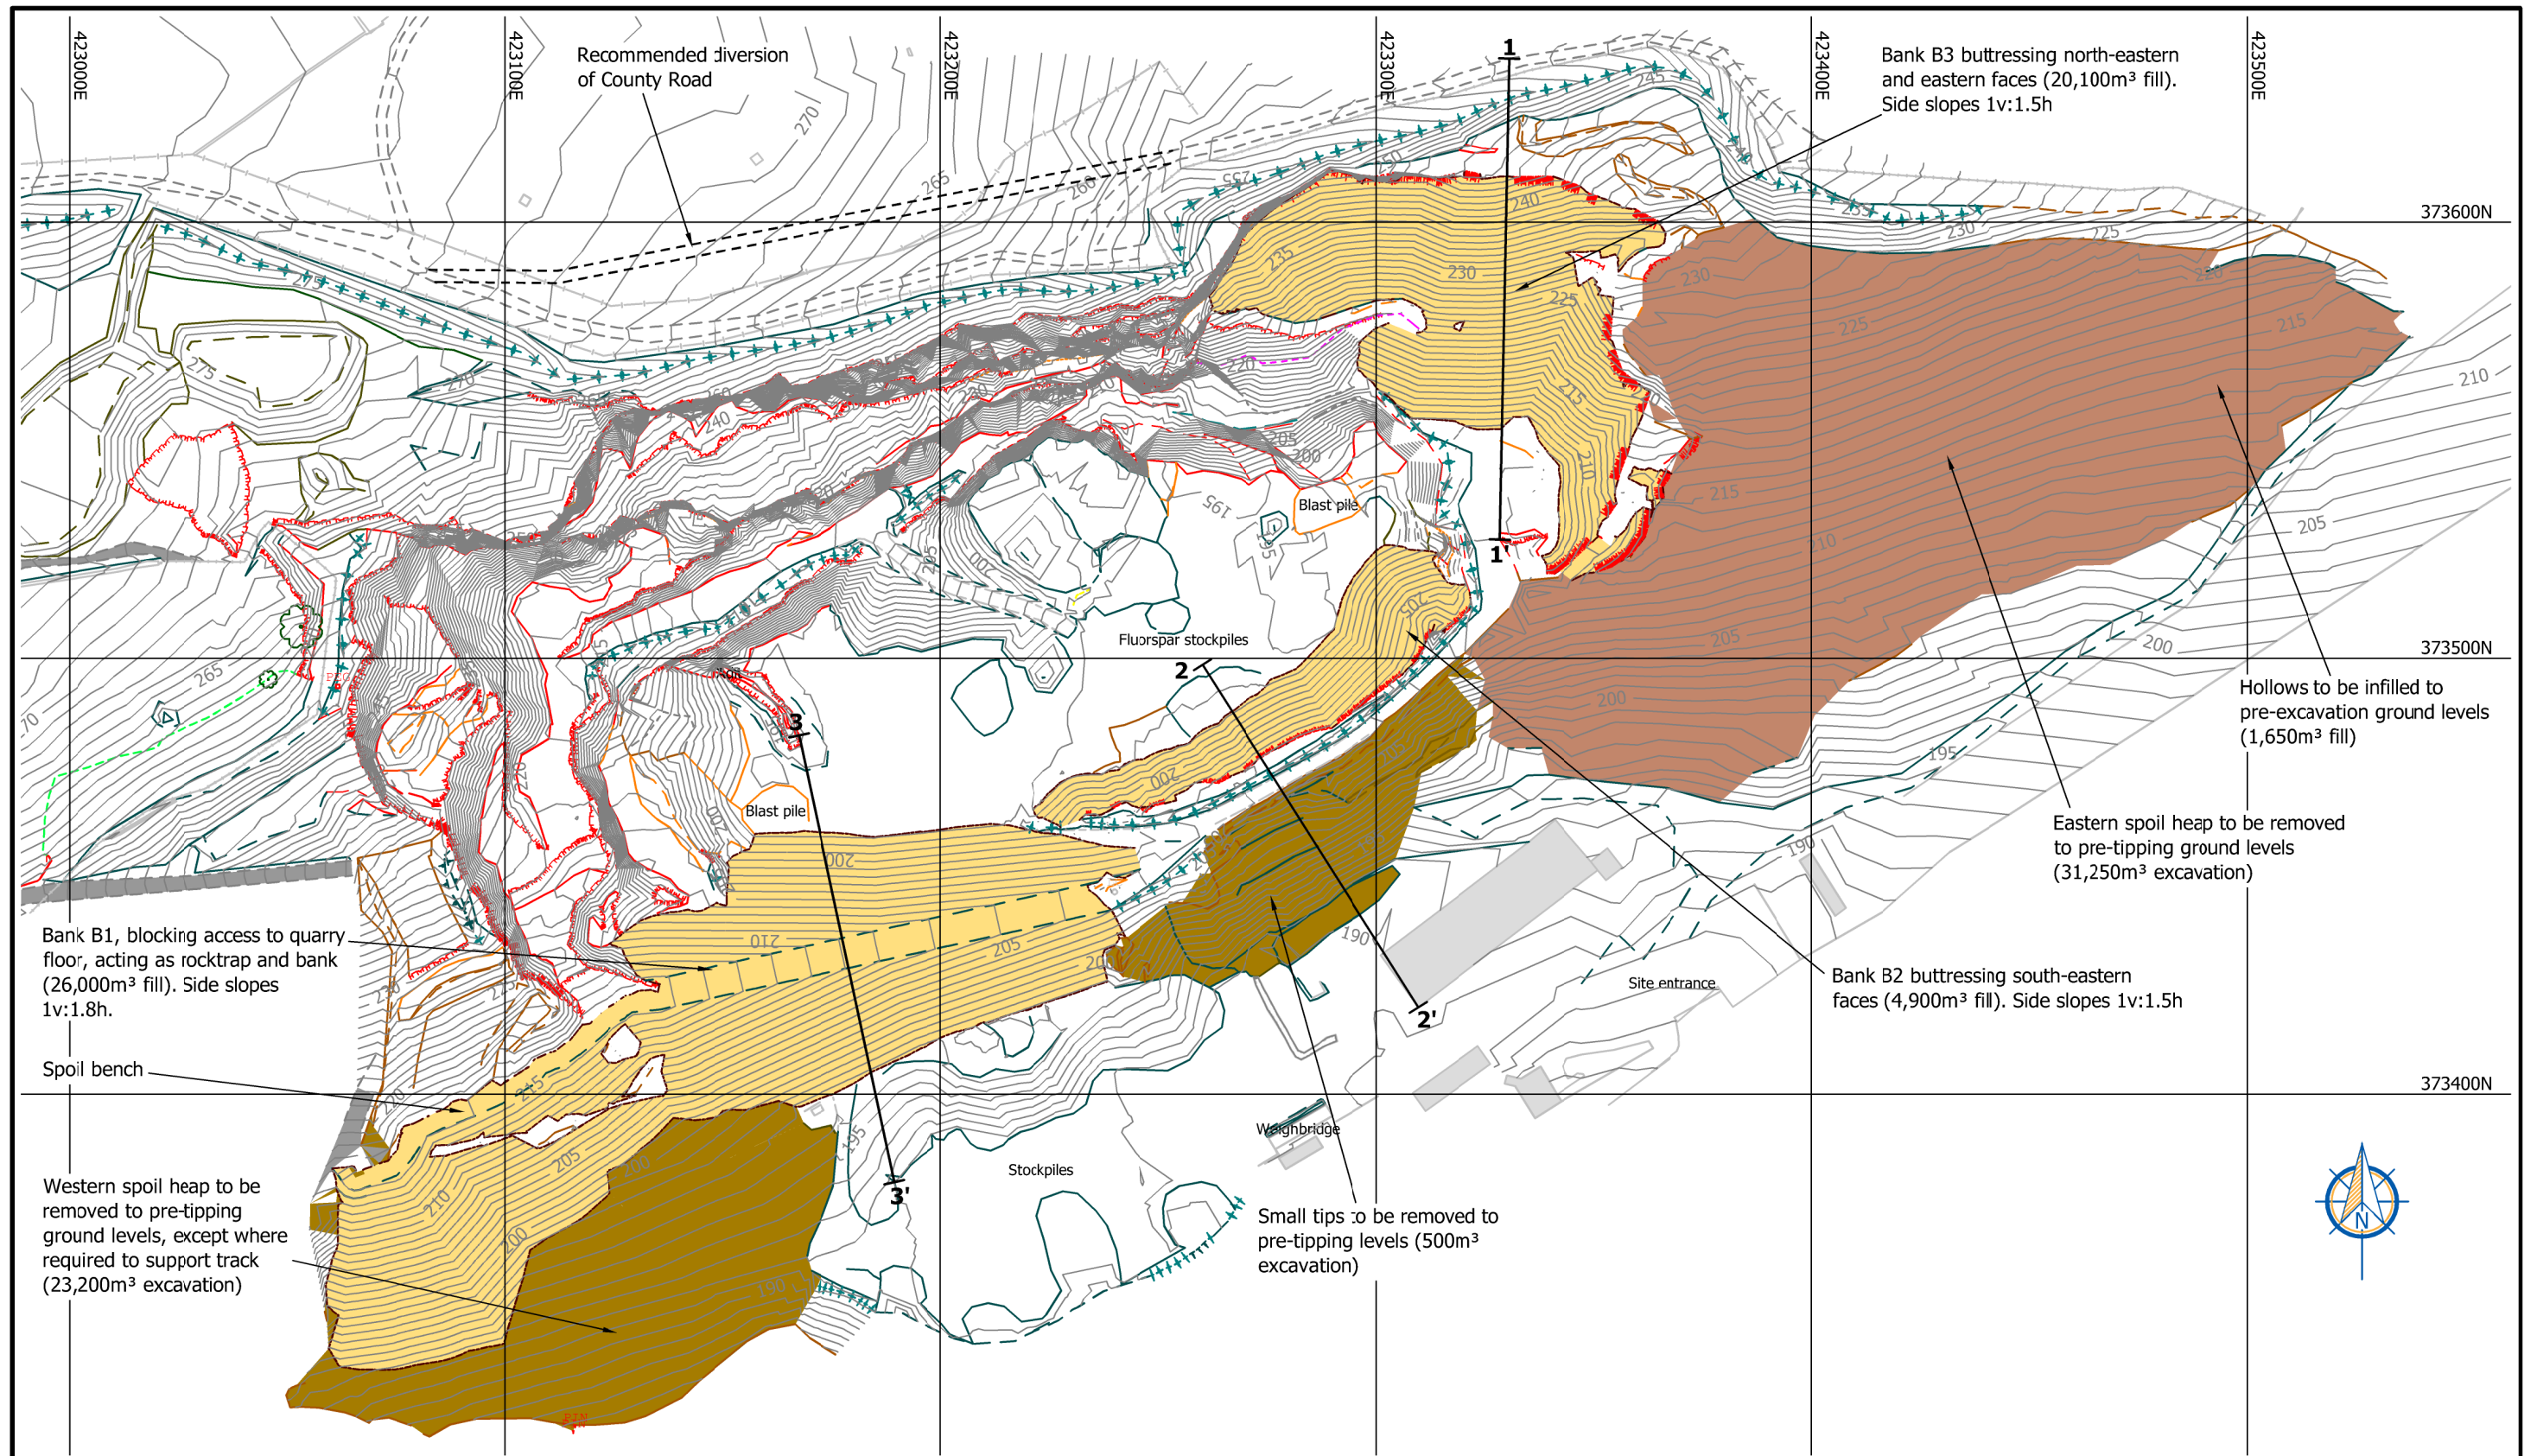
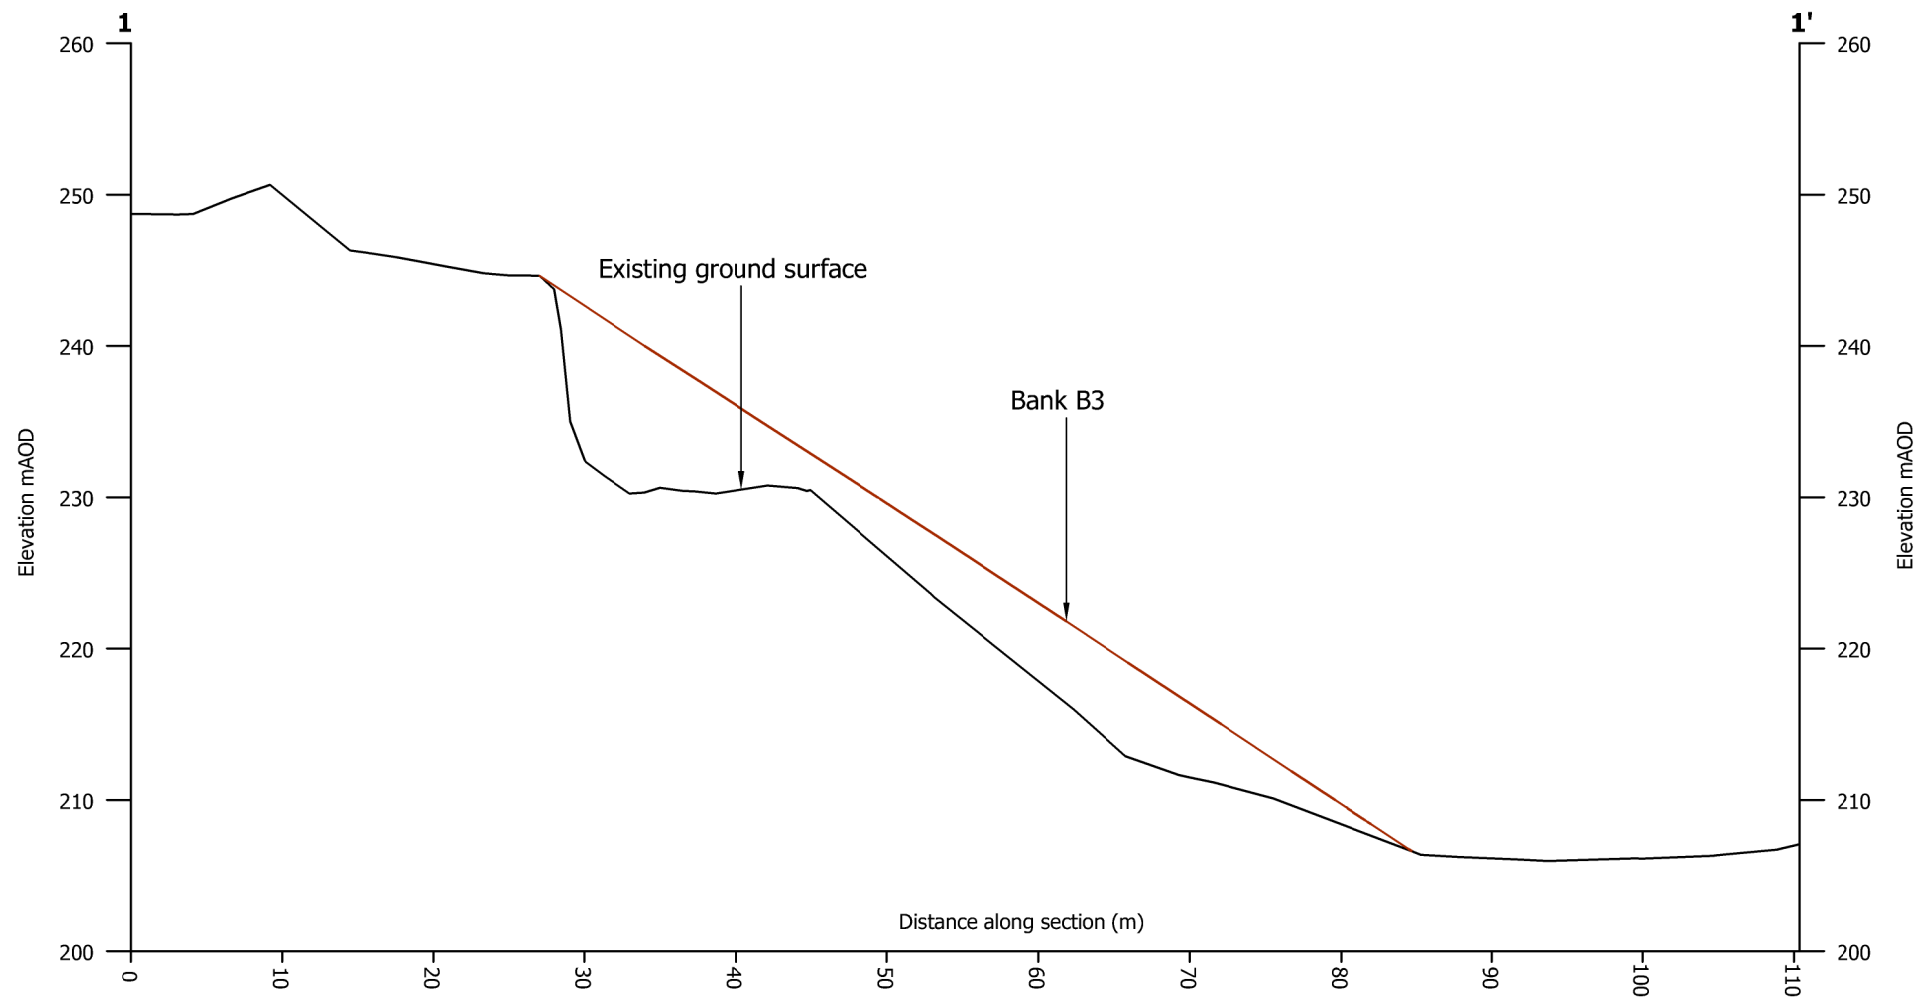
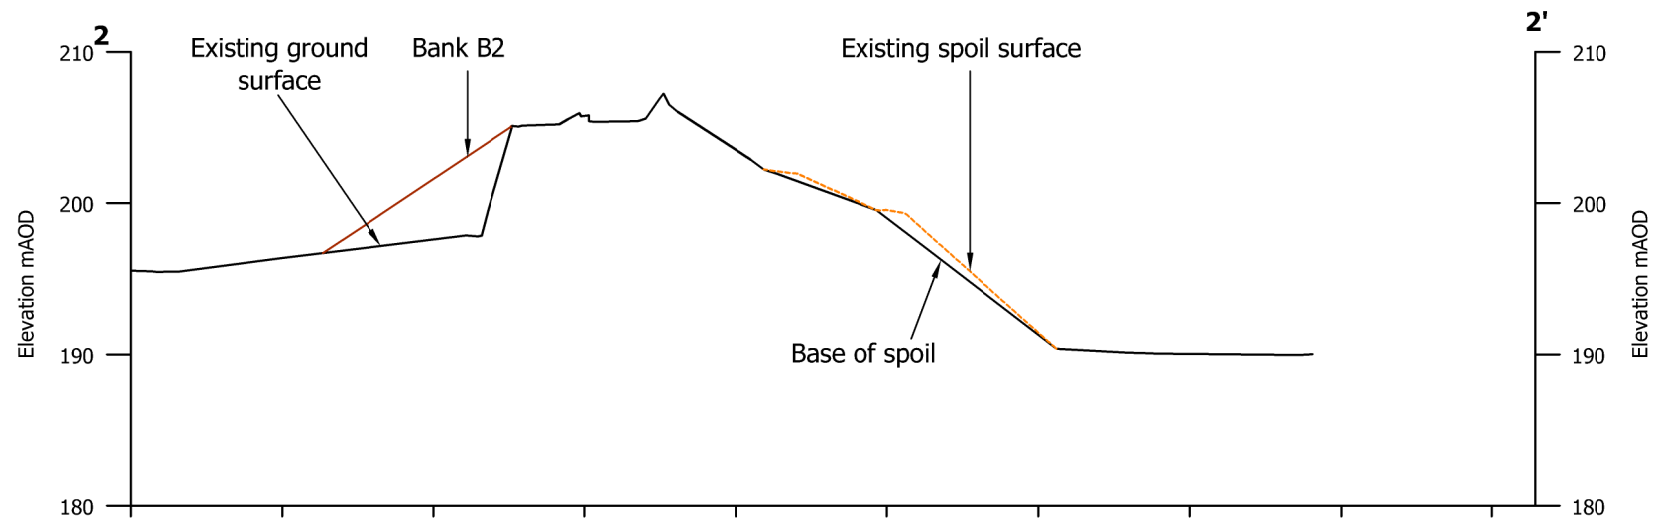
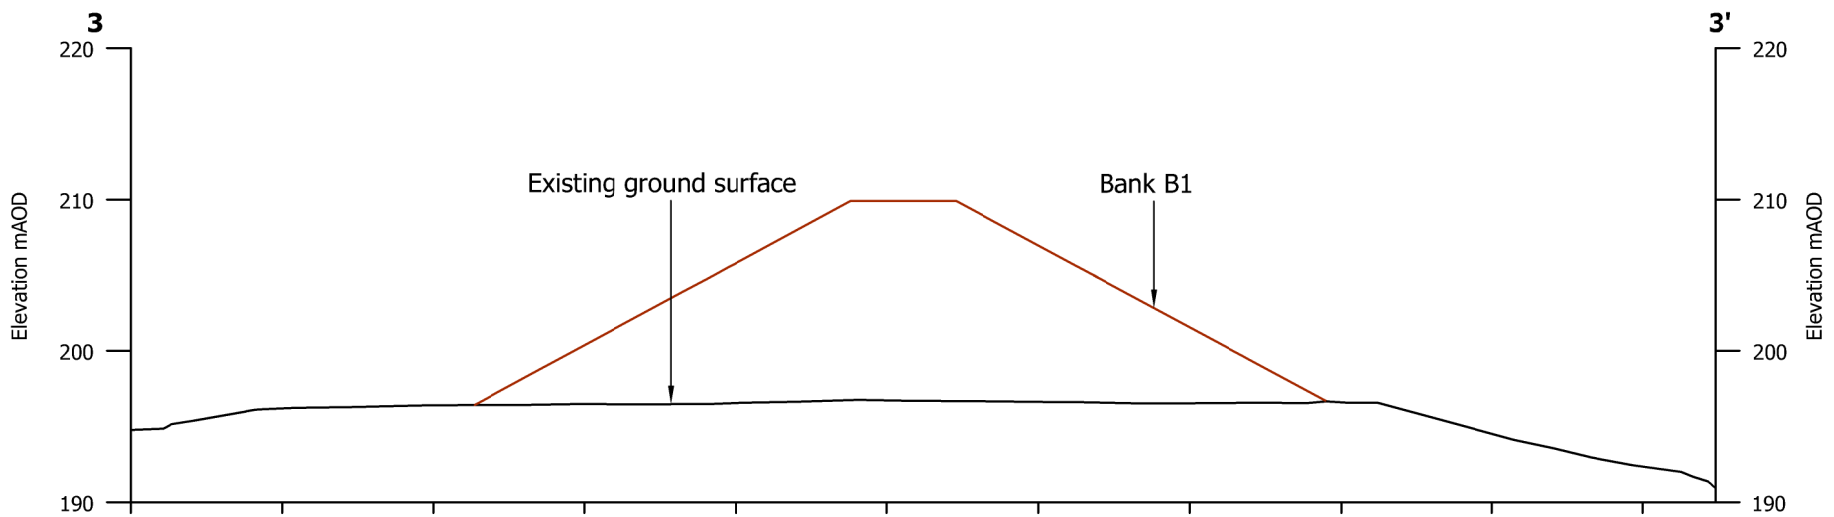
Backdale restoration plan			
Date	Drawn	Checked	Scale
04.12.2014	AEC/EMB	MP	1:1500 at A3
Drawing Ref	Drawing No	Version	
PPLEINC1405	4	C

28. The available fill is far too small a quantity to make the quarry completely safe. The best that can be done (what is reasonably practicable in term of the Quarries Regulations) is to reduce the risks by forming a barrier across the quarry entrance to prevent access and provide a barrier to any falling rocks, together with limited backfilling of the eastern end of the quarry, where faces are lower. The proposed scheme, as shown on Drawing No. PPLEINC1405-4 and 5, comprises four elements, as follows:

- Bank B1, a barrier across the quarry entrance, with a 7m wide crest, combined with a 4m wide ledge formed on spoil around the western flanks of the site, from the western side of the quarry to the remaining section of rock barrier in the centre of the site. This barrier will prevent the escape of rocks from the old quarry faces and discourage access into the danger zone. The barrier and ledge will form a safe route for the track which currently drops through the woods to the top of the western tip. Batters are constructed at 1 in 1.8 (v:h), a slope similar to that of the remaining section of rock barrier and slightly flatter than the existing tip side slopes. The ledge will involve some 9,600m³ of the spoil in the western tip remaining undisturbed (*i.e.* volume of spoil to remove from the western tip will be 23,200m³), and the remainder of the bank will require a volume of 26,000m³ of spoil.

- Bank B2, backfilling against the southern quarry faces to provide a buttress and prevent falls from the top of these rock faces. This will require some 4,900m³ of fill. Slopes are at 1 in 1.5 (v:h) the general side slope of the existing tips.

- Bank B3, backfilling against the upper eastern and north-eastern rock faces. This will render these faces safe from degradation and prevent falls from the top of these rock faces. This will require some 20,100m³ of fill. Slopes are at 1 in 1.5 (v:h) the general side slope of the existing tips.

- Infilling the excavation at the eastern end of the site back to original ground levels. This will take some 1,600m³ of fill.

Bank B1, blocking access to quarry floor, acting as rocktrap and bank (26,000m³ fill). Side slopes 1v:1.8h.

Bank B3 buttressing north-eastern and eastern faces (20,100m³ fill). Side slopes 1v:1.5h

Bank B2 buttressing south-eastern faces (4,900m³ fill). Side slopes 1v:1.5h

Hollows to be infilled to pre-excavation ground levels (1,650m³ fill)

Eastern spoil heap to be removed to pre-tipping ground levels (31,250m³ excavation)

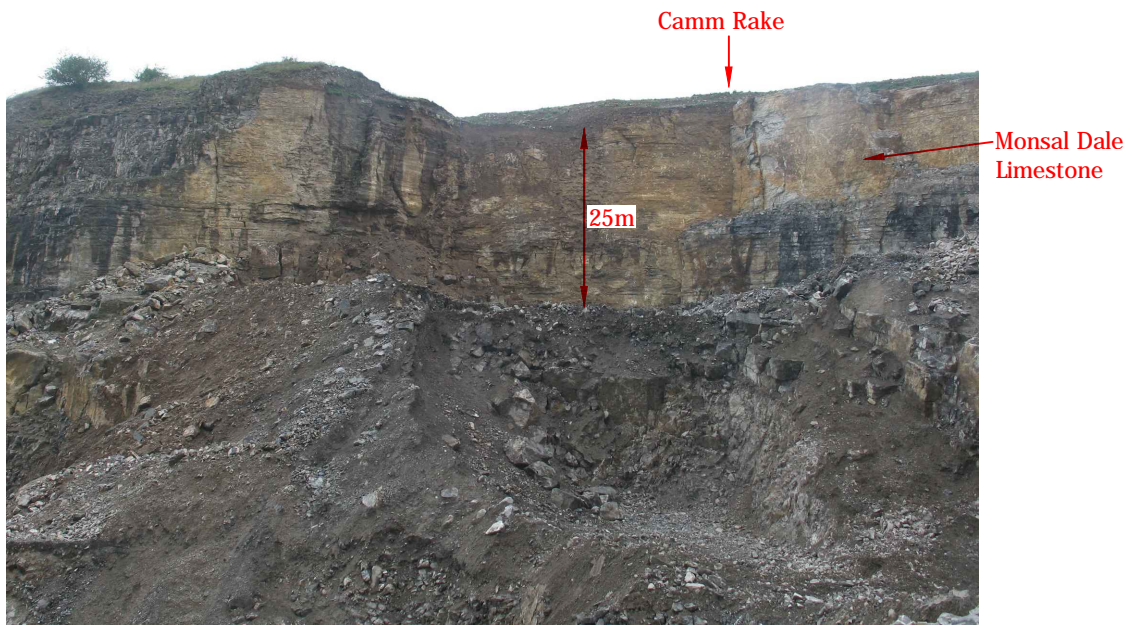
Camm Rake offshoot 1 in Backdale Quarry faces

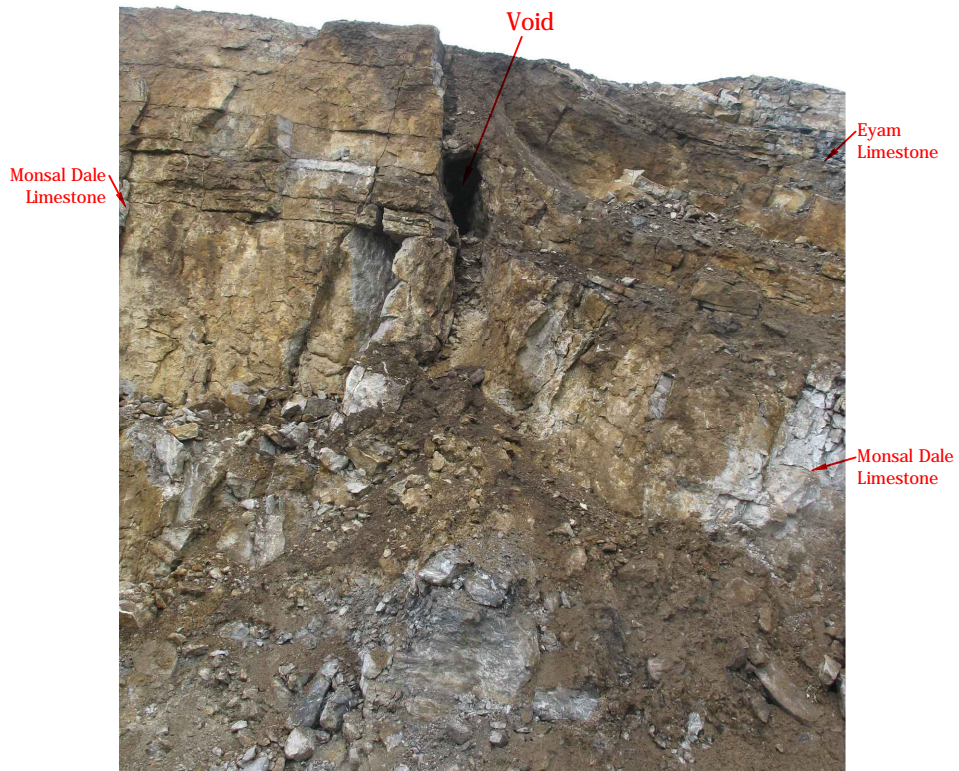
Void in Catlow Rake in Backdale Quarry

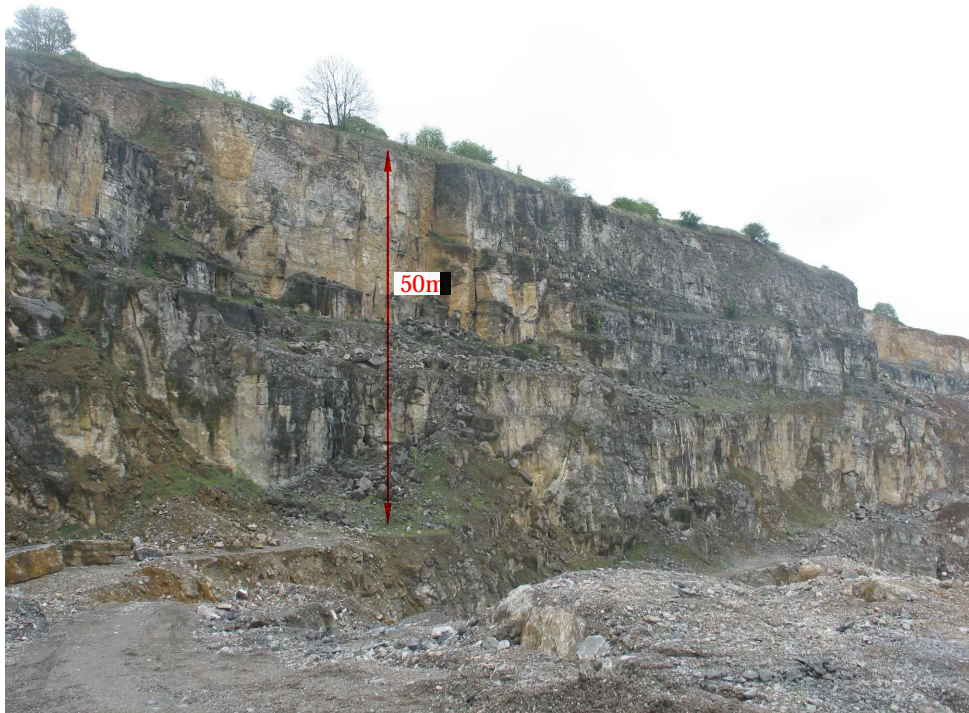
Steep high rock faces, north west side of Backdale Quarry

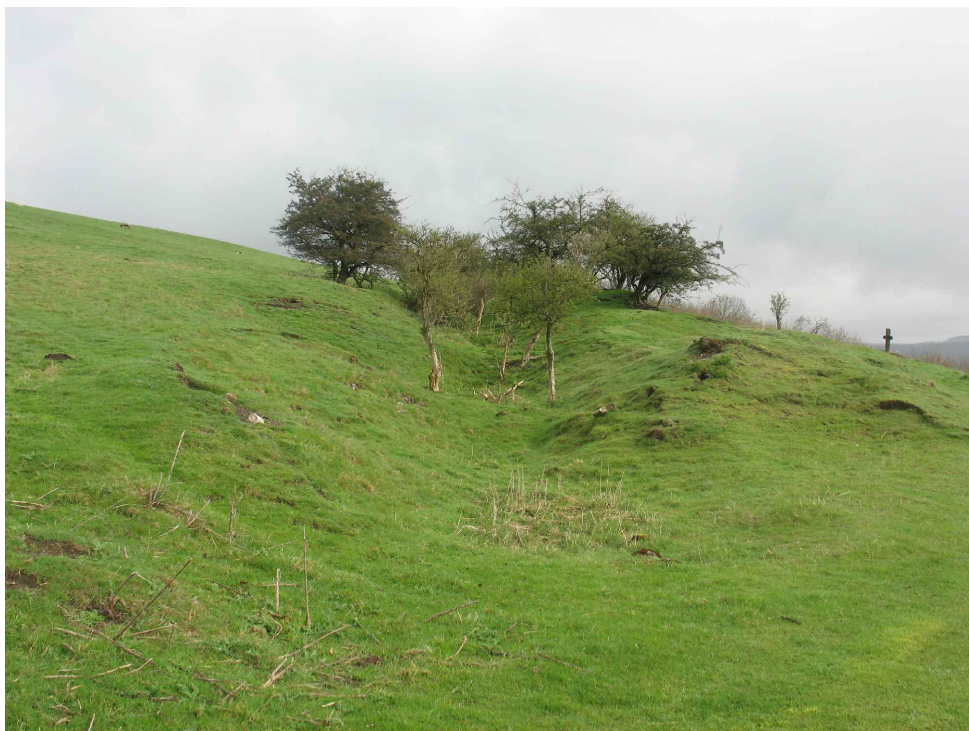
Slot on Camm Rake, Peak Pasture

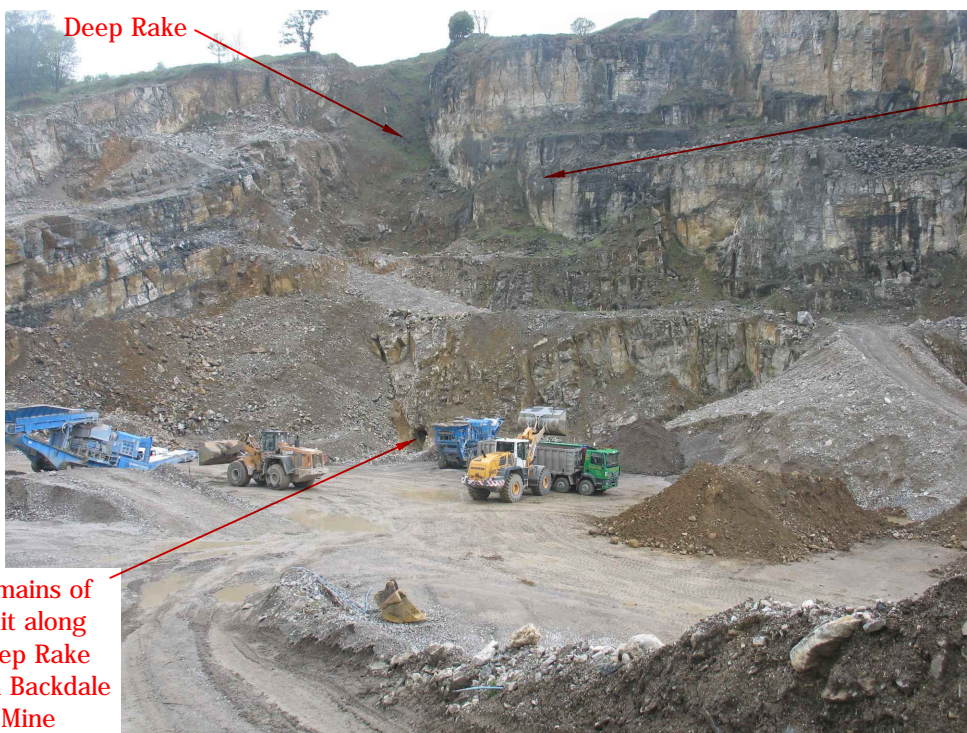
Location of subsequent failure in 2015

North-west corner of Backdale Quarry showing old high faces

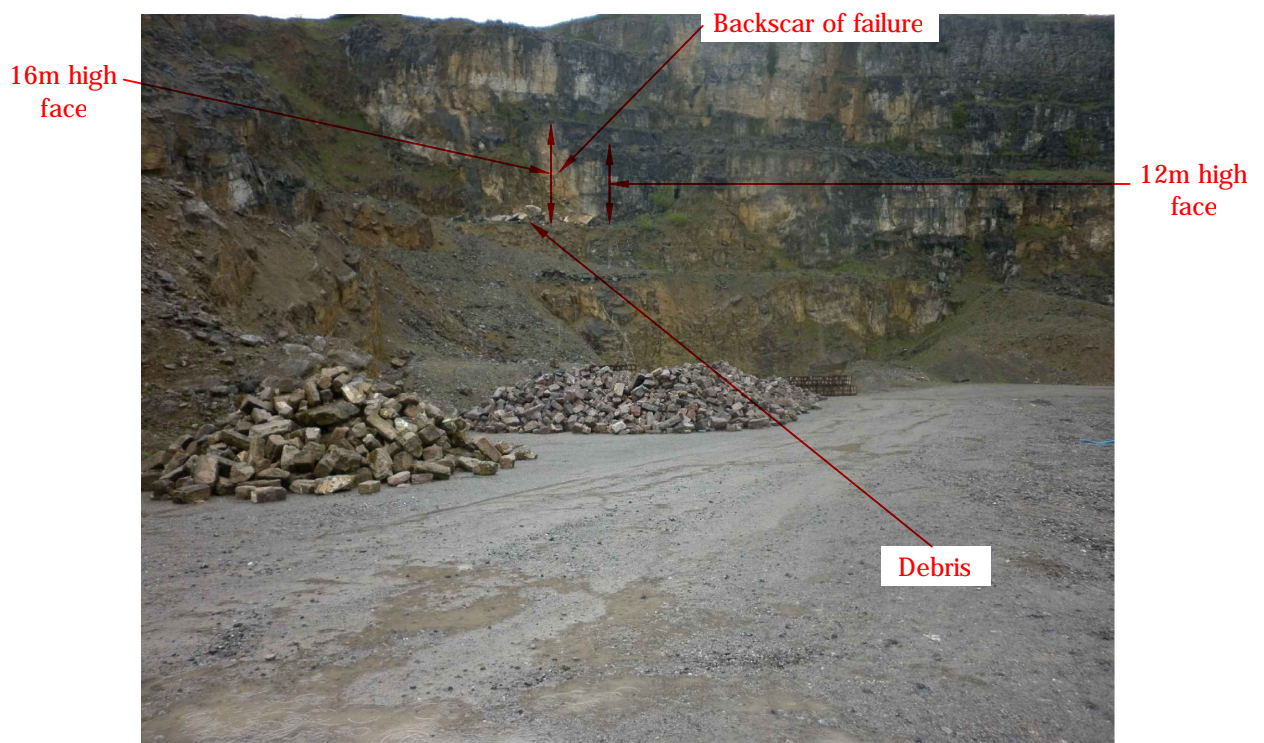
North-west faces of Backdale Quarry showing recent rock failure

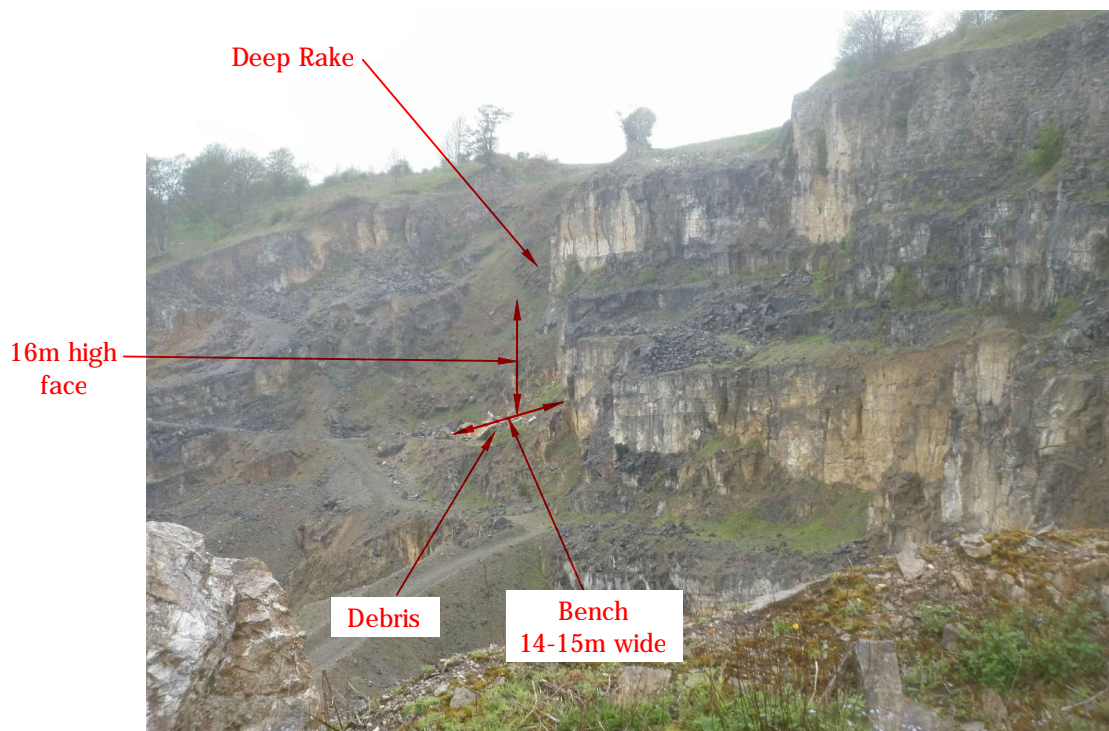
North-west faces of Backdale Quarry showing recent rock failure
