**Enforcement Appeal Land in the Peak District National Park
at Mickleden Edge, Midhope Moor Bradfield, South Yorkshire
APP/M9496/C/18/3215789**

Addendum to Landscape Proof of Evidence

Prepared by Nick Leeming (BA(Hons) dip LA (Dist) MLI

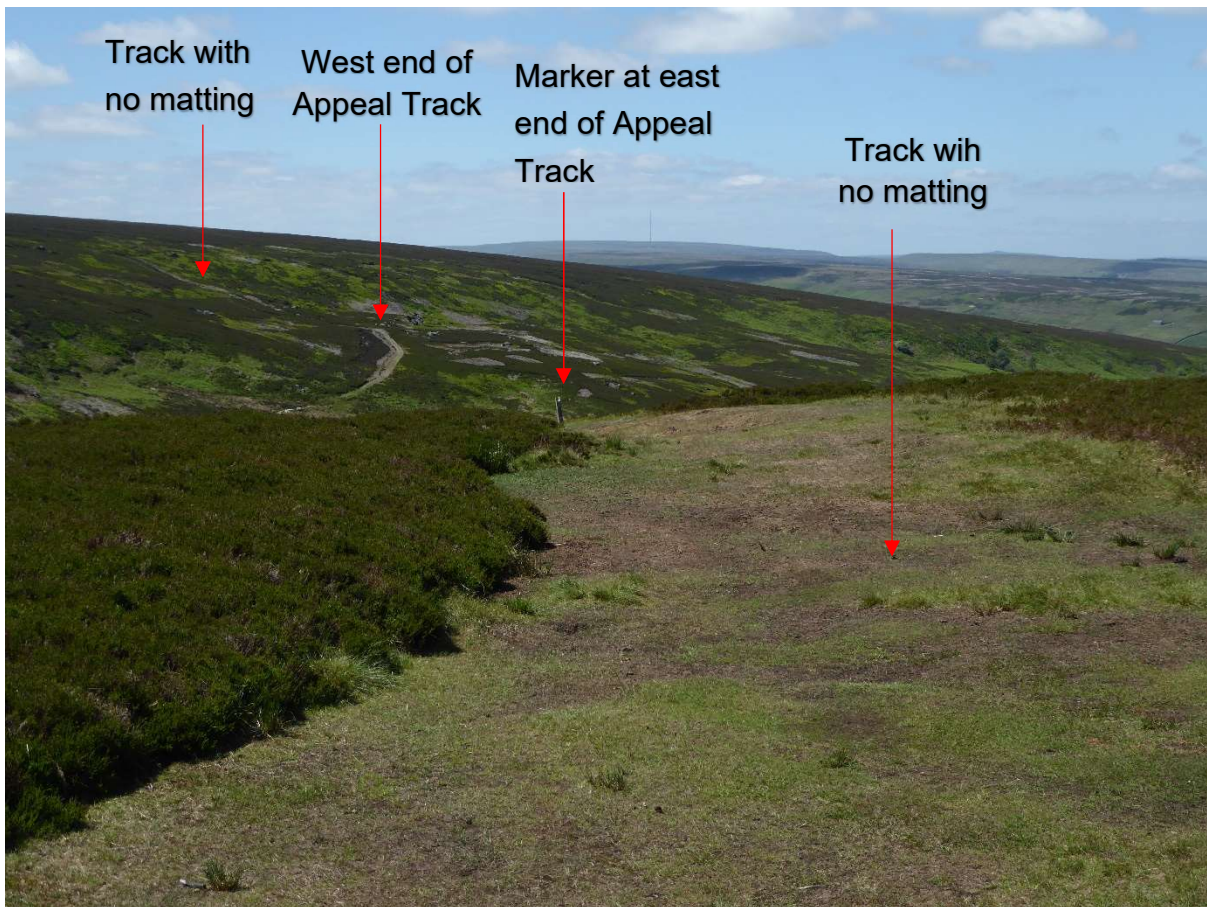
Photograph 19 Photograph 11 Revision A June 2021 View from appeal track at the edge of Lost Lad.

- 4.1 The most striking change since the October 2020 site visit is the change in colour tones of the track and surrounding landscape. In June 2021 the study area displays much more extensive areas of new growth vegetation, presenting itself in the lush green of bracken and grass. As well as the vegetation the greys and browns of other elements in the landscape are also more evident in comparison to October 2020 such as tracks, public rights of way and burn areas. Refer Photograph 19 below.

Add: ***'The track is not unusual and is similar in appearance to other man made routes that have not used matting. (Refer Photograph 19)***

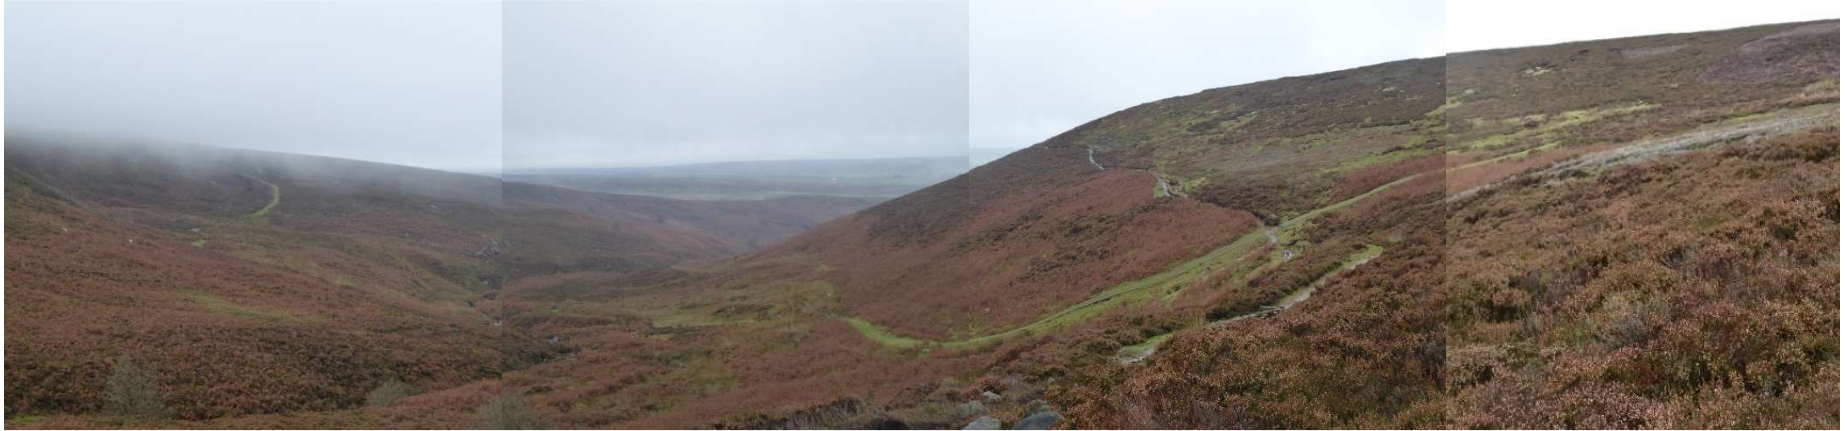
Photograph 20 Panorama 1 View of Appeal Track from Cut Gate October 2020

- 4.2 In addition to Photograph 19 above refer to Photographs 20 and 21 on page 5 of this addendum.

Add: ***‘In addition to areas and strips of brighter green there are more contrasting areas of dark green, bright green, brown and grey across the moor including tracks with and without matting’ (Refer Photographs 20 and 21)’***
