THORNBRIDGE HALL PARK,
ASHFORD-IN-THE-WATER AND GREAT LONGSTONE
PARISHES, DERBYSHIRE

ARCHAEOLOGICAL SURVEY 1995

Bill Bevan

PEAK NATIONAL PARK ARCHAEOLOGY SERVICE

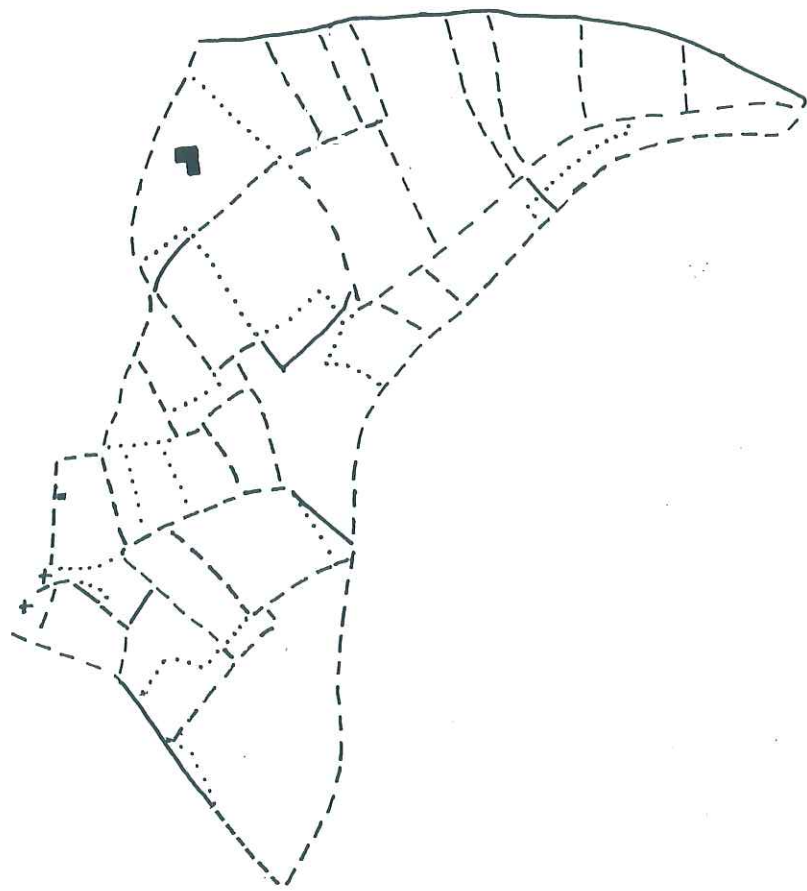
PROJECT THORNBRIDGE HALL PARK	KEY — BOUNDARY ADDED BETWEEN 1824 & 1880 - - - BOUNDARY PRESENT IN 1824 & 1880 BOUNDARY REMOVED BETWEEN 1824 & 1880 ■ ■ BUILDINGS PRESENT IN 1880 + + + UNDEFINED EDGE OF SURVEY AREA

The first hall was built between 1752 and 1790, when it is recorded as being sold to the Moorwood family (Mates 1993) (see fig. 4). Limited gardens occupying a triangle of land around the hall were created. The construction of the hall and gardens removed a number of enclosed fields and some of the remaining open field cultivation strips. There appears to have been no change to the fields within the survey area between 1824 and the tithe plans of 1847 (anon. 1824a; 1824b; 1847a; 1847b). The garden was extended by only a limited amount by 1880 (Ordnance Survey 1880) (see fig. 4). To the east and south the main changes to the enclosed fields were the removal of some boundaries to make larger fields.

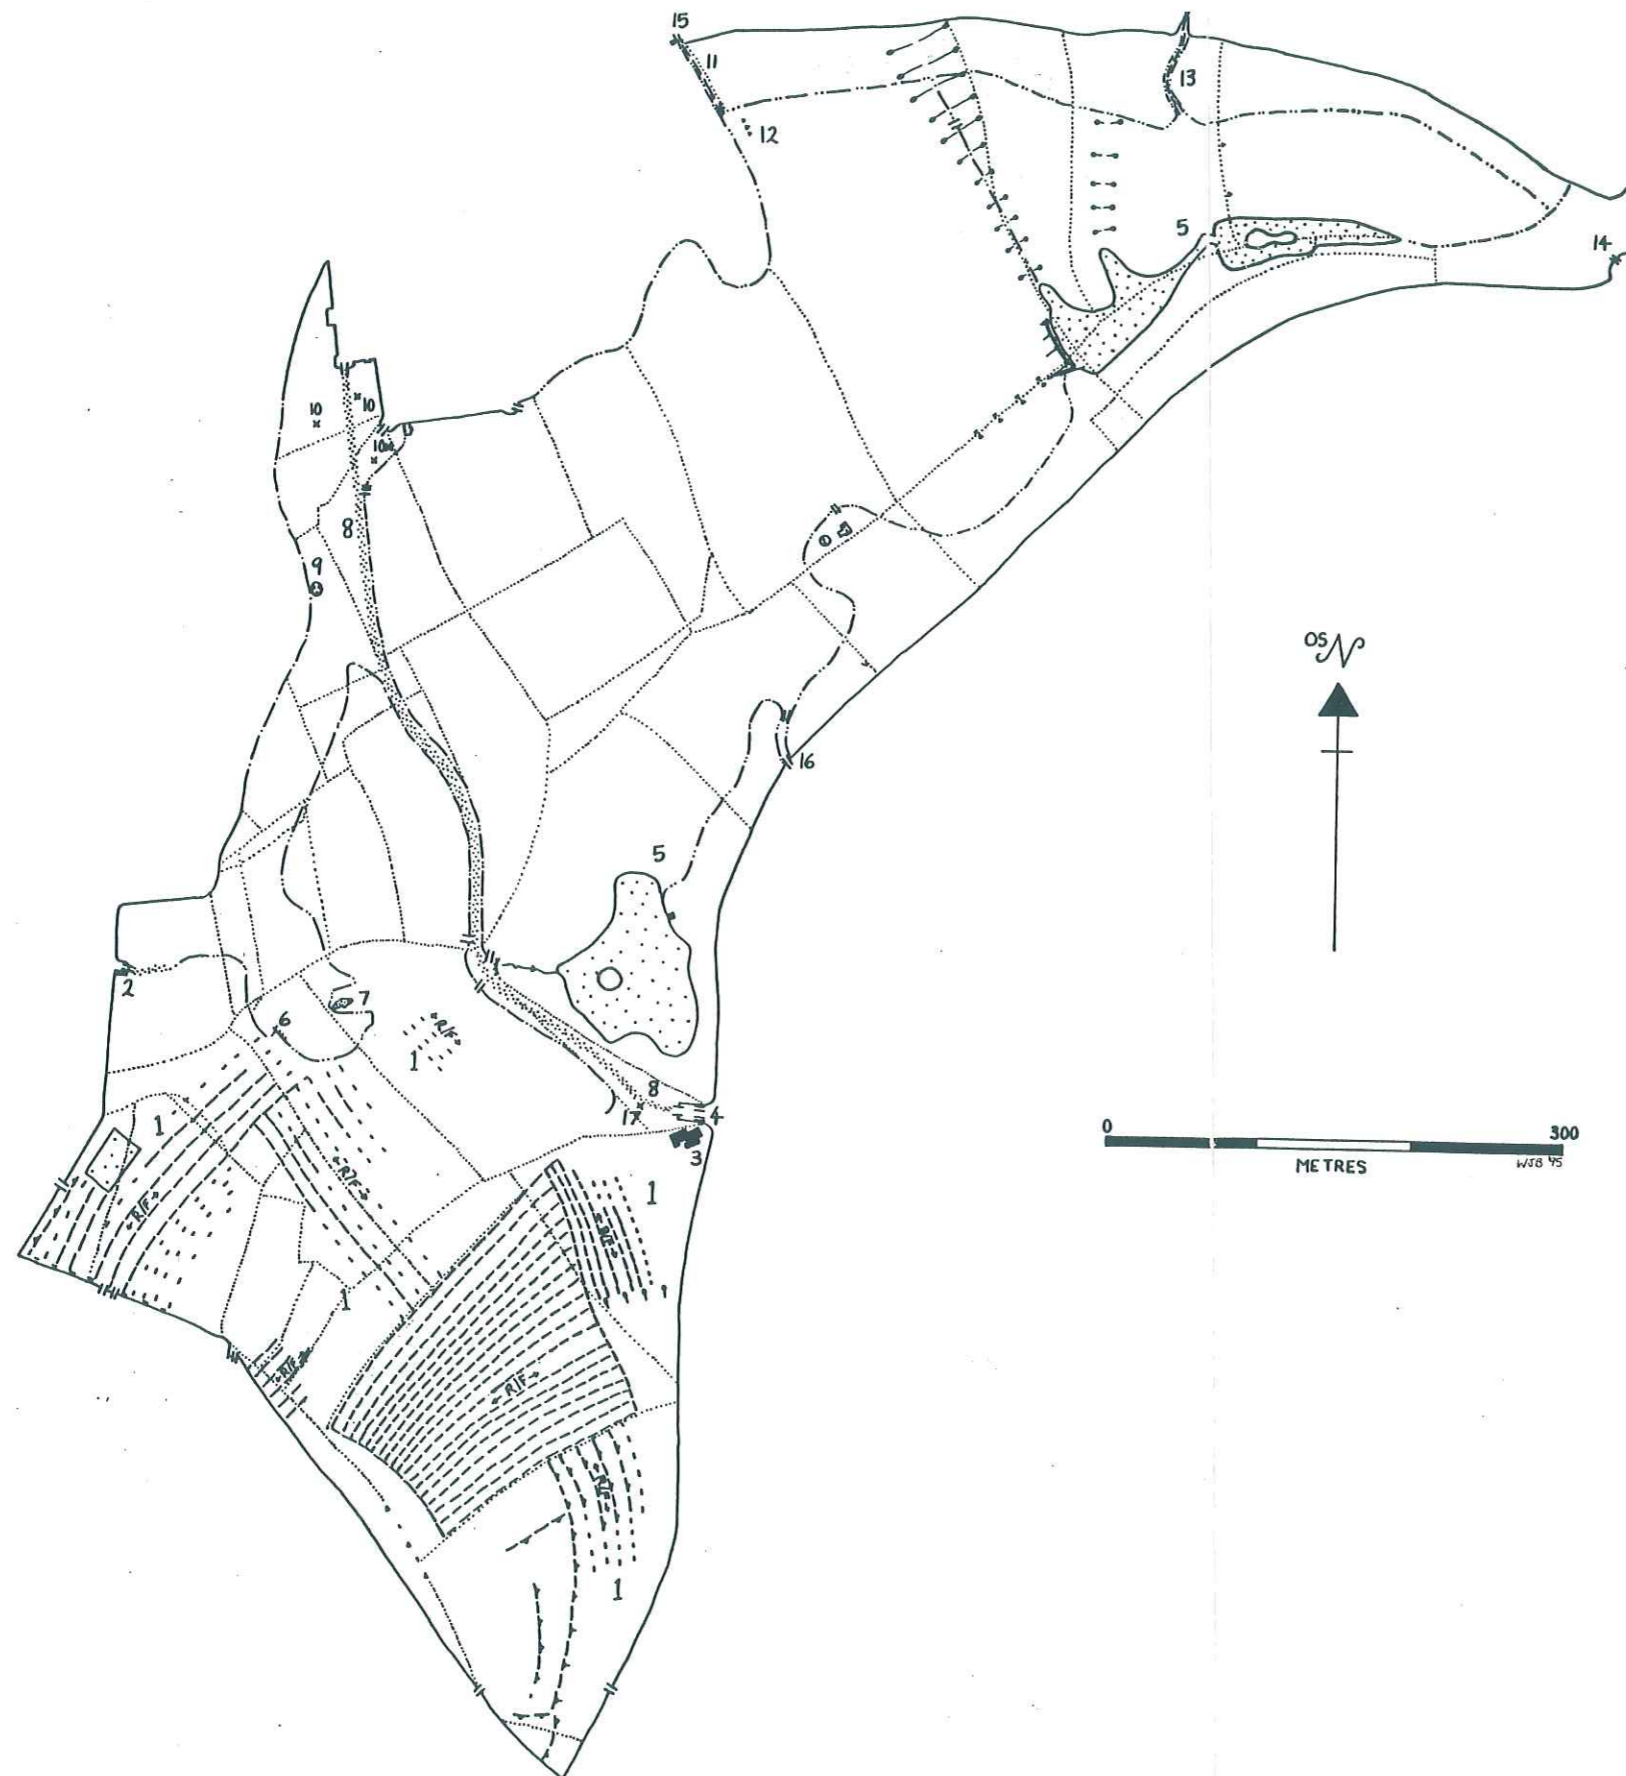
PROJECT	THORNBRIDGE HALL PARK
ILLUSTRATION NO.	6
TITLE	ARCHAEOLOGICAL FEATURES
FIELDWORK DATE	NOV. 1995
DRAWING DATE	APRIL 1996
DRAFTSPERSON	WJB
REF.	/

The following plan (figure 6) records all the archaeological sites identified in the park during fieldwork in 1995. Each archaeological feature is identified by a number which corresponds with that used in the catalogue in Part 5.
